**GEOTECHNICAL EVALUATION OF A MORNING
GLORY SPILLWAY FAILURE FOUNDED ON
EXPANSIVE
AND DISPERSIVE CLAY**

Farhat Javed, Brig. Asghar Nasim

ABSTRACT

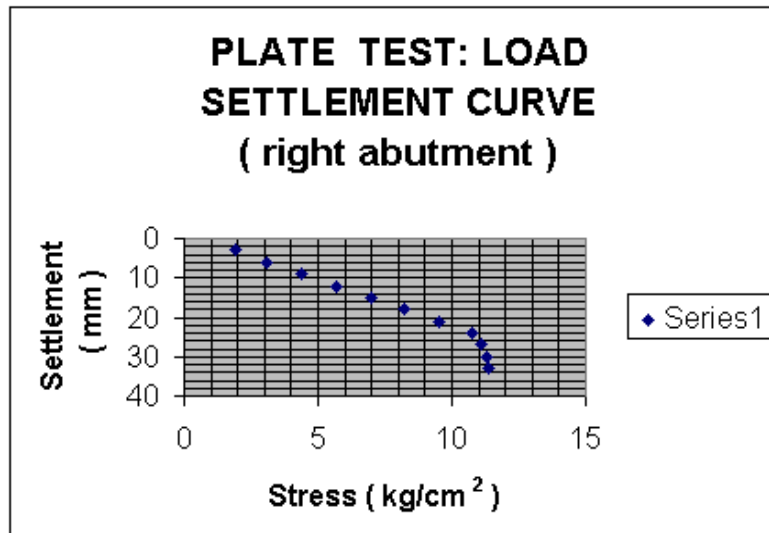
Figure 2. Results of plate load test

Standard penetration tests conducted on the foundation material yielded average blow count of 40 for 3 m depth. The corresponding allowable bearing capacity is 4.8 kg/cm² under undisturbed state. The same soil yielded a low blow count of 7 when the foundation was saturated yielding allowable bearing capacity of 0.7 kg/cm². Equation proposed by Peck et al., (1974) for 25 mm settlement was used for these computations. Plate Load test conducted in the field in dry conditions on the U/S of the spillway crest yielded ultimate bearing capacity of 11.4 kg/cm² corresponding to 25mm settlement (Fig 2). Unconfined Compression test was conducted on nine undisturbed specimens carefully carved out of block sample. These tests yielded average unconfined compression strength of 12 kg/cm² which is in conformance with the results obtained from SPT and plate load test. Unconsolidated Undrained Triaxial Tests were conducted on two specimens. These specimens were saturated prior to shearing and yielded undrained strength of 0.9 kg/cm². This indicates that saturation of this material can cause ten times reduction in compressive strength. Free *swell test* (Katzir & David, 1968, Das, B.M, 1990) was conducted in the odometer cell under a small surcharge of 0.07 kg/cm². The test was conducted on two specimens (Fig 3) and for each the specimen swelled from original height of 20 mm to 22 mm. The swell is, therefore, 2 mm and the value of free swell comes out to be 10%. The swell pressure of Surla shale was determined through the *restrained swell test*. The specimen was placed in an odometer under a small surcharge of about 0.07 kg/cm². The load on the specimen was increased periodically after it was inundated so that the height of the specimen remained constant. The vertical stress necessary to maintain Zero volume change is the swelling pressure. When this test was conducted on Surla clay it yielded a swell pressure of 1kg/cm². The final moisture content of the specimen was 14.4 %.

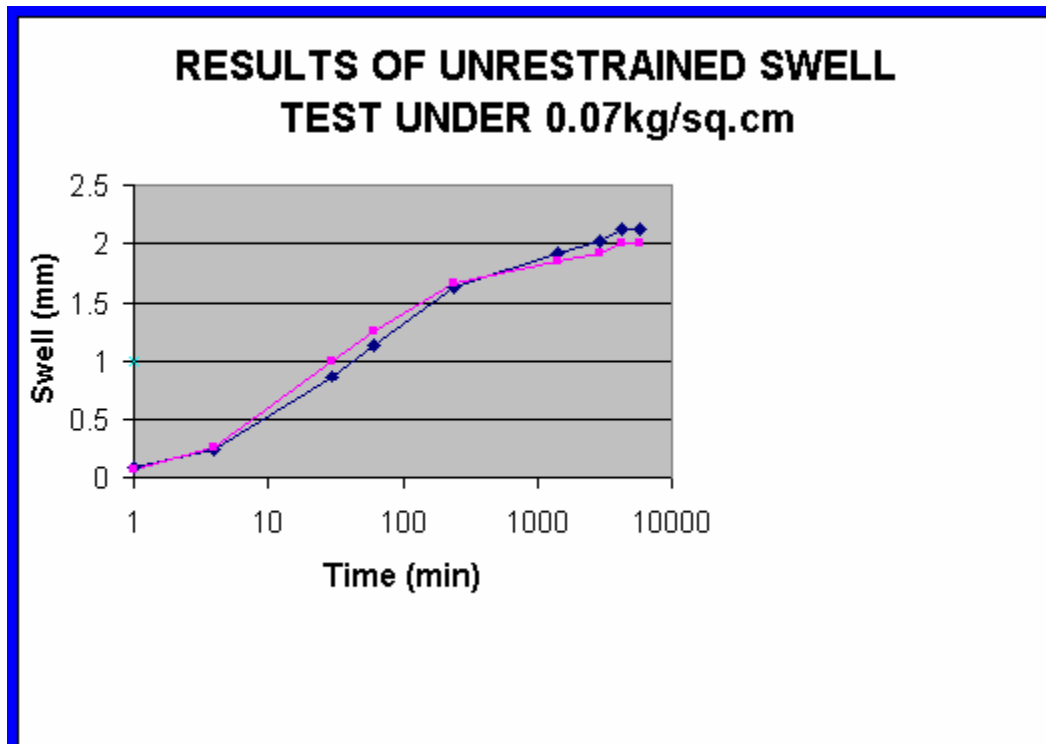
Figure 3. Results of unrestrained swell test

A number of unrestrained swell tests were also conducted on Surla clay. An initial pressure of 0.1 kg/cm^2 was applied over each specimen to simulate field loading from the concrete slab. The specimen was inundated and allowed to swell. Once the swelling seized the specimen was loaded. The pressure required to bring back the specimen to the original height is the swelling pressure. Typical test results reported in Fig. 4 and Fig. 5 indicate that the average swell pressure is 2 kg/cm^2 . The swell pressure from this test is roughly twice the swell pressure from

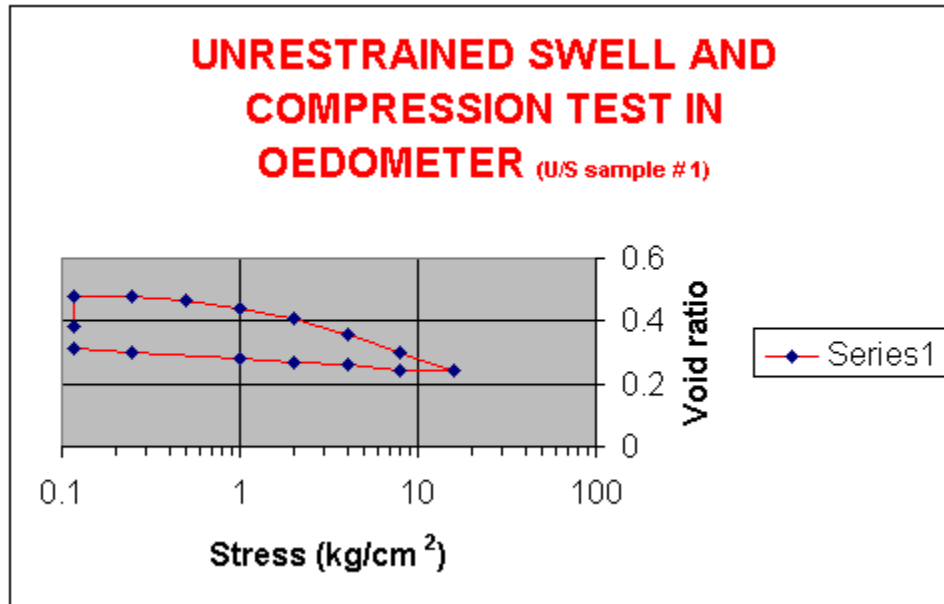
Figure 4. Results of unrestrained swell and compression test in Oedometer

the constrained swell test. The average value of a_v & C_c was determined to be $0.005 \text{ cm}^2/\text{kg}$ and 0.2 respectively. Pinhole test (ASTM, 1998, Sherard et al., 1976) was also conducted on Surla clay to determine the erodability or dispersion potential. When the sample was subjected to 5 cm of head the out flowing water experienced a colour change implying that soil particles were coming out. Thus the soil has high erodability potential and is classified as D1 according to ASTM specifications.

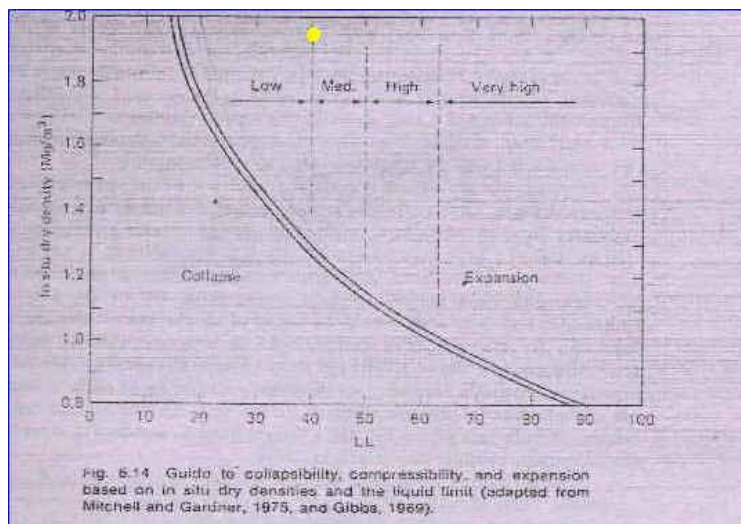
Figure 6. Liquid limit and in situ dry density of surla clay plotted on the curve proposed by Mitchell and Gardener (1975)

The region is frequented by collapsible soils and it was speculated that failure of spillway occurred due to soil collapse upon saturation. The consolidation test was performed on undisturbed samples collected from the U/S, middle and D/S portions of the spillway. These tests were expected to show collapse of soil structure upon saturation. On the contrary the soil expanded when it was saturated thus establishing that the foundation material is expansive clay. A number of methods and soil tests were used to confirm swelling characteristics of Surla dam clays. These included swelling tests and other simple laboratory tests and correlations with the classification and index properties of the soil. Swelling clays characteristically possess high liquid limit and plasticity Index. For the range of plasticity index of 15 to 28 and shrinkage limit of 10 to 16 the probable expansion of the soil is in the medium range. Thus the clay at Surla dam has medium swelling potential. Similarly when the liquid limit and in situ dry density of surla clay (40 and 1950 kg/m³ respectively) were plotted on the curve proposed by Mitchell and Gardener (1975) , the Surla clay plots as medium expansive(Figure 6). Seed, etal. (1962) developed the relationships (Fig.7) for artificial mixtures of sands and clays compacted to maximum unit weight by standard Proctor compaction and allowed to swell against a 6.9 kPa (1 psi) surcharge. These relationships between activity and percent clay sizes have also been shown to be applicable to natural soils. The purpose of Figure 7 is to identify a potentially swelling soil, which may require further study and tests such as an expansion or swell test. As per this graph Surla dam clay has medium swell potential. Based on *modified free* swell index for clays, as suggested by Sivapullaiah, Sitharam, and Rao (1987), the modified free swell index for Surla clay is 3.54 thus indicating that the soil has moderate swelling potential.

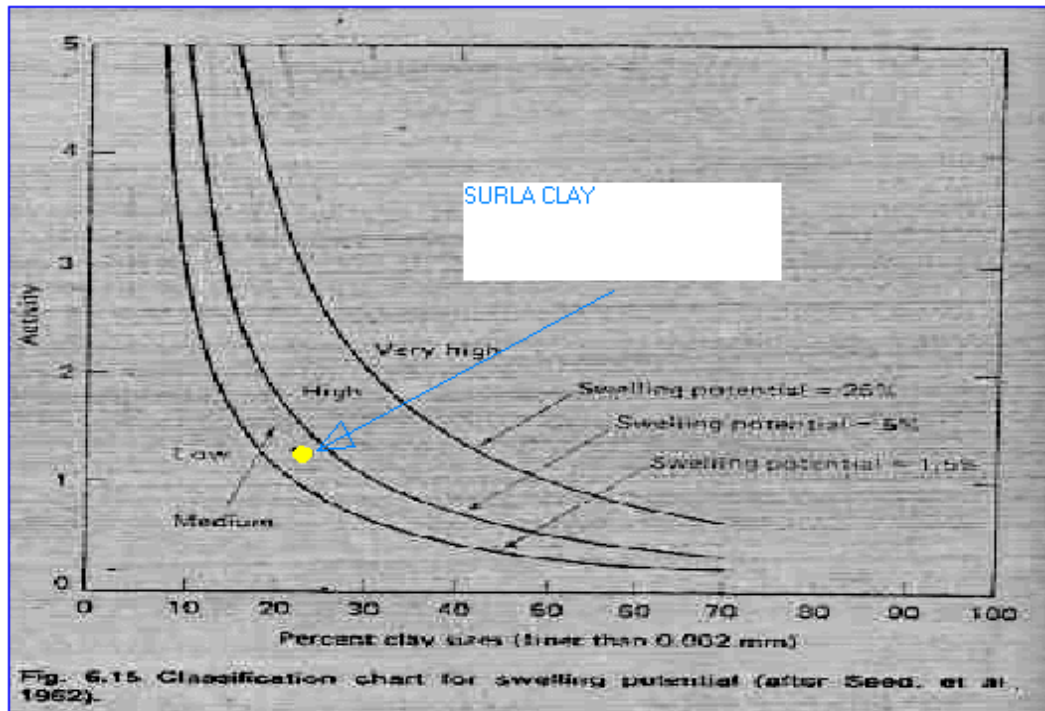
Figure 7. Identification of potentially swelling soils using activity & % clay

These results confirm that the Tables and curves developed by various agencies and researchers are reasonably accurate for predicting swelling potential of a soil based on simple index tests. Unconfined compression, SPT and plate load tests were conducted at site to determine the bearing capacity of soil under saturated and unsaturated states. Allowable bearing capacity of the soil in its unsaturated undisturbed state is very high i.e., 4 kg/cm². Standard Penetration Tests and plate load Tests under saturated conditions were also conducted in situ by pre-wetting foundation material. These results also yielded a bearing capacity much in excess of the pressure applied by the self weight of the structure i.e., 0.1 kg/cm². Triaxial tests were conducted on undisturbed samples in saturated state to determine the bearing capacity of foundation material in saturated state to model foundation saturation after impoundment of reservoir yielding allowable bearing capacity of 0.34 kg/cm². It implies that the spillway is safe against soil bearing failure and some other mechanism caused distress.
