PAPER No. 223.

REFLOORING THE SUKKUR CHANNEL BRIDGE.

By S.L. Kumar, Assistant Bridge Engineer, N.W.R.

This Paper on the reflooring of the busy rail-cum-road bridge at Sukkur describes the work, how it was carried out with a minimum of inconvenience to traffic and how improvements have been introduced to facilitate maintenance.

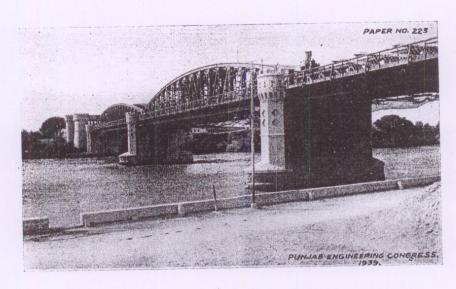
Photo No. 1. The Sukkur Channel Bridge on Indus.

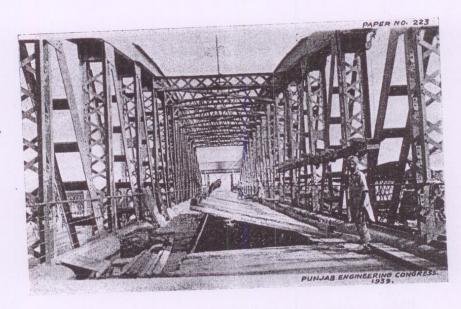
Photo No. 2. Lowering of the Draw Bridge.

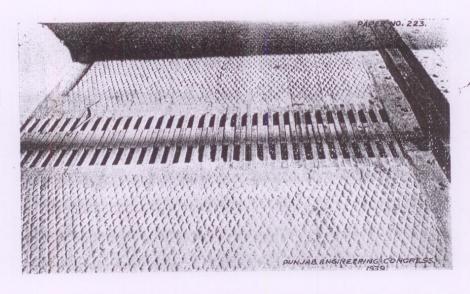
Photo No. 3.=Expansion Arrangement (part) on Pier.
