**FAILURE OF SUKKUR
BARRAGE GATE NO. 31
AND
REPLACEMENT
PROGRAMMES STUDY**

A. R. Memon

ABSTRACT

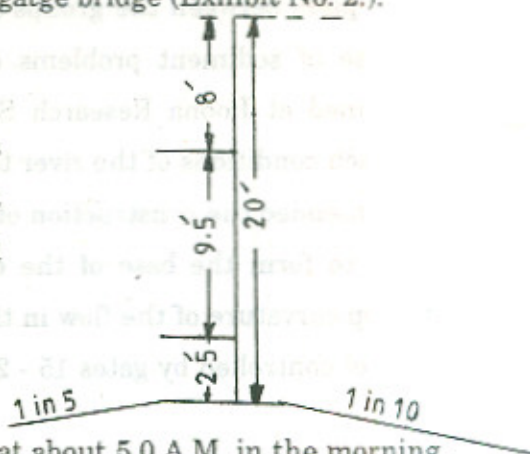
The rough sketch alongwith two bow girders is shown at the side. The details of bowgirder are shown at later pages. The load distribution between upper and lower girders is approx. 40 : 60.

5. It was during 19-20th night of December 1982 at about 5.0 A.M. in the morning, that the lower bowgirder of gate No. 31 went with a big bang and the whole gate settled at about 7 ft. above the cill crushing the skin plate as well as upper girder. It being 'December', the gates completely were closed as Kotri Barrage does not get any winter supplies.

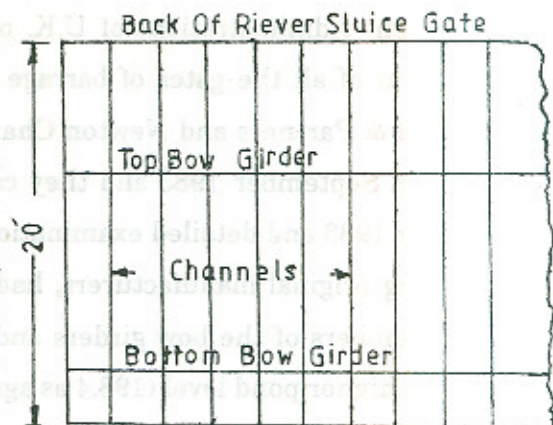
(b) Skin Plate Stiffeners :

A high percentage of these have corroded right through leaving ragged flanges on the bow girder with large holes through the channel section webs. On the river sluices, this damage is mainly at the bottom of the gate where the lower bow girder is attached. On the scouring sluices the damaged area is higher up in the region of the upper bow girder. The fixing bolts were also badly corroded.

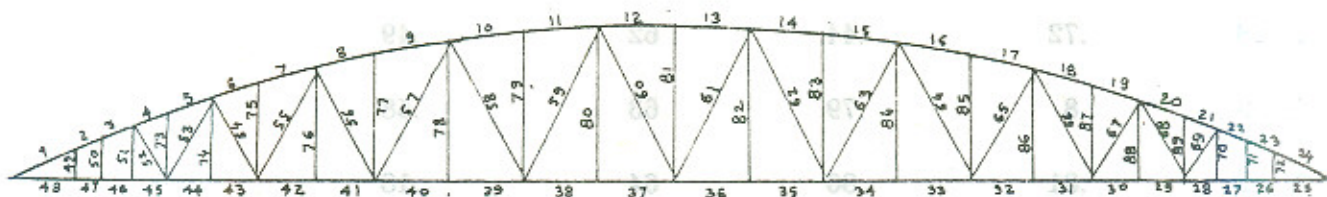
Typical Bow Girder for river/scour gates.

The examination of stresses indicate that the original design stresses are generally acceptable. The central section of the curved back bow beam is the most heavy stressed member. Highest stress ratio values are for the back curved beam and front channel beams from 0.37 to 1.04 and 0.47 to 0.87 respectively.

The analysis of the results indicated that curved beam member 6-7 showed stress ratio of 1.11 and 12-13 showed 1.29. Even the diagonal members which were stressed to roughly 50% permissible loading (originally) showed as high as 0.85 to 1.02 stress ratios. The result was even confirmed by the strain meter guages. The main cause has ben the corrosion, over the years, of the useful metal. The failure has taken place when the useful metal has corroded by more than 30% in some of the members of upstream curved beam bow girder.
