WARSAK DAM PROJECT PROBLEMS & REMEDIES

Dr. Izhar ul haq
Director DMO WAPDA.

WARSAK DAM PROJECT PROBLEMS AND REMEDIES

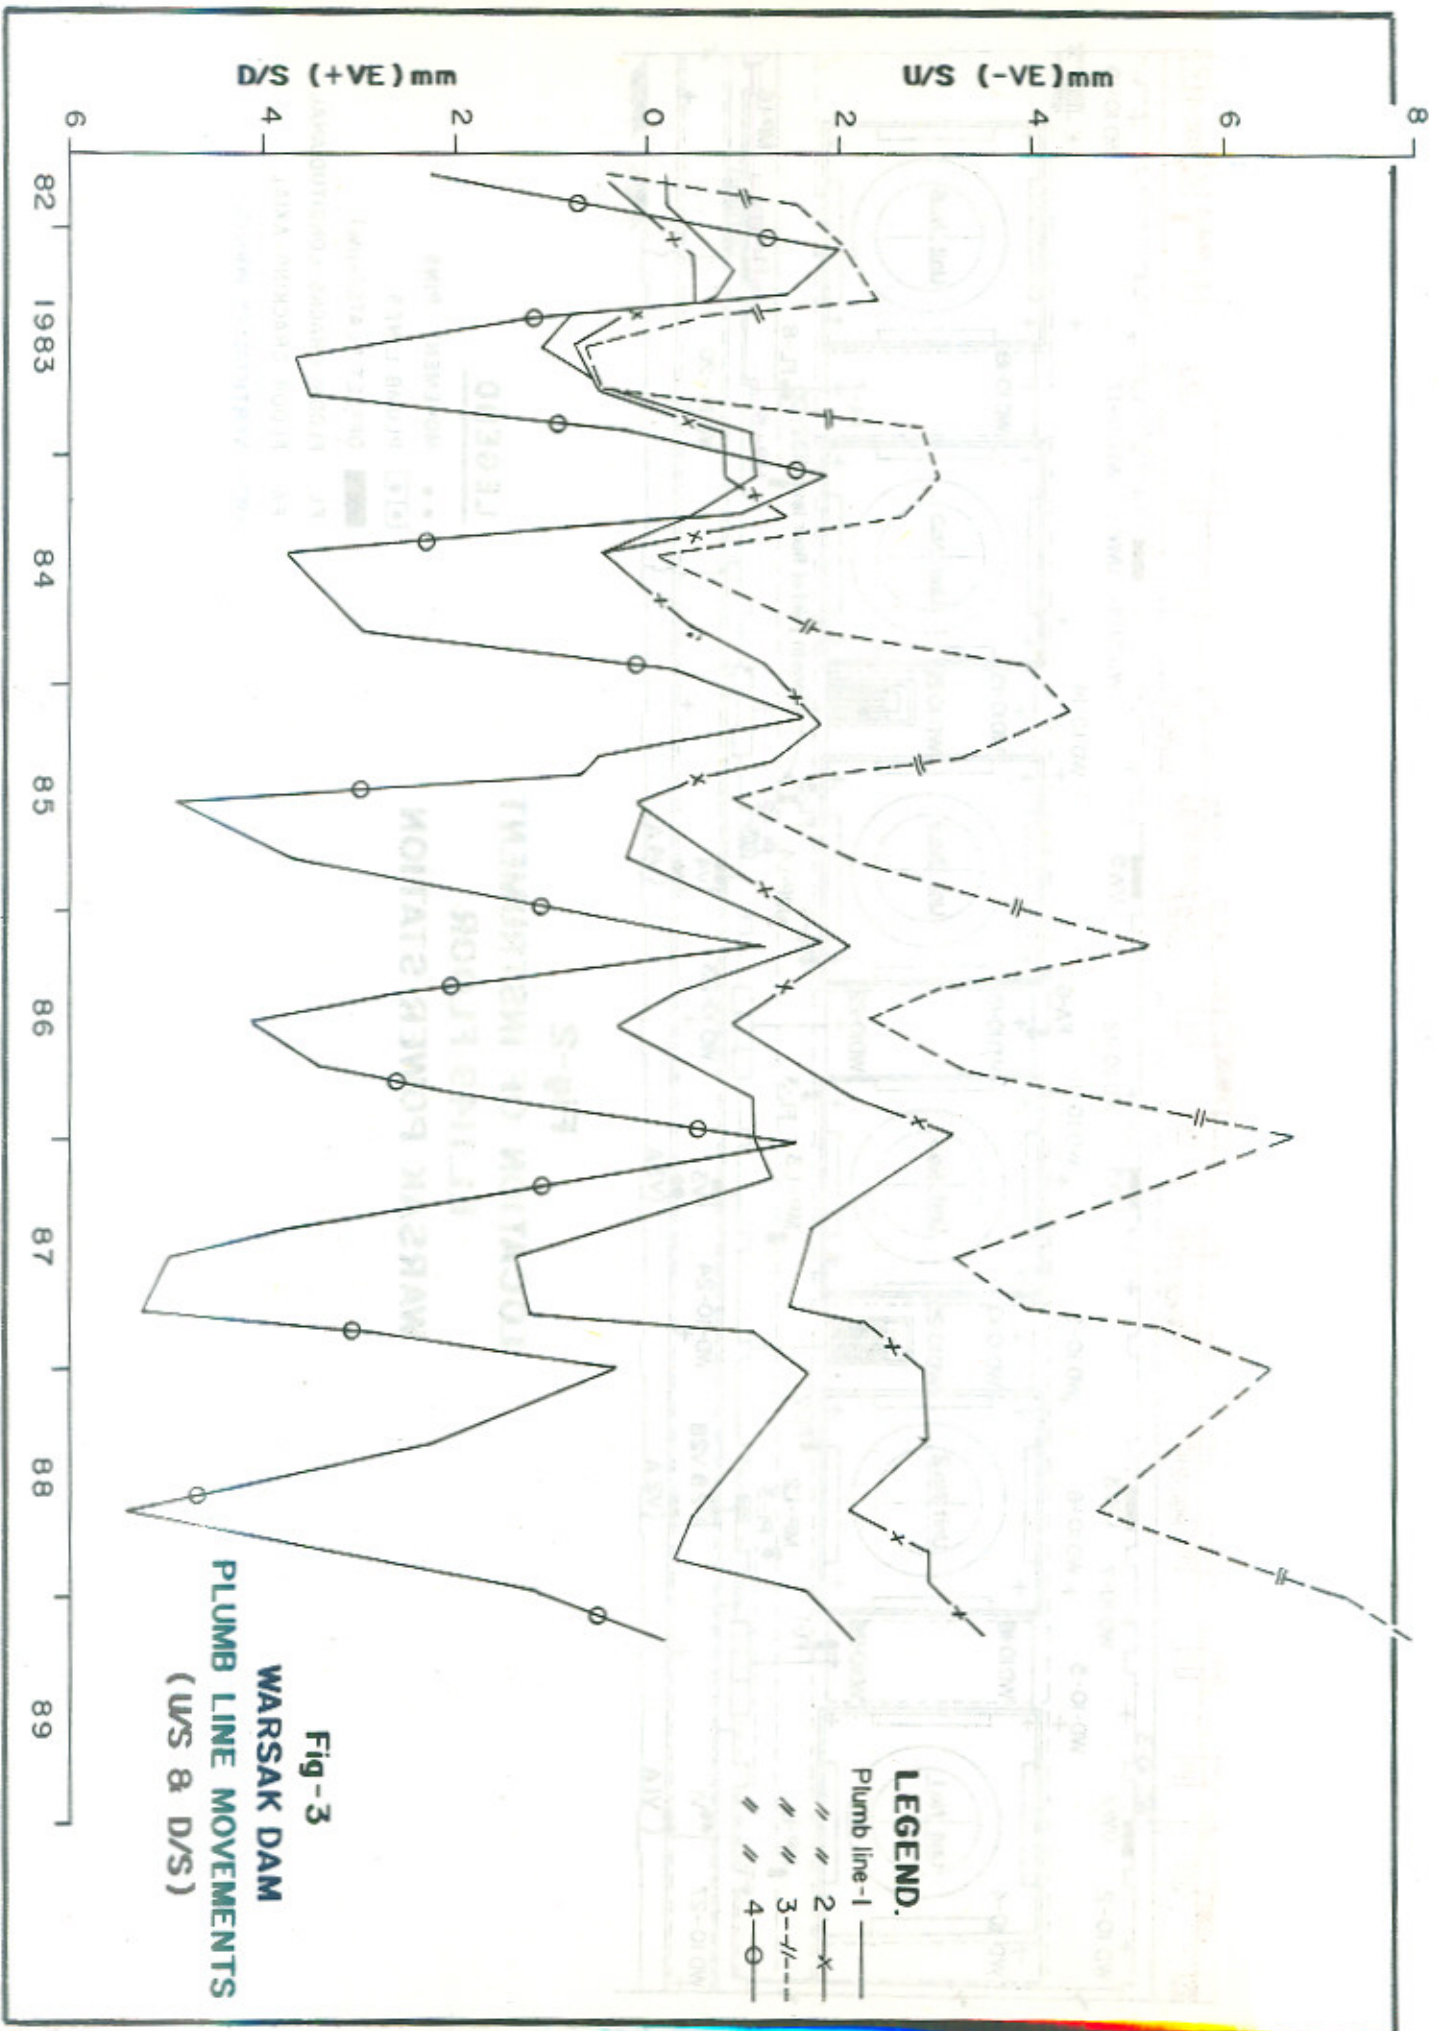
Plumb lines Nos. 1 &2 were installed during Nov. 1975, while Nos.3 and 4 during April, 1982. The data have been plotted at Fig.3. The major movements occur in the upstream and downstream directions, while the movements in east-west directions are negligible. From the trend and pattern of the movements of plumb lines, two types of movements are established in upstream and downstream direction. One may be termed as cyclic and the other one as residual. Cyclic movement corresponds to the seasonal variation in temperature in the area. All the plumb lines move in the upstream (southward) direction during winter and in the downstream (northward) direction during summer having their peaks during Dec. and June respectively.

When compared with the previous years, it was observed that with the passage of time the peaks of cyclic movements vary gradually with a specific trend producing a residual movement in one direction. For example movement of plumb line No.3 is continuously increasing in upstream direction, while at plumb line No.4 it is continuously increasing in downstream direction. The movement of plumb lines No.1 and 2 has no significant trend but on the whole it is slightly in the upstream direction. Thus due to residual movements, the peaks in every subsequent years are greater than the previous

years. These types of movements confirm the presence of structural movements in the area.

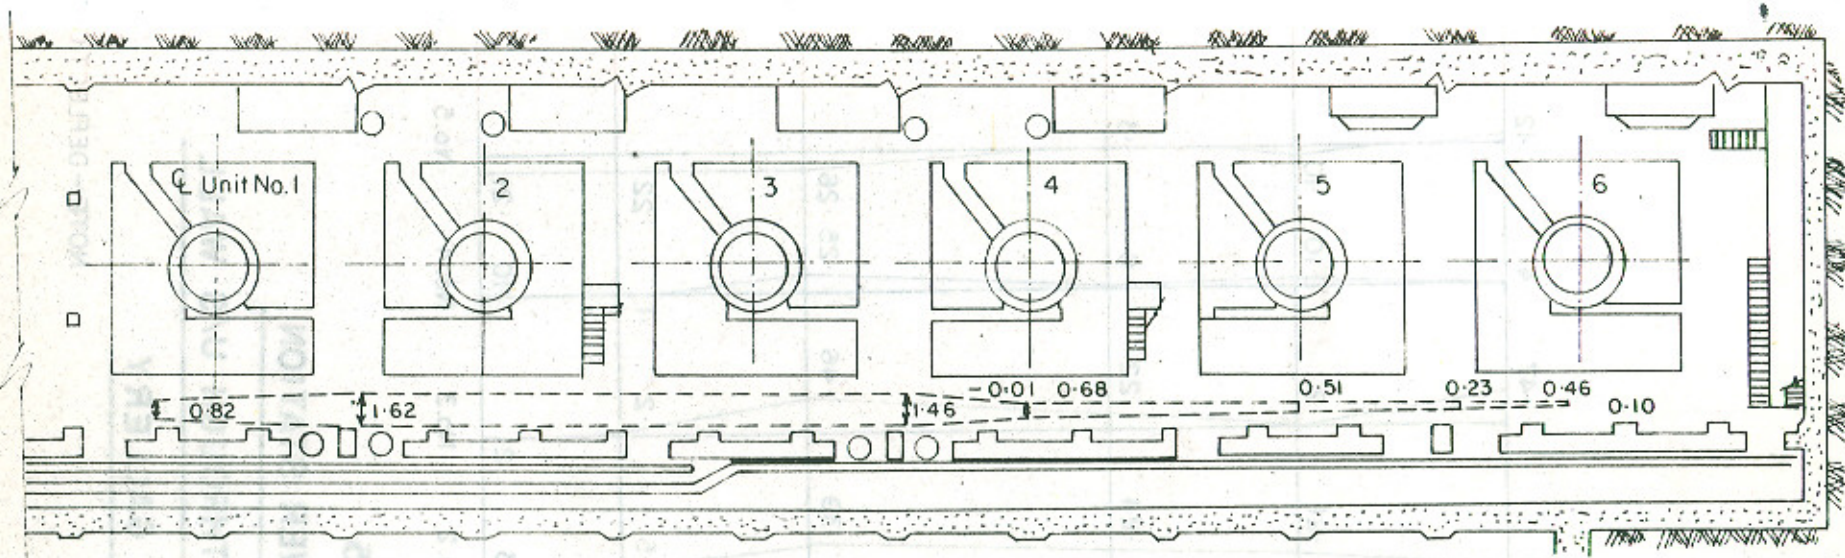
Fig. 4

Six number movement pins designated as L1 to L6 have been installed across the longitudinal construction joints at elvation 1132 floor, downstream and opposite of each unit (generator housing). Out of these pins No.1 to 4 were installed during March 1975, while the remainings No.5 and 6 were installed during Nov.1980. These pins have been showing continuously an opening trend since their installation. This is the area where longitudinal joint opening is maximum as compared to any other area of the building. The magnitude of openings with the passage of time is given in the table below, and shown in Fig.4.

Pin No.	Movement upto 15 Nov. 1980 (Inches)	Movement upto 15 Nov. 1984 (Inches)	Movement upto 15 Nov. 1988 (Inches)	Movement upto 15 Feb. 1989 (Inches)
L1	0.045	0.115	0.175	0.196
L2	0.198	0.382	0.51	0.525
L3	0.245	0.453	0.63	0.655
L4	0.335	0.52	0.725	0.75
L5		0.1075	0.22	0.23
L6		0.025	0.0325	.04

From the set of above readings it is obvious that maximum joint opening has taken place at unit No.4. The magnitude of opening increases along the joint, going from east to west. The movement decreases significantly in the extreme west i.e, opposite unit No.6, however the pin No.5 and 6 were installed 5 years later.

MOVEMENT ACROSS MAJOR CRACK (In mm)

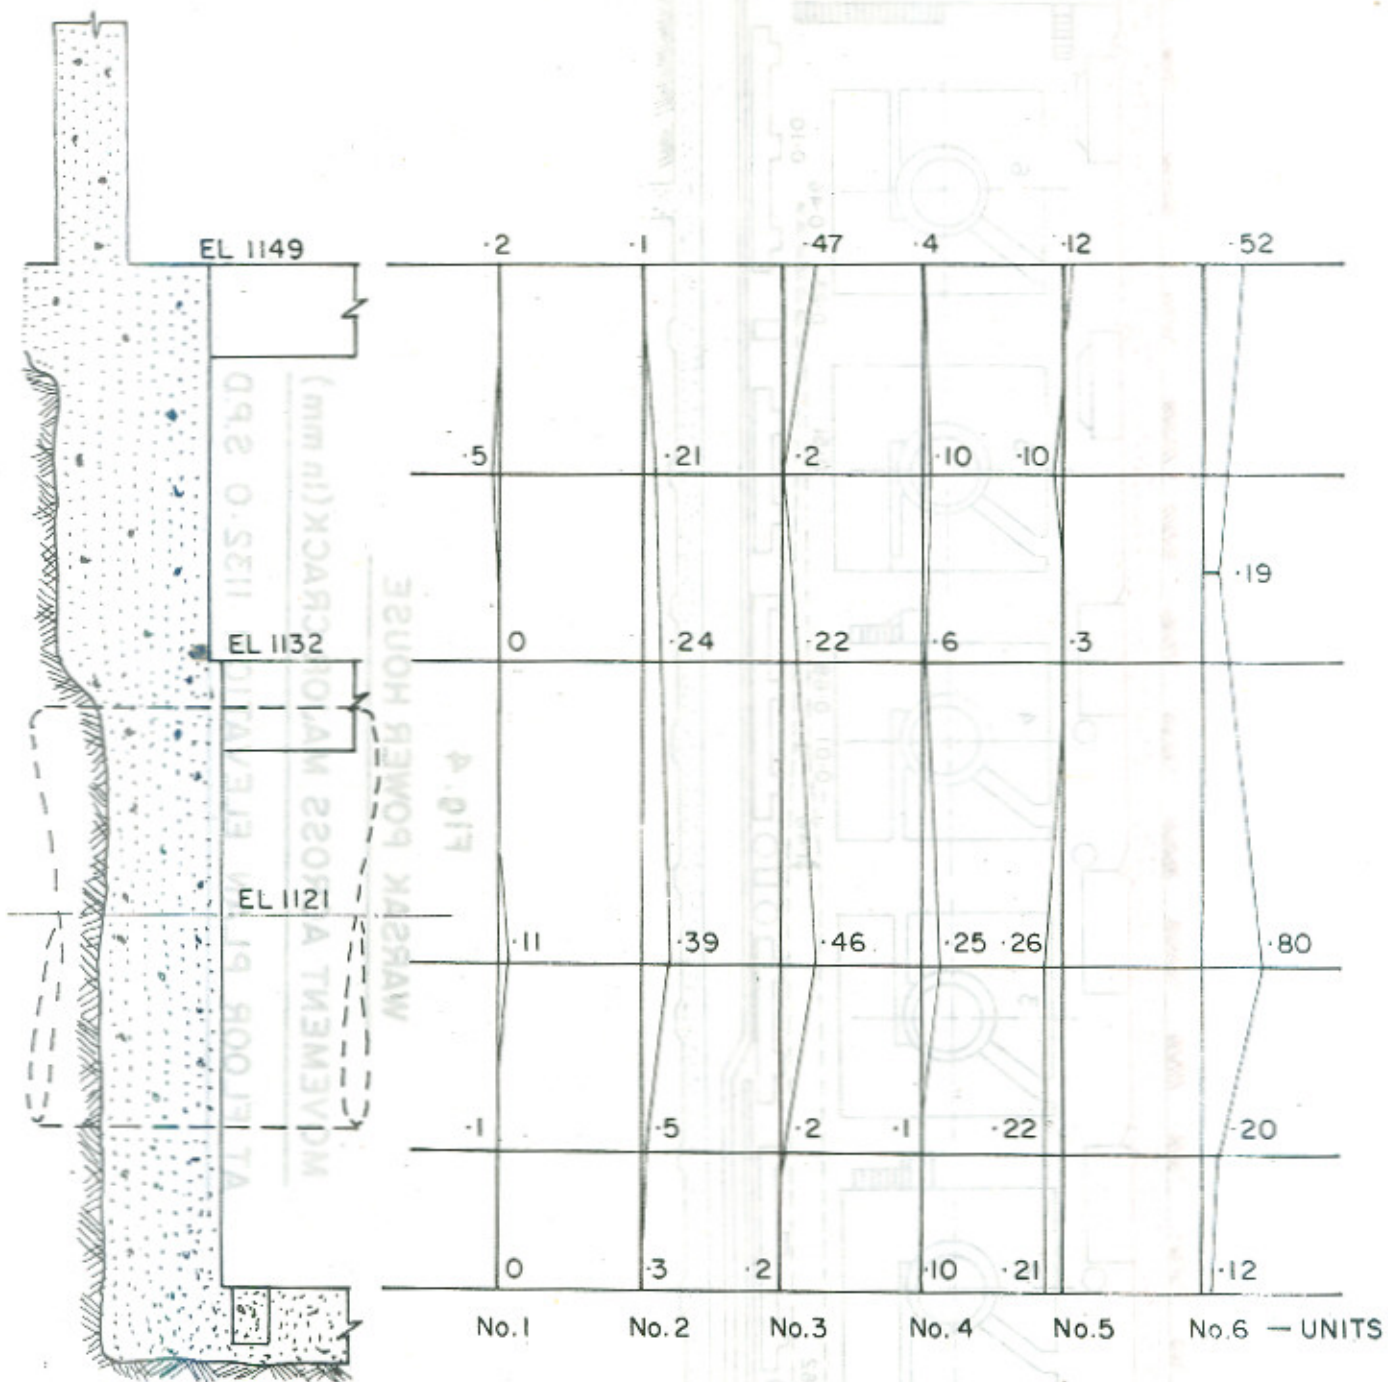
Fig-5
WARSAK POWER STATION
VERTICAL SECTION THROUGH U/S WALL
OF VALVE GALLERY

Fig.5 shows the movements on a vertical cross section through the upstream wall of the valve gallery, while Fig.6 shows the movements on a vertical cross section through the downstream wall of the power house. The most significant feature of these sections is the large and consistent displacement which occurs within the height of the draft tubes. When reviewed in conjunction with the dominant diagonal cracks observed in the walls of the draft tubes, it is apparent that the building as a whole is being moved outwards by some forces located above 1085 ft. elevation. As there is little to indicate that significant lateral displacement has taken place on the valve gallery side of the concrete blocks housing the scroll case and as there has been no bed rock movement of any significance, the cause of the outward movement in the downstream wall of the power house must lie within the structure itself. The overall lateral movements are shown, together with the upward movement and the major cracking in Fig.7.

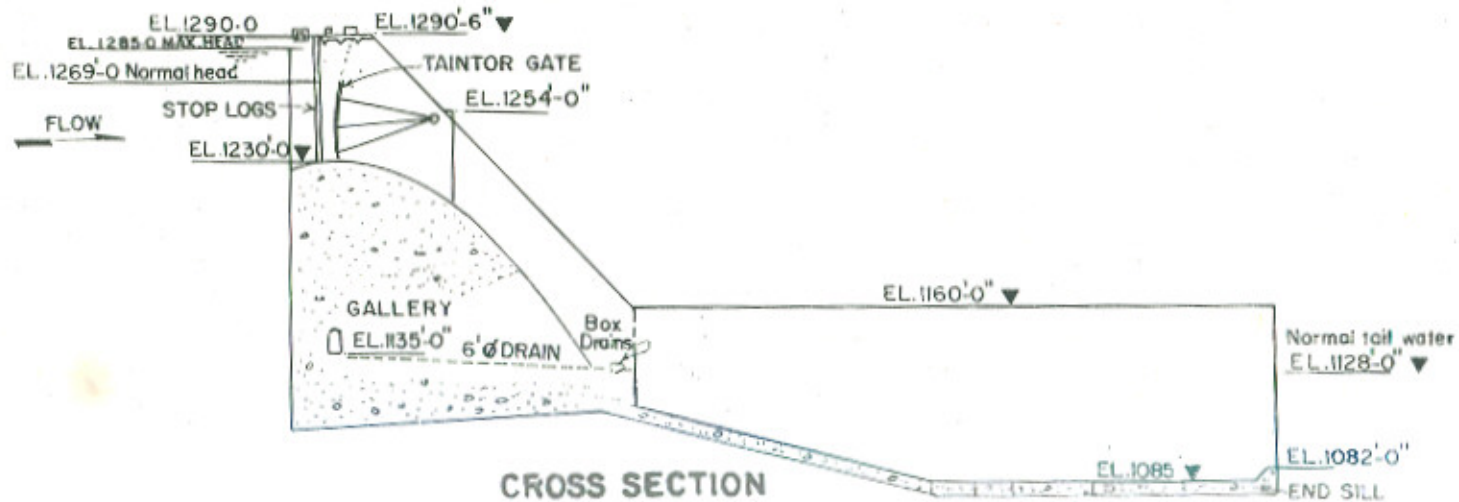
**Fig-10 MAIN DAM SPILLWAY CHUTE STILLING BASIN
VARSAK DAM**

The chute of spillway is eroded and sand blasted. The concrete aggregates are exposed over the entire surface. However the erosion is not deep and no reinforcing bar is exposed.

Although the stilling basin was repaired in 1978-79, the concrete lining has been again destroyed by the grinding action of abrasive sand and stones. At present a lot of debris is lying on the floor of the stilling basin.
