# **TROUBLES EXPERIENCED WITH THE SILT EJECTORS ON TAUNSA CANALS AND REMEDIAL MEASURES**

**Shafaat Ahmad Qureshi<sup>1</sup>**

#### **TROUBLES EXPERIENCED WITH THE EJECTOR AT RD 7500 DG KHAN CANAL**

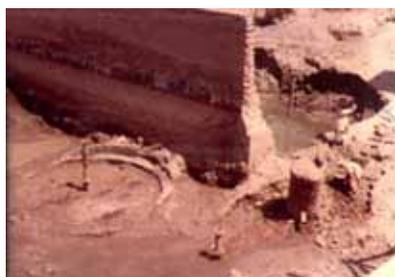
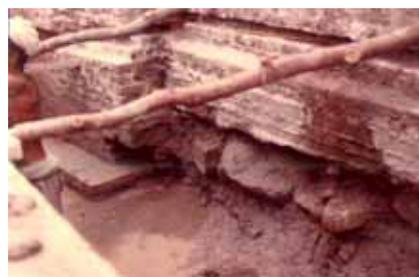
1. On 16.3 1975 a boil (Ref W1 plan 1) downstream of fourth concrete block in the first row of its

- inverted filter was spotted. Thus in order to avert failure of the structure a ring bund, around the boil, was immediately raised; and sufficient quantity of fine bajri was poured over the site of the boil. Later on the boil was plugged with cement concrete with the help of a caisson sunk over it.

4. On 3.1.1976 while dismantling the damaged flared out walls, all of a sudden the boil in the inverted filter zone (W1) again became active and started causing trouble in the execution of work. Thus in order to contain the boil, a ring bund of cement masonry had to be constructed around the boil, Yet when dismantling of the left side flared out wall was completed up to top of its foundation wells i.e. R.L 421.60 water started leaking a distance of 20 ft from the corner of the junction formed by impervious floor, left side abutment and return wall (Ref W2, plan 2) Efforts made to locate the source of leakage and to control the same remained fruitless.

Position of Boils, Ring bund and Caisson    Loose stones over transom slab of foundation wells of left side wall

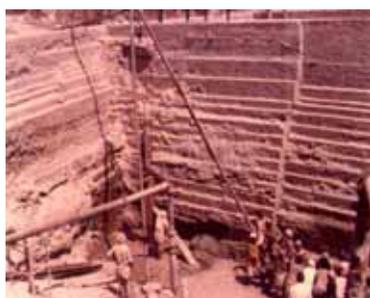
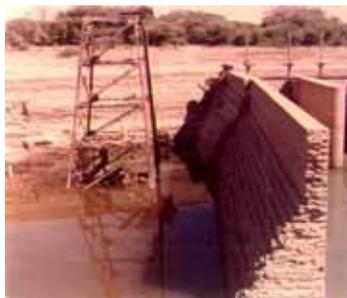
#### **Corner at the back of right abutment where boil erupted during Sheet piling**

After about 1½ hour, when water table in the working pit rose to R.L.423.00 the boil again disappeared automatically. However, it re-emerged at about 10.30 PM and continued till 6.00 AM the next day i.e.12.4.81 (when it again stopped without any intervention) The water level in the pit at that instant was at RL .419.50; out side the pit at the back of left side abutment at RL 421.6 and in the central D/S portion of the ejector (escape side) at RL 420.50

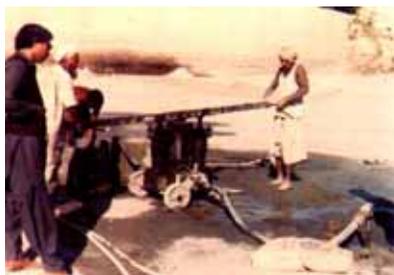
Sand grouting in the floor of the ejector in canal bed

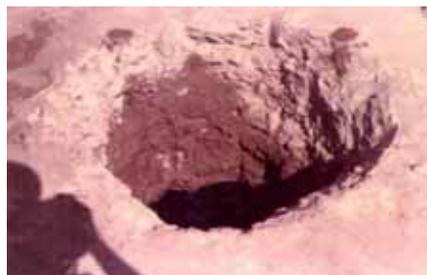
The extent of cavities and hollows can, however, be imagined from the fact that some of those opposite hole No 28 and opposite 27-A (only 4 feet away from the ejecting tube on the D/S side were observed to be 3.5 feet and 5.5 feet respectively. So by the end of Sep.1981 nearly 26,000 cubec feet of sand was grouted in them -mostly with gravity flow of water.

A view of a cavity in the floor of the ejector

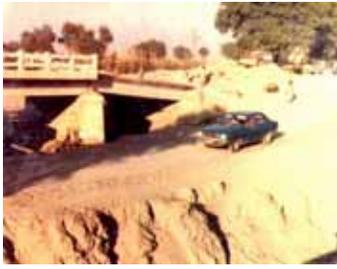
Road Diversion (during 1979)      Flow through the ejector after Remodeling      Temporary bridge over the escape
