**SEEPAGE CONTROL AT TARBELA DAM  
THROUGH  
UPSTREAM BLANKET**

**AMJAD M. AGHA,**  
M. ASCE, MIE (Pak)

Chief, Soils and Foundation Division  
National Engineering Services (Pak.) Ltd. Lahore

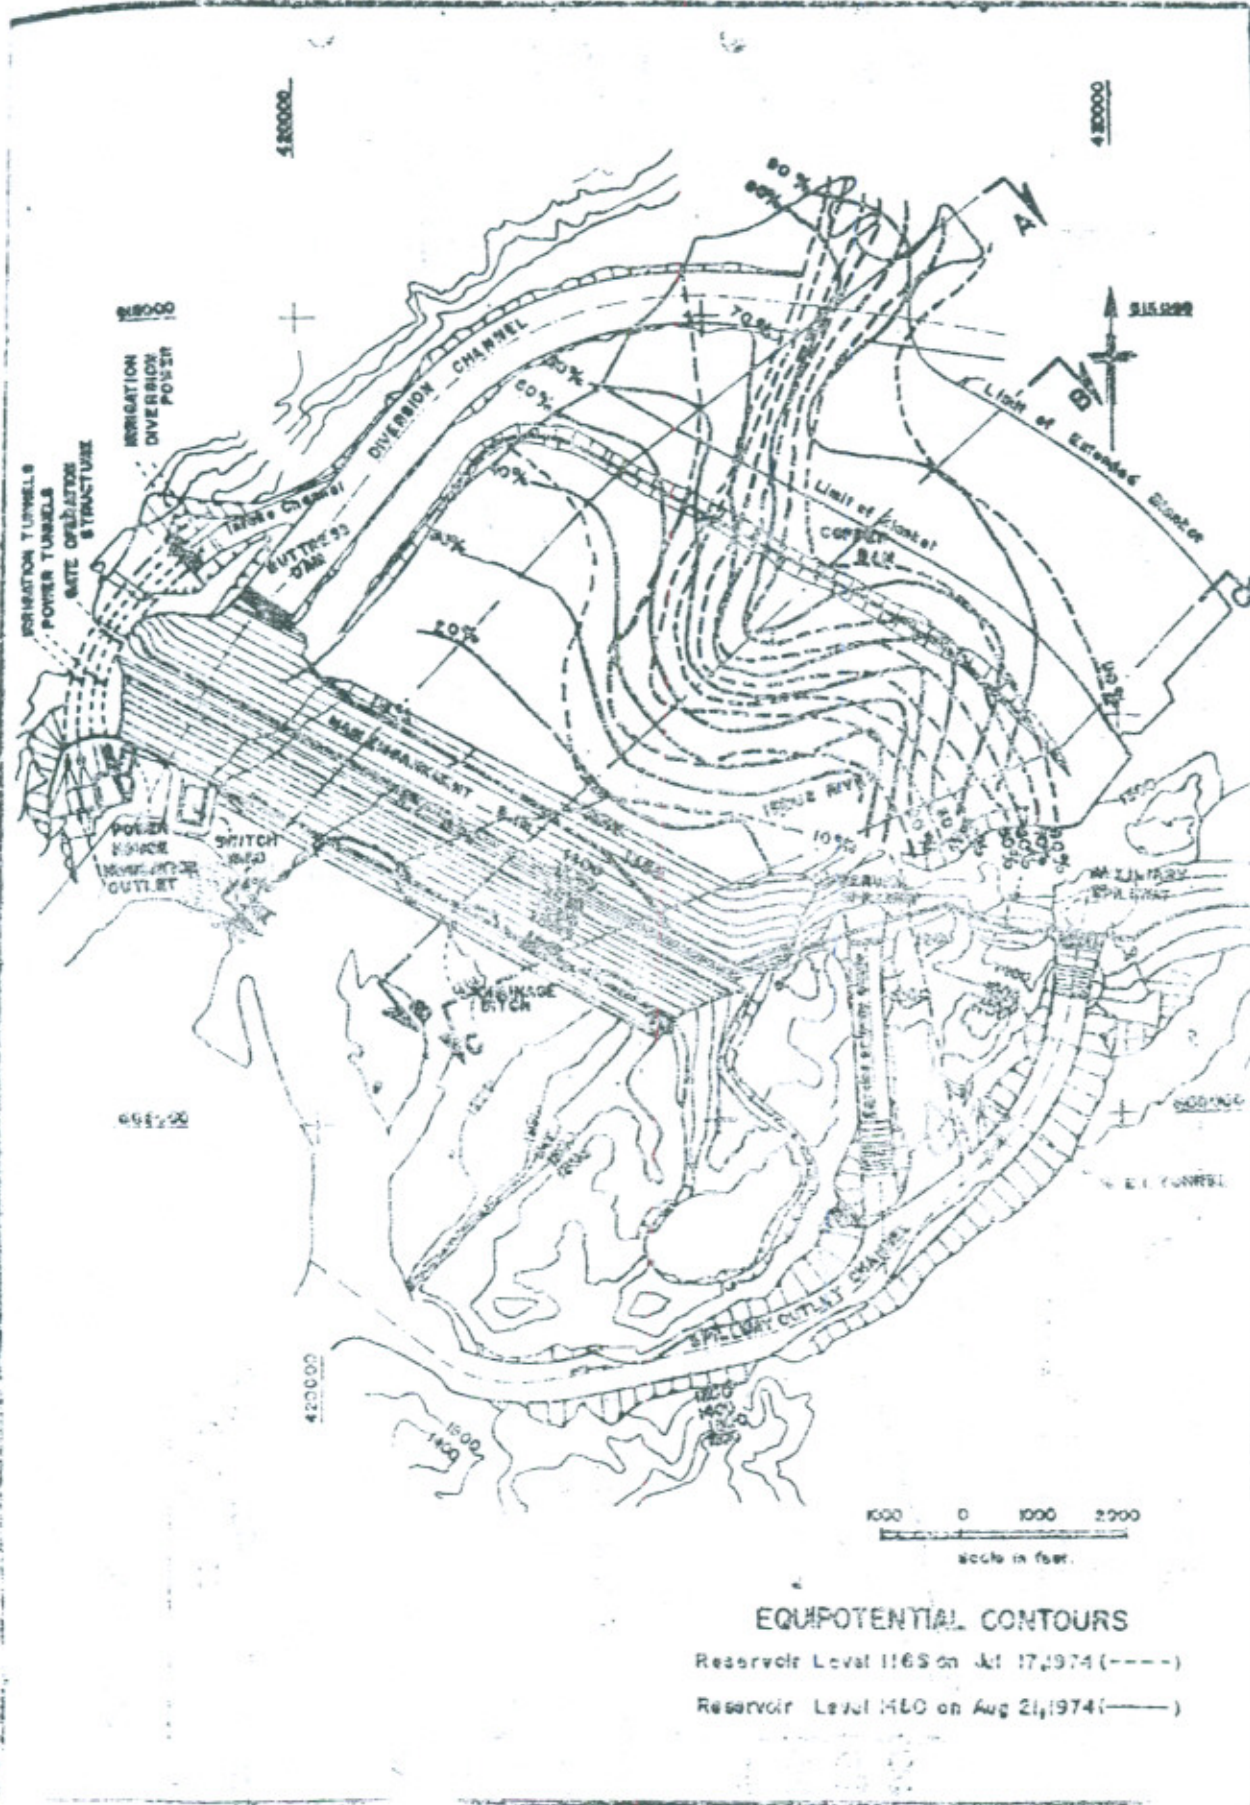
Fig. 2

Plots have been drawn (fig-2) showing the equipotential contours under the blanket for various levels of the reservoir.

These plots have been made along three sections. Section AA is through the right bank, Section BB is in the middle of the valley and section CC is through the left bank. The potentials in terms of percentage reservoir head are plotted under the blanket for different reservoir elevations.

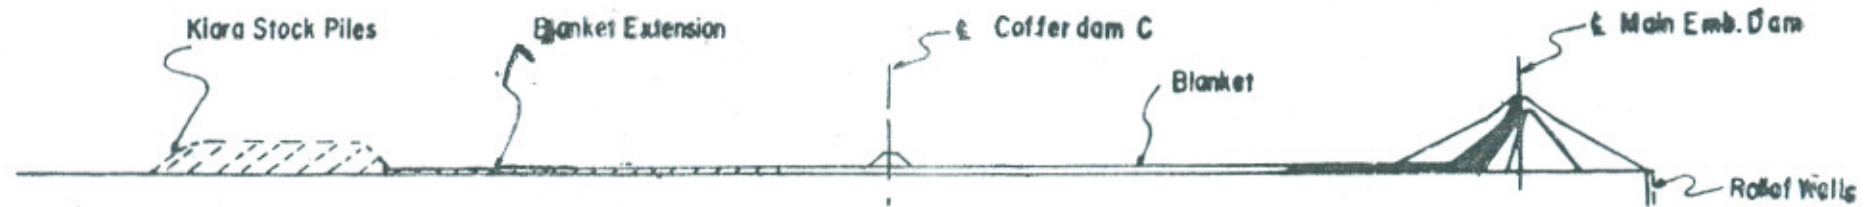
Fig. 3

In the plot AA (fig.3) at reservoir elevation 1168 the percentage potential immediately downstream of the extended blanket was 17 percent. However, the potential at the same point at reservoir elevation 1460 become 58 percent. The

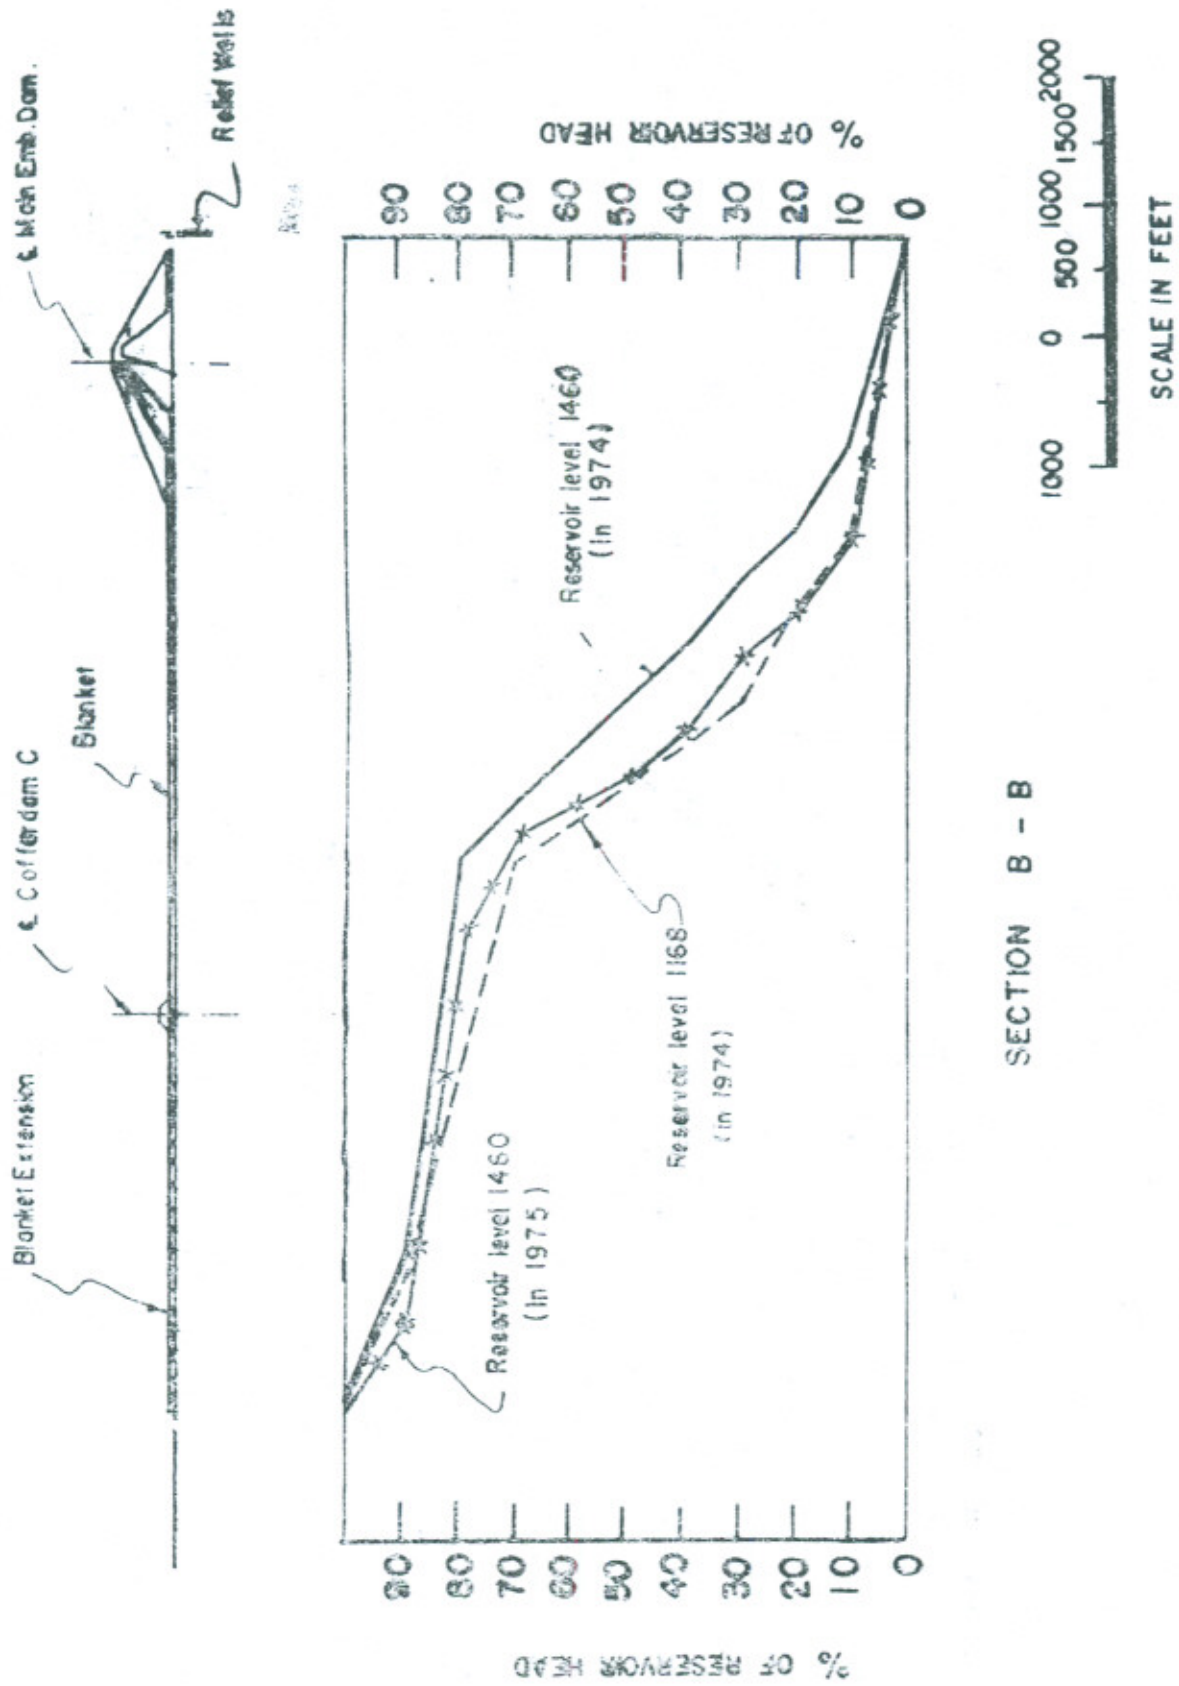
Fig. 4

plot BB, (Fig. 4) in the middle of the valley, shows very little potential drop in the extended portion of the blanket, and downstream of coffer dam 'C', there is an abruptly steep drop in the potential. The difference in the potential for higher reservoir elevation is not so significantly marked in the mid valley area. The plot CC (Fig. 5) on the left bank shows very little potential drop under the extended blanket and again downstream of cofferdam 'C' there is a steep drop. The potential lines also show a considerable shift from 1168 reservoir elevation to 1460 reservoir elevation, particularly in the area immediately downstream of the cofferdam 'C'.

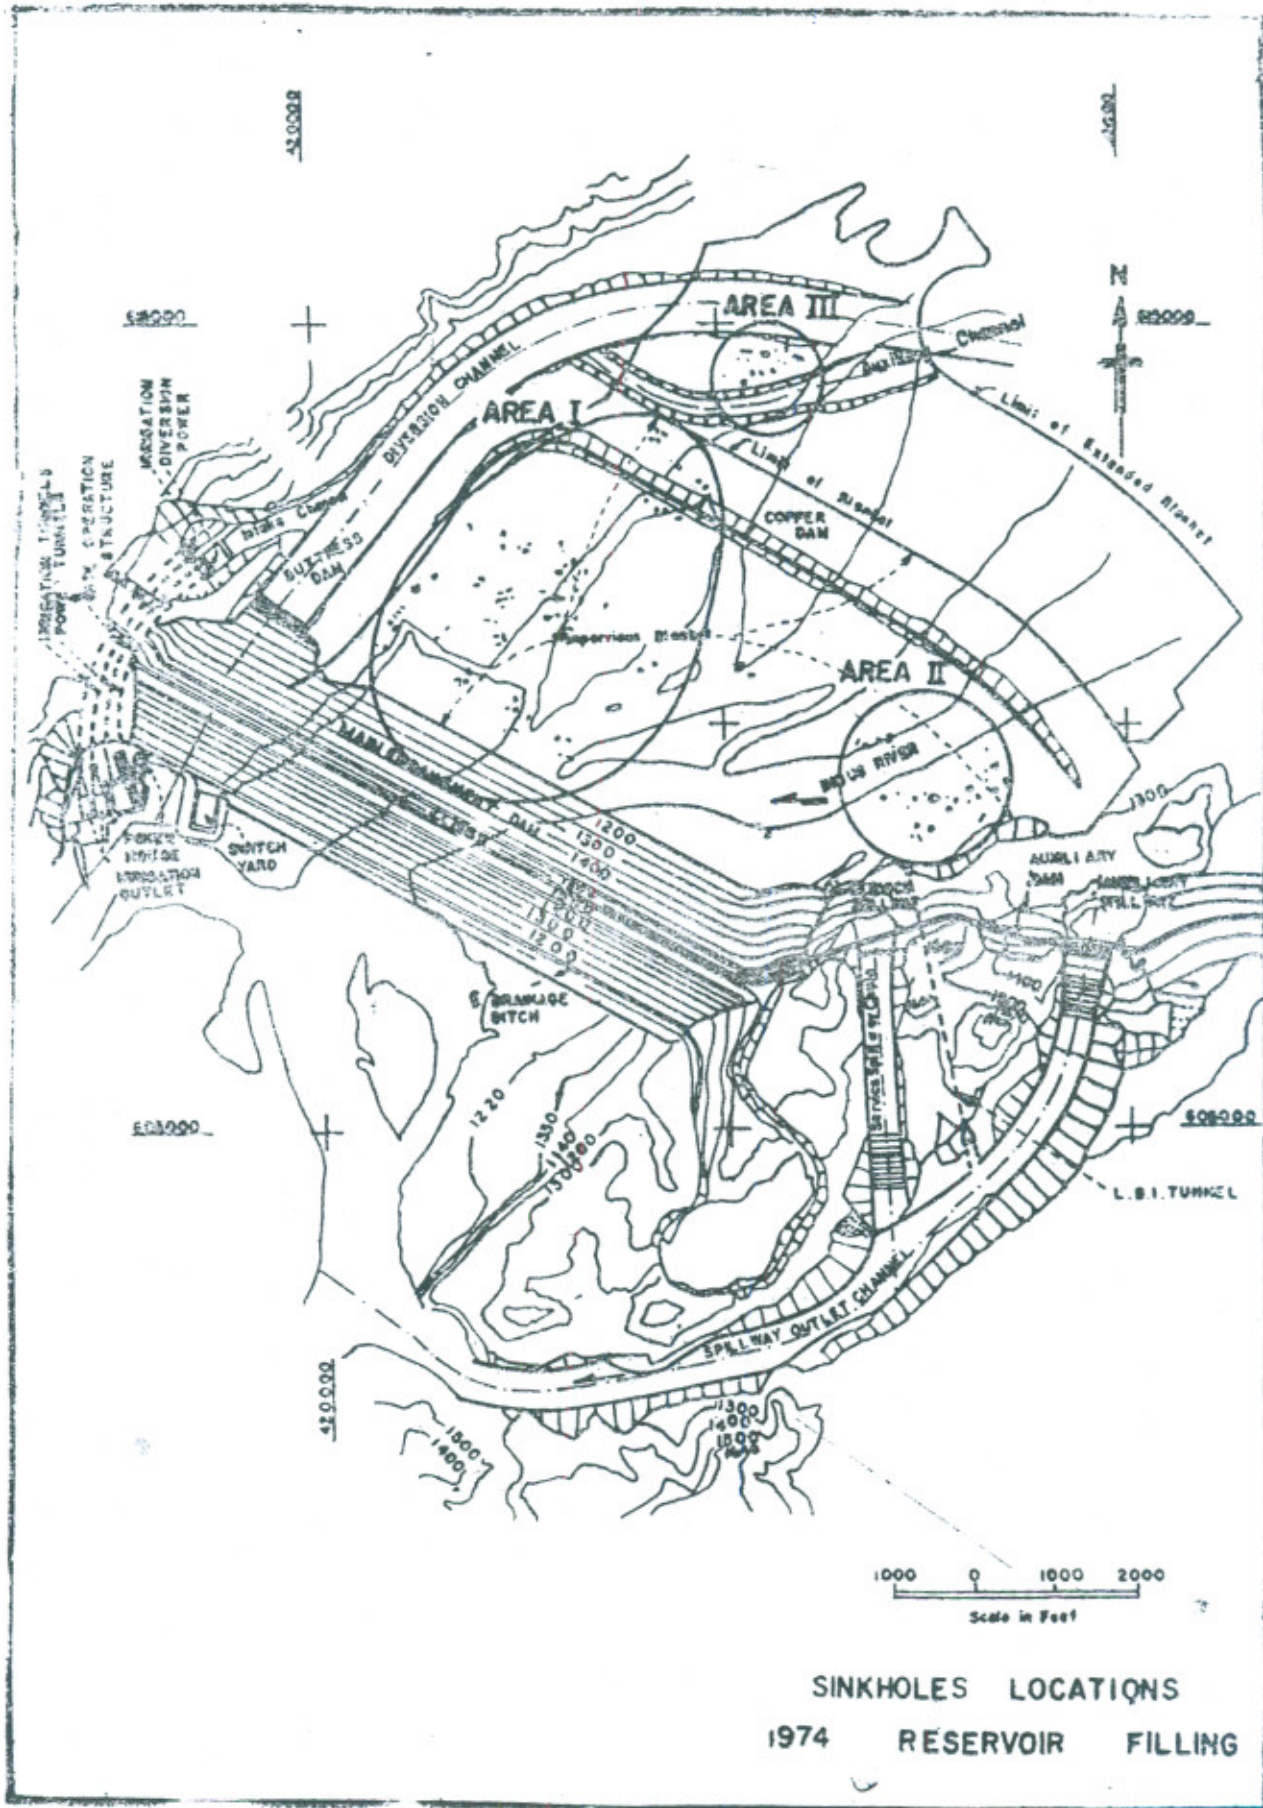
Fig. 6

Sink-holes varied in diameter at the surface from few inches to 30 feet. These were concentrated mainly in three areas (Fig. 6). The largest of these areas is on the right side of the main blanket and blanket extension between main dam station 15 to 68 and between the main dam and auxiliary diversion channel. The second area is on the left side between the left bank tunnel intake structure and cofferdam 'C'. The third area which is relatively smaller is in the blanket extension between the main diversion channel and the auxiliary diversion channel. The sink-holes are of circular shape with almost vertical walls, however, there were several sink-holes which were truncated cone type, with diameter increasing with depth. The investigations carried out by the Consultants revealed that none of the sink-holes penetrated to the full thickness of blanket in the main blanket area, although some of the vertical cracks were found to go down to the foundation materials. In the extended blanket between diversion channel and auxiliary channel, a number of sink-holes and subsidences were deep enough to penetrate through the small thickness of blanket in this area.

There were over 200 sink-holes in area between the main dam and auxiliary channel. The largest sink-hole was 19 feet diameter and the deepest one was 13 feet deep. In the left bank, there were over 50 sink-holes, with maximum diameter of 28 feet and with maximum depth of 5.7 feet. There were less cracks however substantial migration of fines from the blanket into the foundation materials was noticed in this area. In the blanket extension at right bank the number of sink-holes was over 50, and a number of these holes penetrated through the full depth of blanket. The maximum diameter being 18 feet and maximum depth was recorded as 8 feet.

The reason for the formation of sink-holes is not completely known and different hypotheses have been presented by the various experts. The following causes have been discussed.

In view of the thickness of the alluvium in the valley of over 600 feet and uneven rock profile under the alluvium, the possibility of differential settlement is there. It is quite likely that some of the cracks which have appeared in the blanket may be due to this reason. It is also possible that the fines from the bottom part of the blanket were washed into the foundation open-work gravels through these cracks causing cavities, which resulted in local subsidence in the blanket. The sink-holes did not penetrate all the way into the blanket, because the foundation material have got choked with these fines. This situation may have been temporary, and it was likely that with higher reservoir pressure, at least, some of the sink-holes may have fully penetrated in the foundations.

Fine sand underlies the blanket over limited area in an irregular pattern, except over a width of 500 feet immediately upstream of the upstream toe from where most of the sand was removed before the placement of blanket. It has been considered that such fine sand is easily removed by flowing water. In contrast the blanket, which is well graded and compacted, can bridge over narrow channels which may form in the surface of sand under the blanket. The erosion channels in the sand surface beneath the blanket can readily get started at any location where sand adjoins gravel with open voids into which the sand can pipe, thus causing a cavity under the blanket.

This cavity or loss of support under the blanket may result in the rupture of the blanket under the reservoir load, particularly where the blanket thickness is small. The rupture will cause a tension crack along the bottom of blanket. In addition to sand, the blanket material may also be eroded from the roof of these channels, particularly if tension crack has opened up at the bottom of the blanket. Seepage through the blanket in the plane of the crack will tend to disintegrate the compact structure of the blanket and with chunks of blanket material dropping into the channels. The fines from these chunks of the blanket will be eroded along with the sand while the coarsest particles would tend to pave to the bottom of the channel. Progressively, a shallow depression may form along the top of the crack in the form of a sink hole.

The repairs of the blanket by filling up the sink-holes and making mounds over them, and the placement of the additional blanket was completed before the impounding season of 1975. In 1975, the reservoir was steadily filled and along with it the monitoring of the performance of the blanket is being continuously carried out. Additional piezometers have been installed under the blanket and a special sounding device called the Side Scan Sonar is imported to the site to detect the formation of sink-holes.

The sink-holes formulated are being filled up through a special bottom dump barge. A mix from silt to cobble size particles is prepared, moistened and dumped at the location of sink-holes indicated by Side Scan Sonar. It is being hoped that the sink-holes will be treated in this manner. The barge carries a load of about 100 cubic yards of material and 10 loads of the barge are dumped at each location of sink-holes. The process is slow and of some doubtful success, because dumping of material through 400 feet depth of water is susceptible to lose lot of fines on its way down.

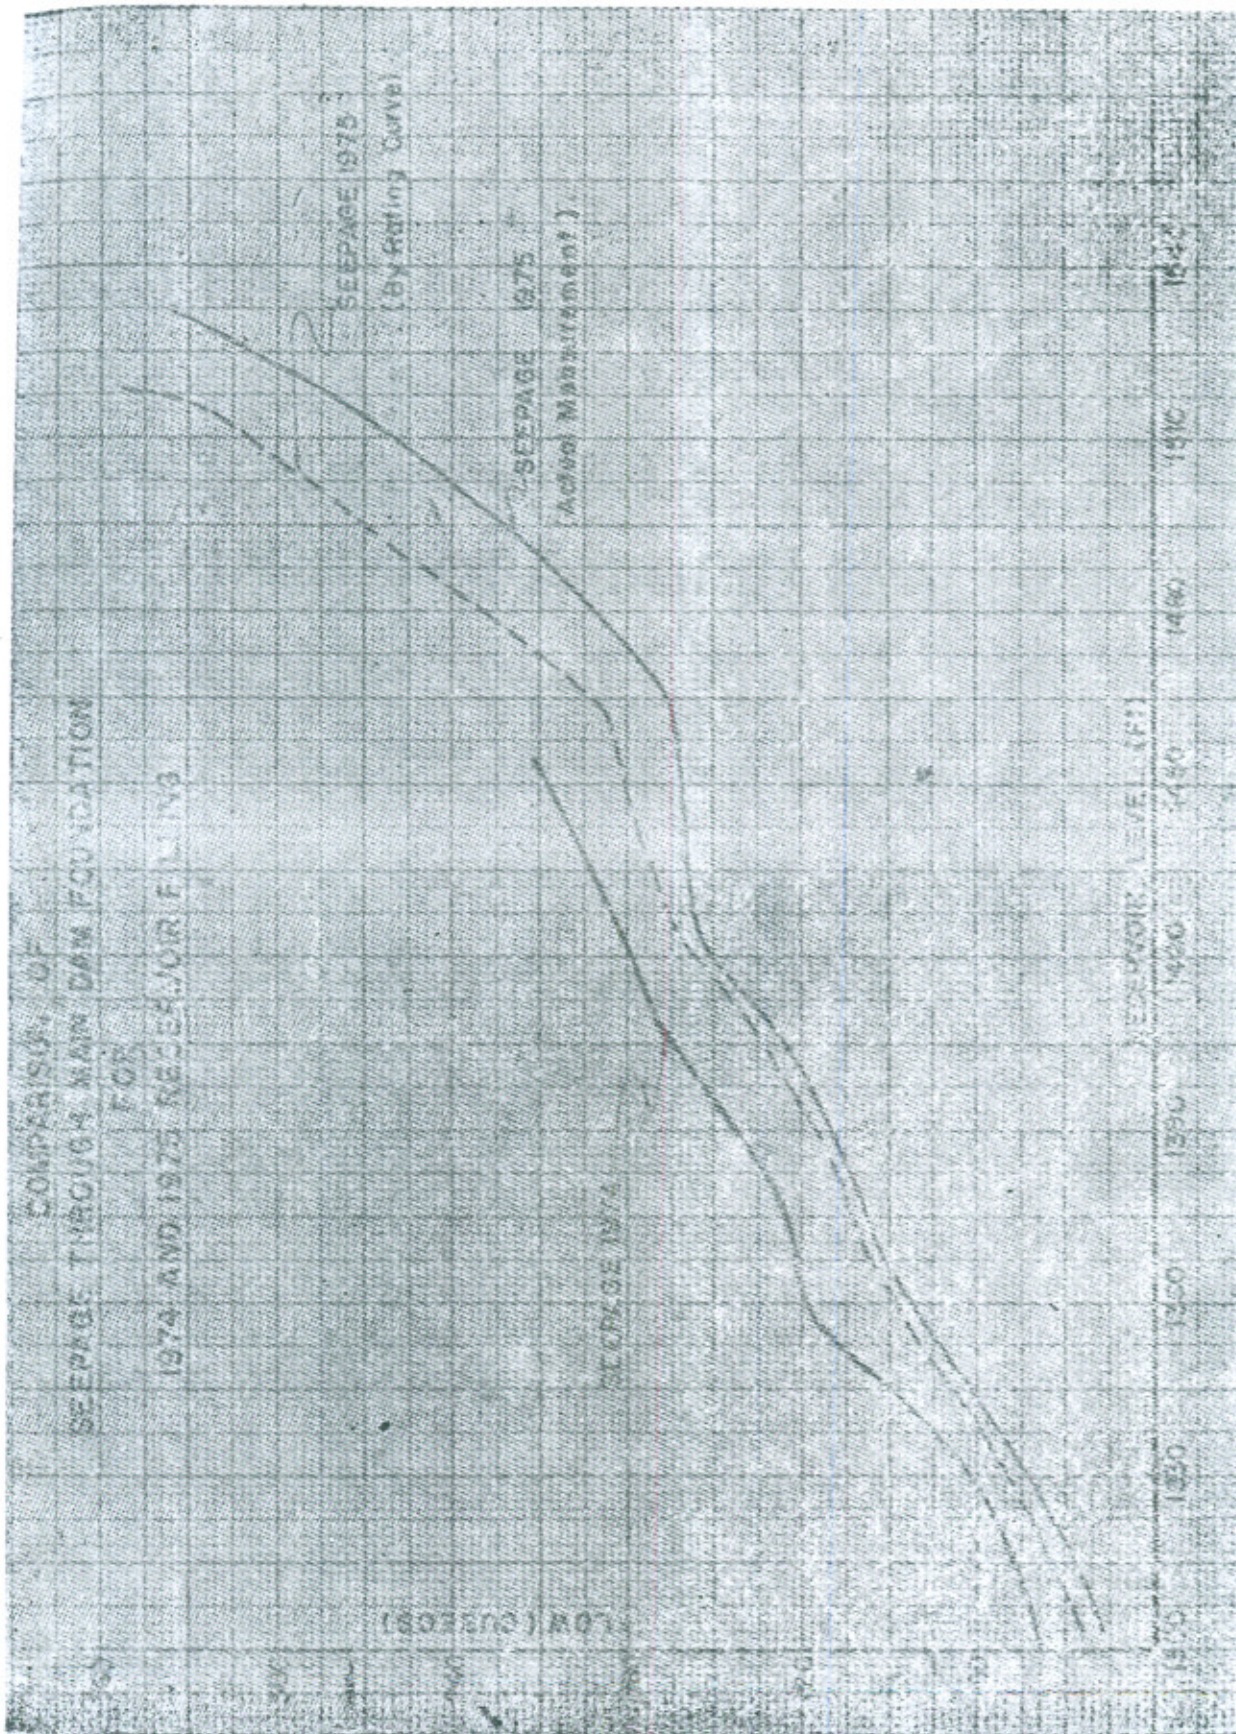
The seepage through the foundation in 1975 is also relatively less (Fig. 8) and for the same reservoir level it is about 80% of 1974 value. It is, however, noticed that there appears to be a sharp rise in the seepage quantity beyond reservoir level of 1465, and maximum seepage intercepted through the relief wells at reservoir elevation 1530 has been reported as 360 cusecs. The reservoir will be maintained at the high elevation for a number of months and the monitoring of the blanket will keep providing the continuous information about its performance.
