### **F-1.0 Post Damage Experiments at Irrigation Research Institute and CSU of Tunnel 3 and 2, 1974-1975.**

#### **E-6.5 Model Studies on Tunnel 2 to Investigate the cause of Damage.**

# Hydraulic Model Studies for Tarbela Dam

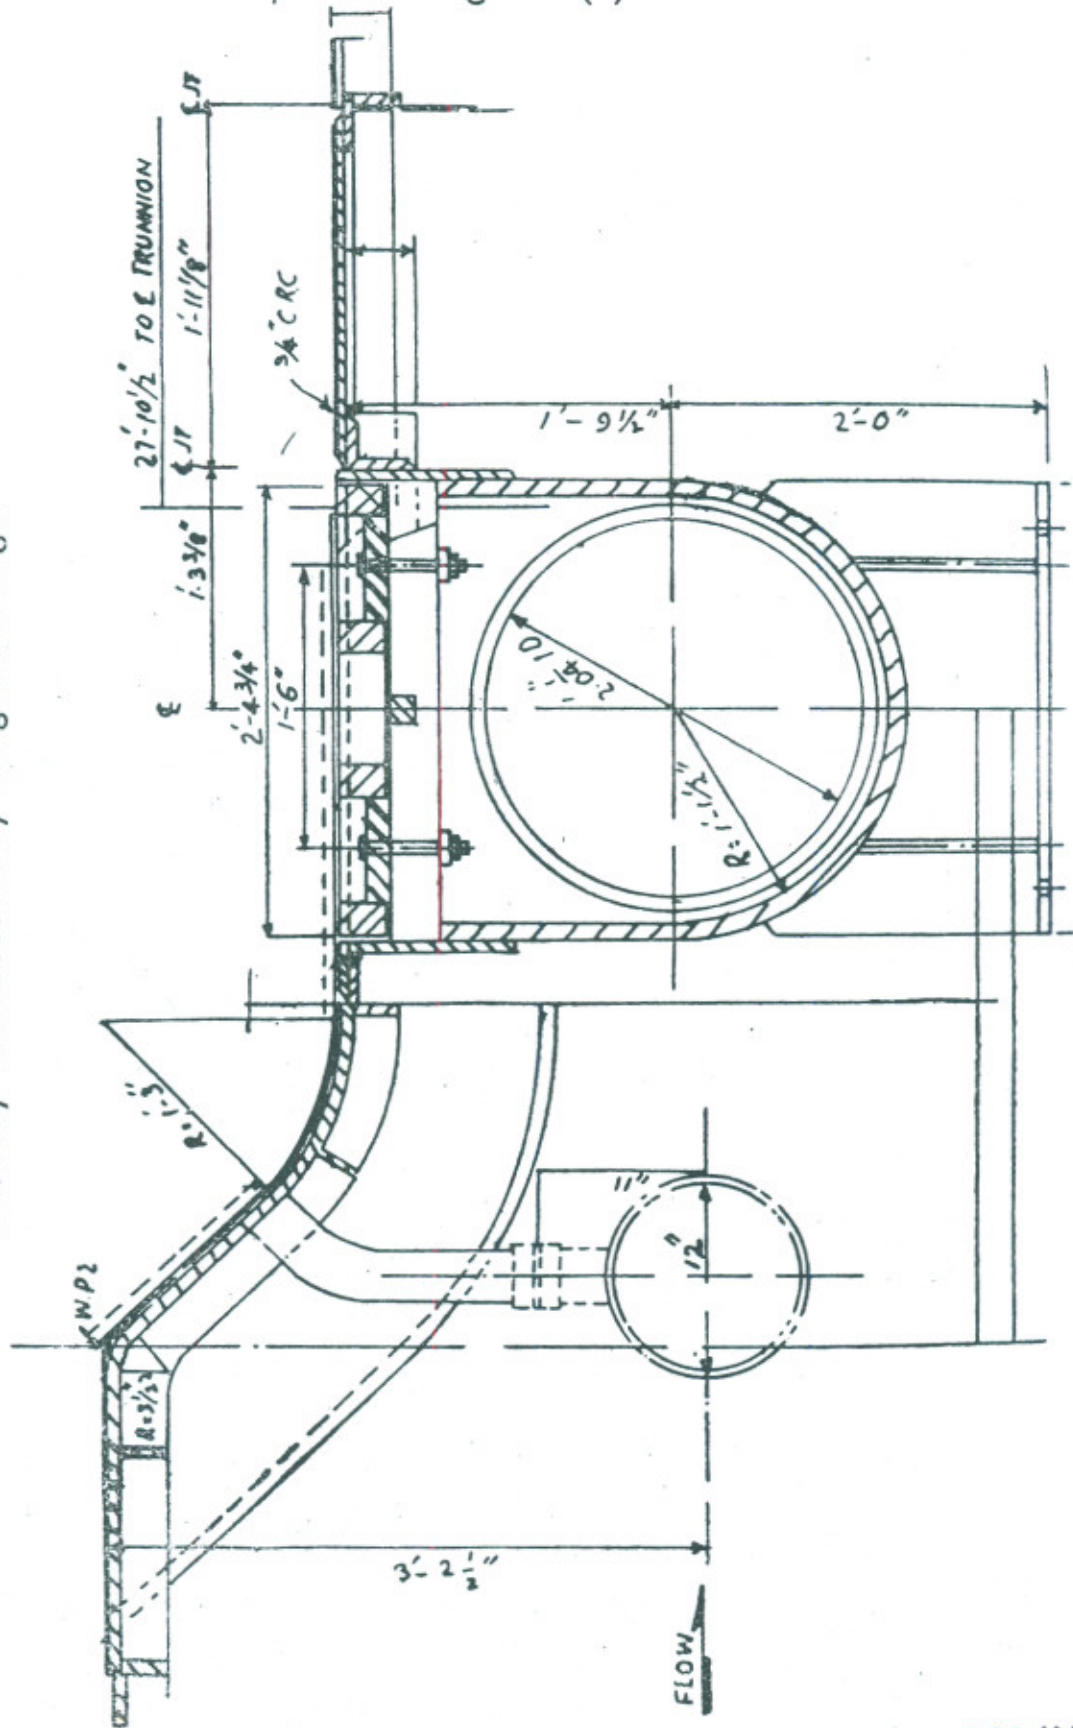
TARBELA DAM PROJECT  
OUTLET CONTROL STRUCTURE AERATION SYSTEMS  
Primary and Secondary Original Design

primary airvent system located below the toe of the floor of the chamber.

- (b) The primary airvent system downstream of the toe of the step showed no air demand with full gate opening up to reservoir El : of about 1400, whereas the secondary system started having air demand at about El : 1350.

- (c) In case of partial gate opening excepting 6.0 feet gate opening the component of flow created by the curved face of the gate prevents the jet from springing clear of the primary airvent and consequently very little air demand is created in the trough of the primary airventilation system. In fact the trough was partly filled with turbulent water.

The test, therefore, indicated that airvent slit should be placed as near the toe of the step as possible. The shape of the replacement cover of the trough now decided by the consultants to be installed as a results of tests at CU and Irrigation

Research Institute, Laboratories provides a slit four inches downstream of the upstream edge of the air trough. The air intake slit as now modified at site is at the position indicated by the test made at Irrigation Research Institute.

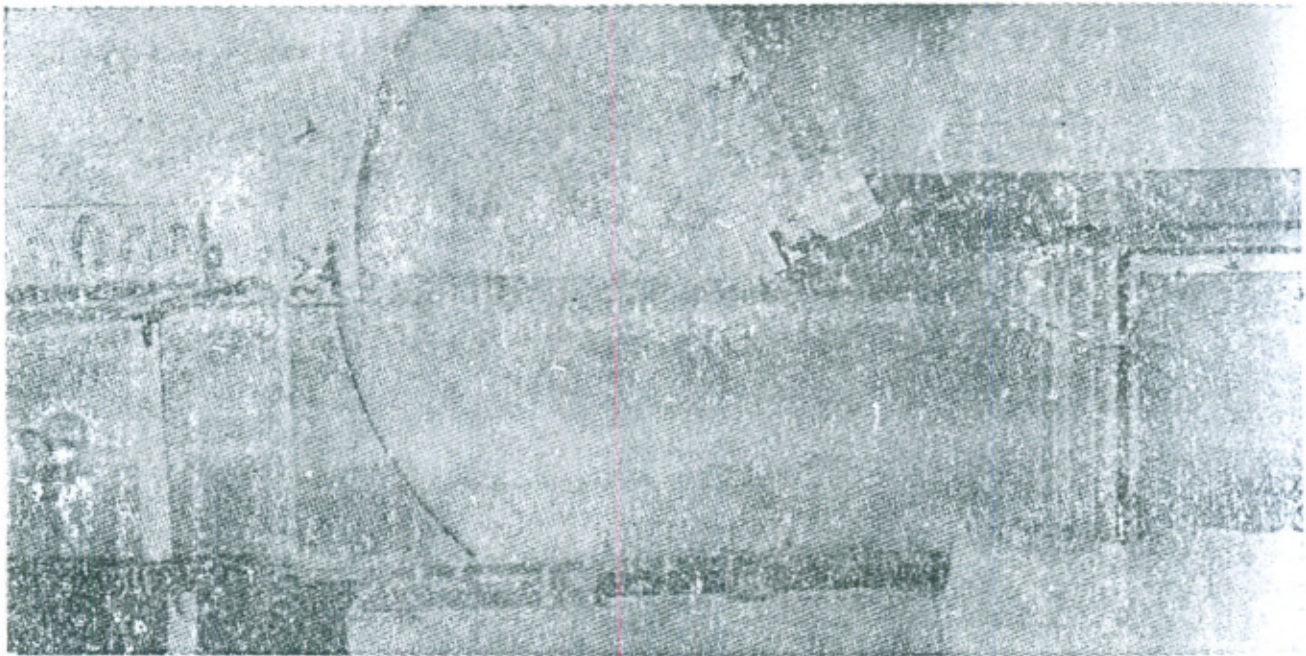
Fig. 38

Vortex formation along the offset wall of Gate Chamber

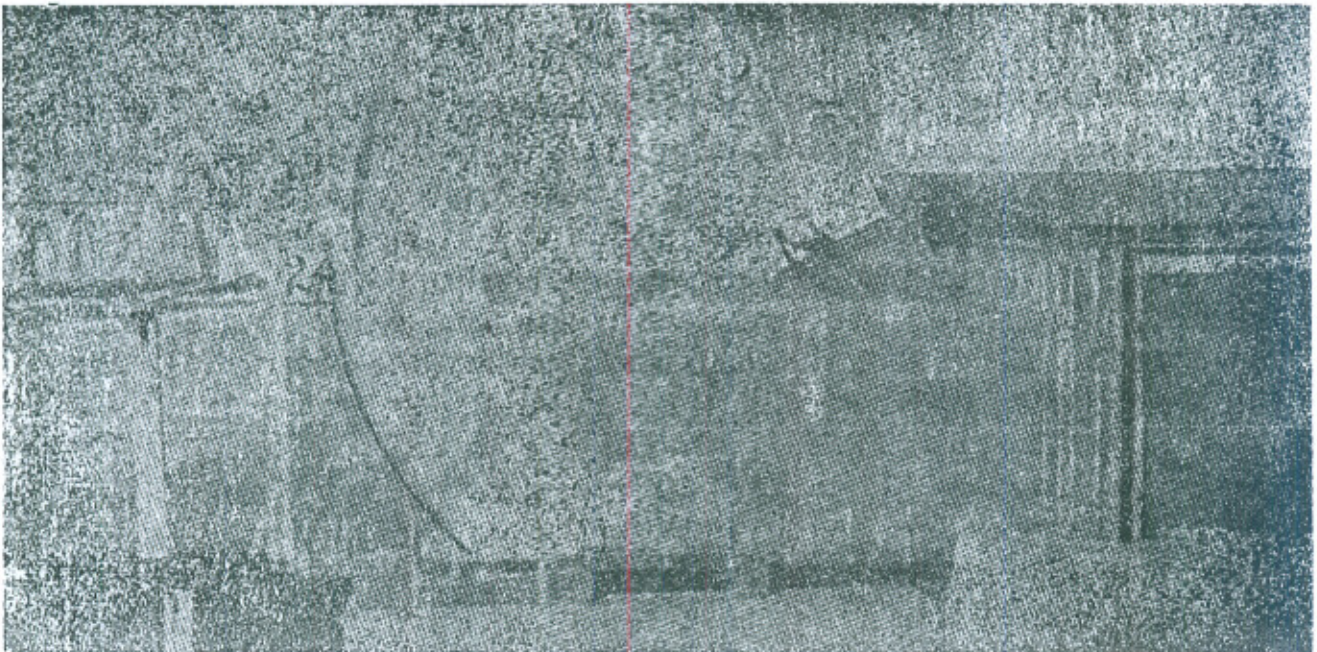
Fig. 38

Vortex formation along the offset wall of Gate Chamber

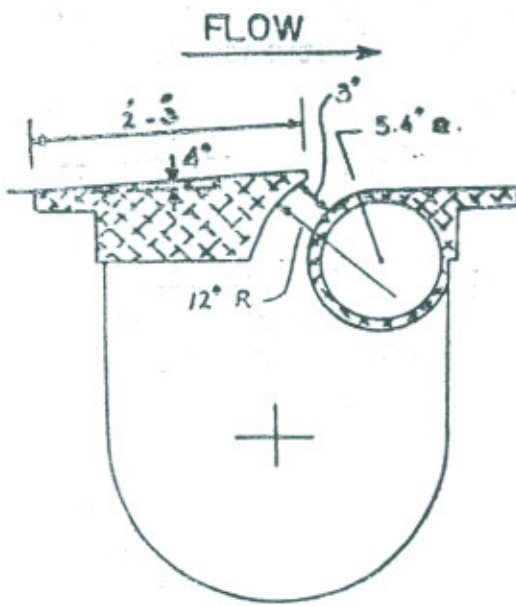
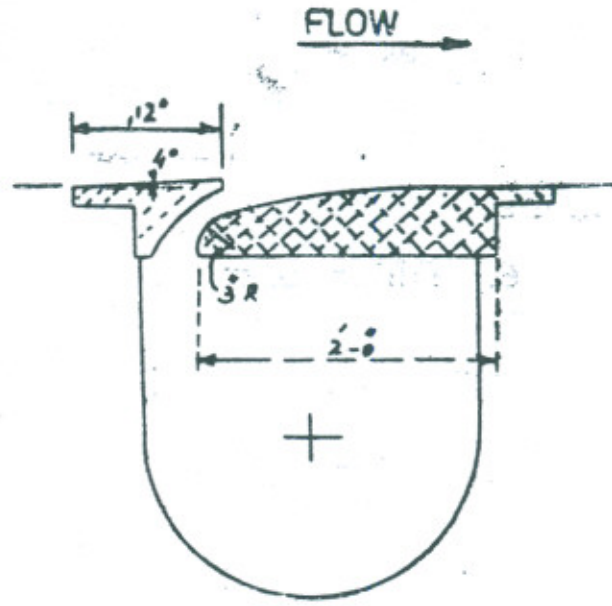
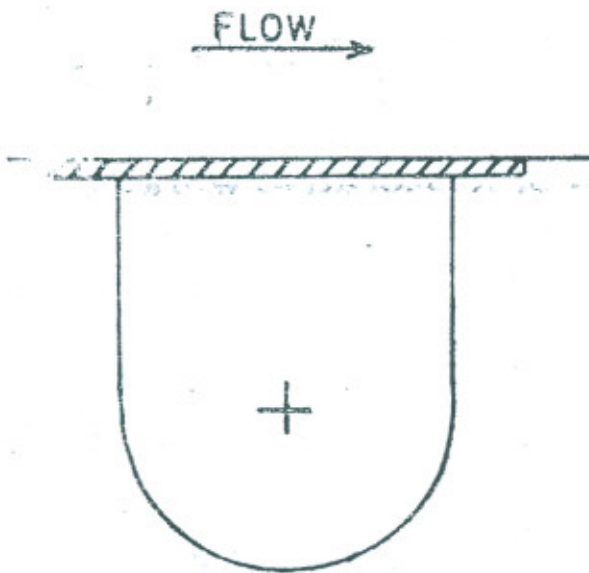
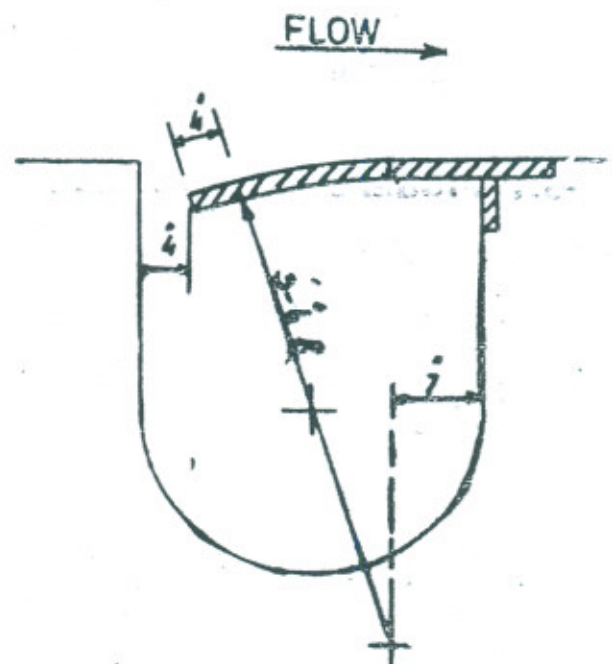
In the prototype the grating over the aeration trough was uprooted and carried down by the force of water jet. Several schemes shown in Figure 39 for the design modification of the

2. On the basis of the test data there was little difference in performance of aeration trough cover schemes 2 and 4 Fig. 39 as regards ‘observed’ air flow through the aeration trough.

1. Appoxy repair to gate chamber of  $T_3$  (accepted as temporary repair only) as replacement to steel lining.
2. Change made in the design of primary airvent trough as per scheme 4 of Figure 39.

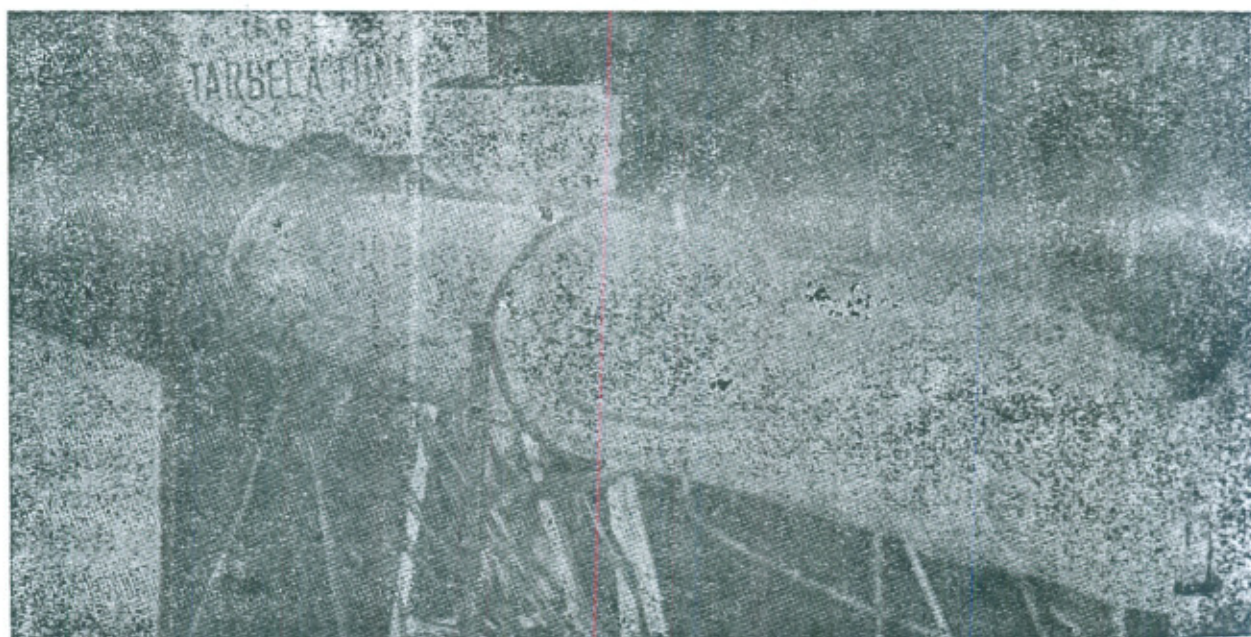
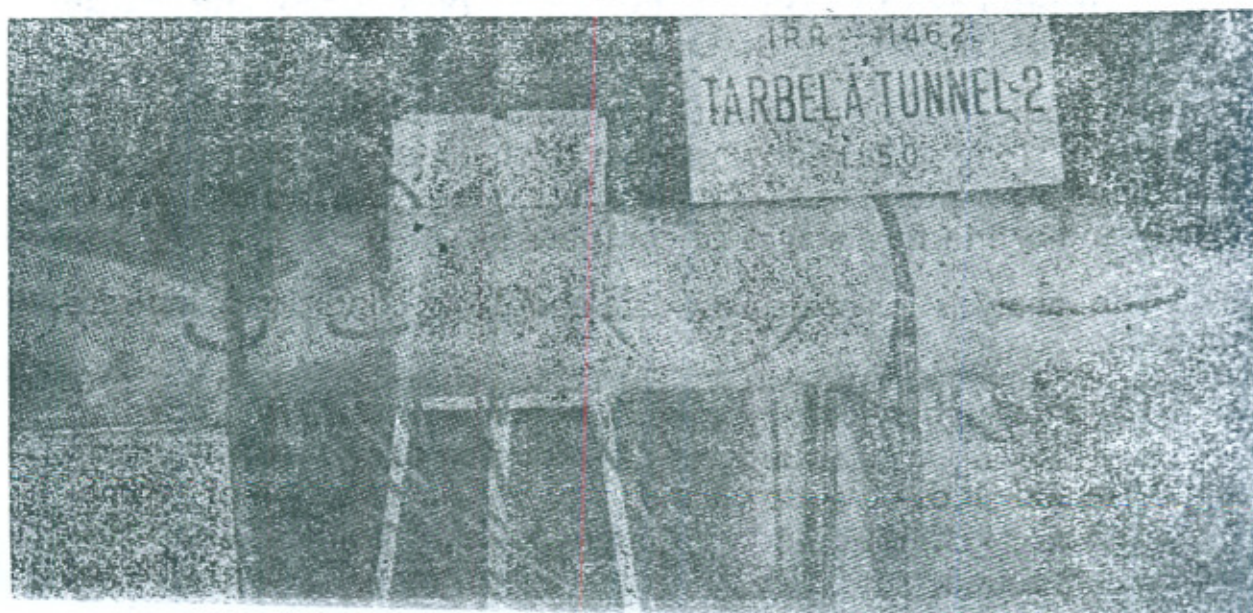
Fig. 42 (a, b)

transition. The two spiralling flows interact and form a single white jetting flow that follows the bottom section of tunnels. (See Fig. 42). The piezometric and transducer pressures along invert and  $45^\circ$  angle in the damaged portion of tunnel are plotted in Fig. 43 a-e which indicate negative pressures up to 40 feet during operational condition of 1974. The negative pressure could result in a damage by cavitation. Abrasion due to high velocity of the order of 160 ft. per/sec. can also occur. It is to be noted that material round this tunnel being Sugary lime is highly pervious. Inside negative pressure combined with outside positive pressure built up due to seepage may have caused the tunnel failure. Once the tunnel wall got damaged and punctured in the initial stages the hill consisting of sugary lime stone could be intermittently sucked into the tunnel, explaining the turning of the river water emerging from tunnel 2 intermittently brownish red for a few minutes. The damage progressively increased once the tunnel gave away at one place.

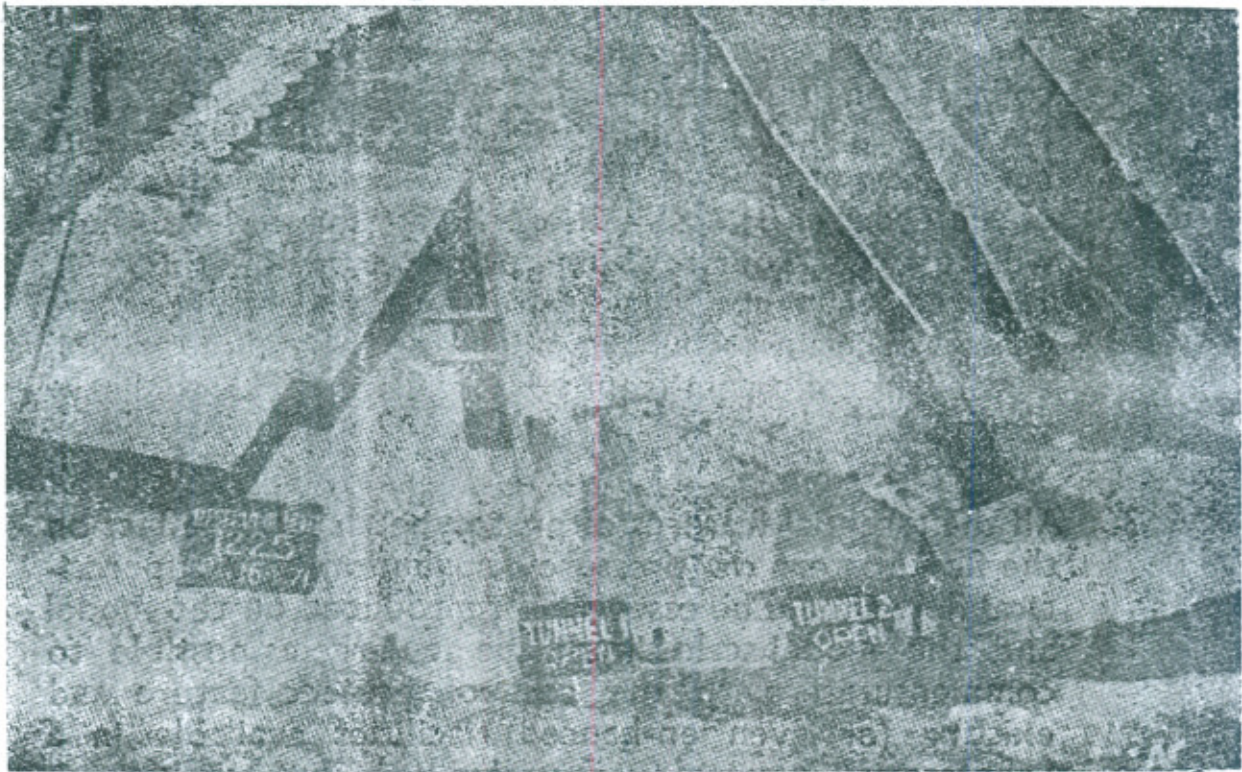
Fig. 44 (a)  
TARBELA DAM PROJECT  
RIVER DIVERSION MODEL  
Scale = 1 : 80

Flow Conditions in Tunnels outlet area with Tunnels 1 &amp; 2 open

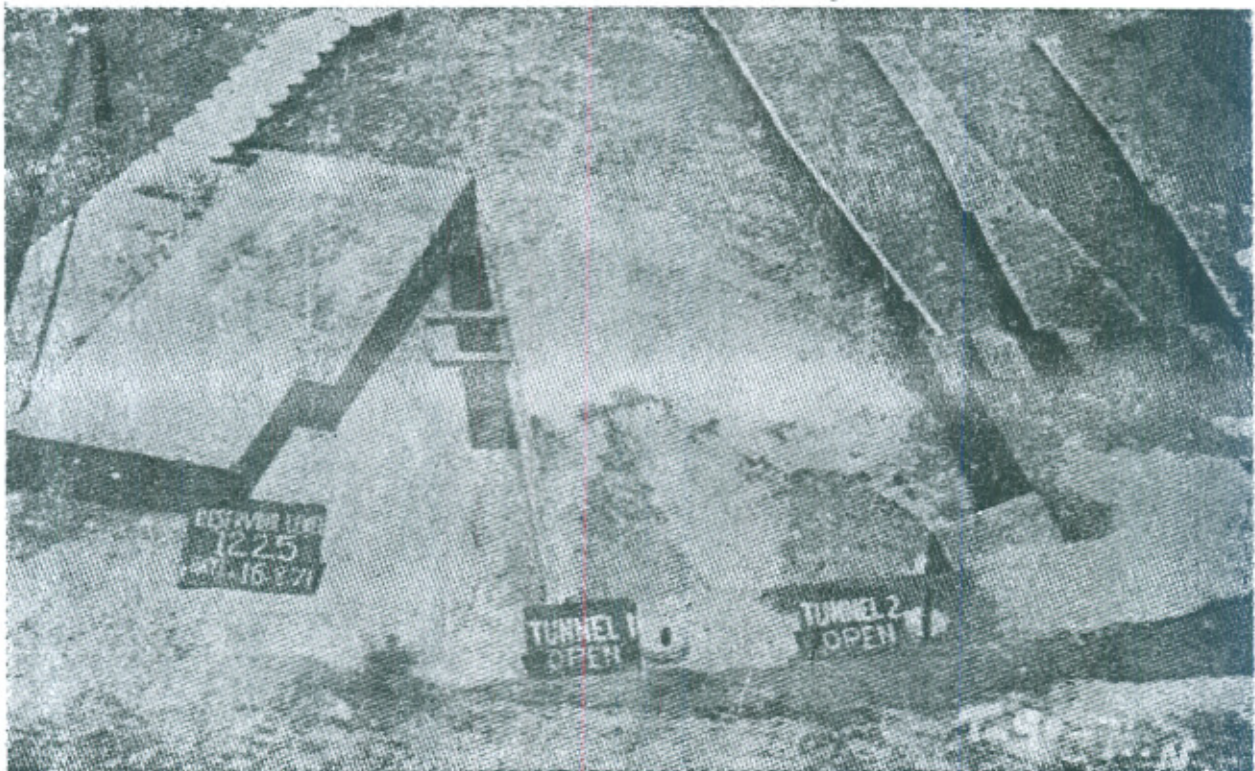
Fig. 44 (b)  
TARBELA DAM PROJECT  
STAGE III RIVER DIVERSION  
PROTOTYPE

Flow Conditions in Tunnels outlet area with Tunnels 1 & 2 open  
Res, EL. 1225

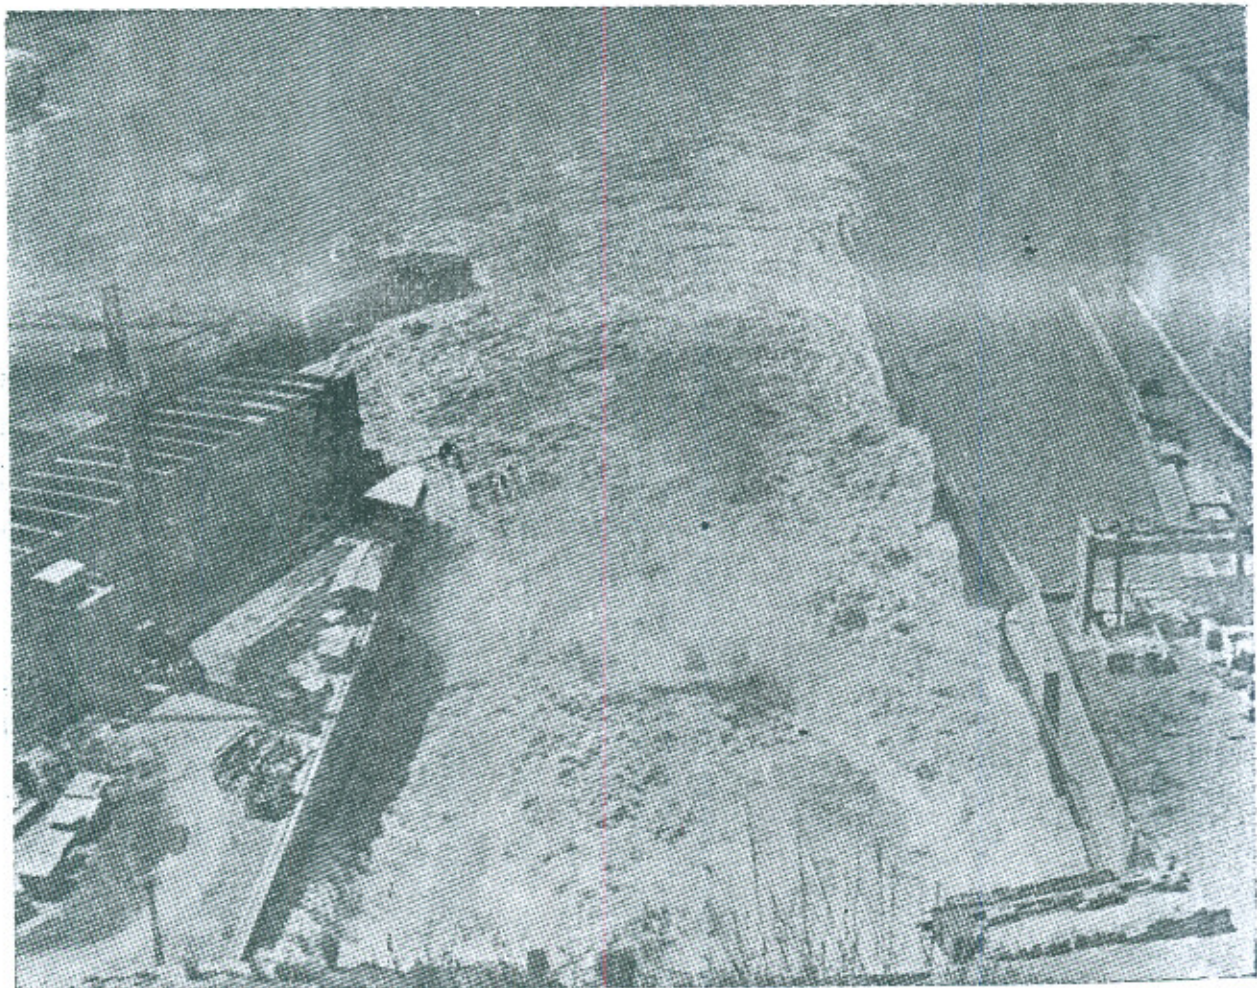
Fig. 44 (b)  
TARBELA DAM PROJECT  
STAGE III RIVER DIVERSION PROTOTYPE  
PROTOTYPE

Flow Conditions in Tunnels outlet area with Tunnels 1 & 2 open

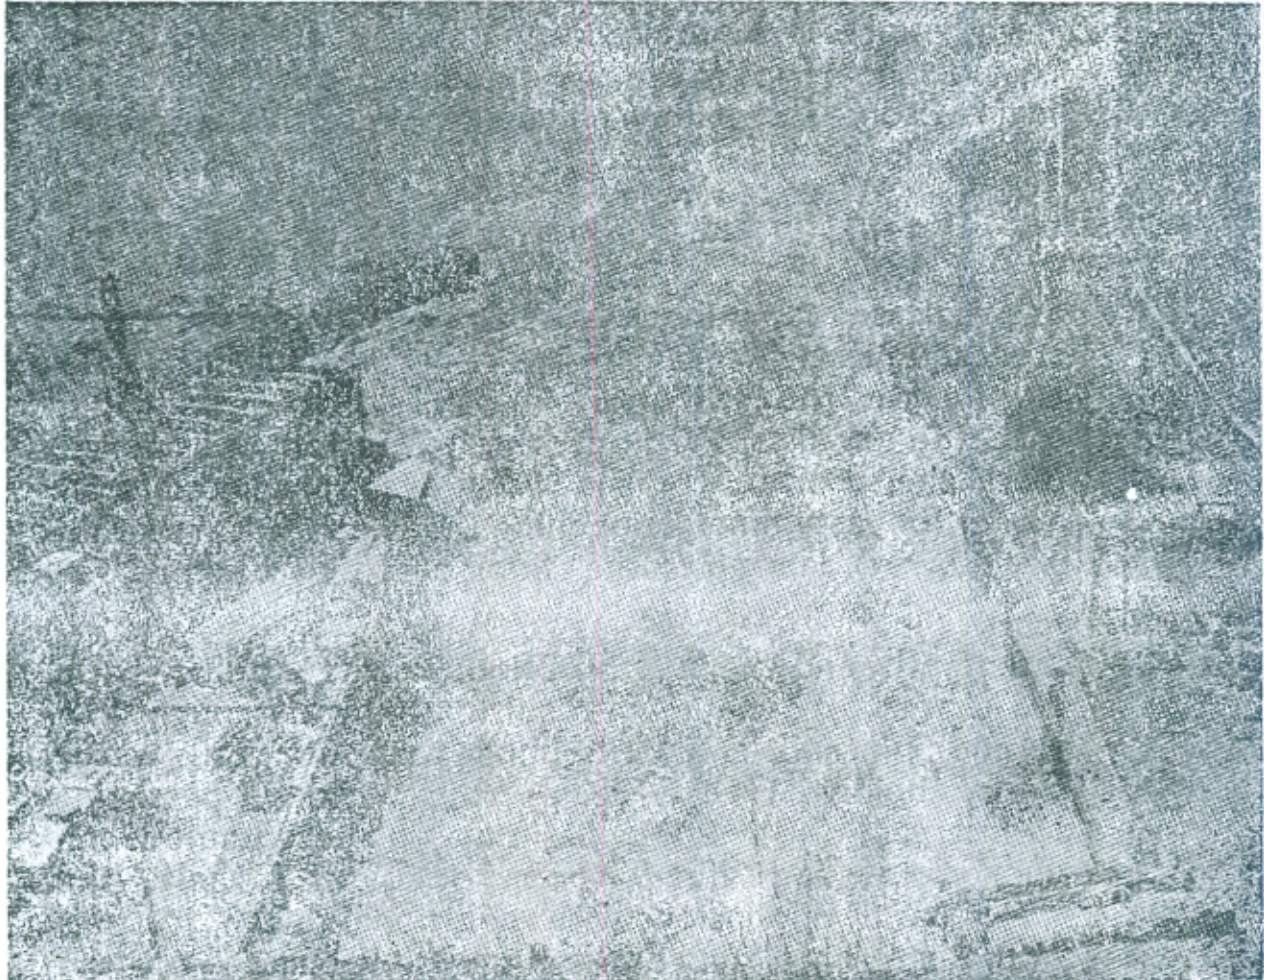
Flow Conditions in Tunnels outlet area with Tunnels 1 & 2 open

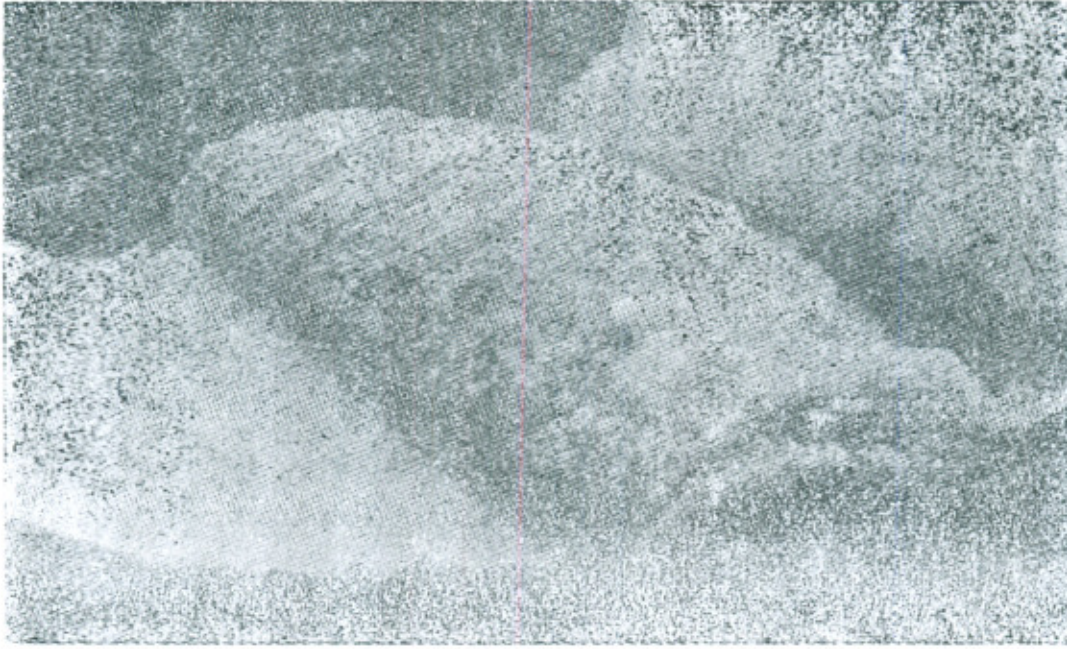
Fig. 45 (a)

The plung pool has formed some distance away from the flip bucket.

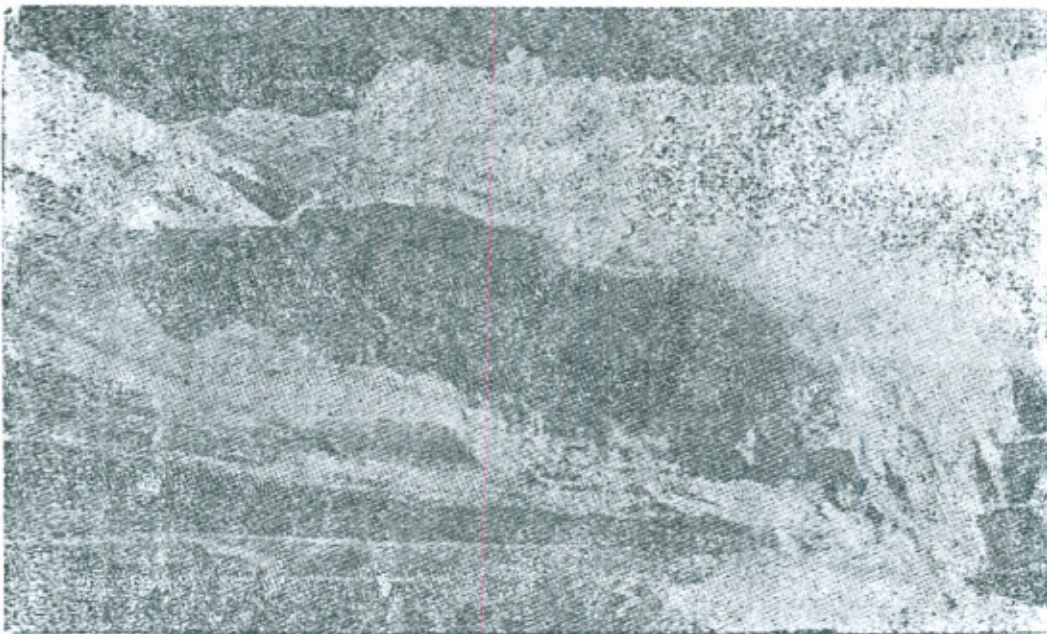
Fig. 45 (b)

Notice erosion on both flanks in the plunge pool area in the tail face of service spillway. The basic rock 'B' is still holding where as the poor rock upstream of it has gone.

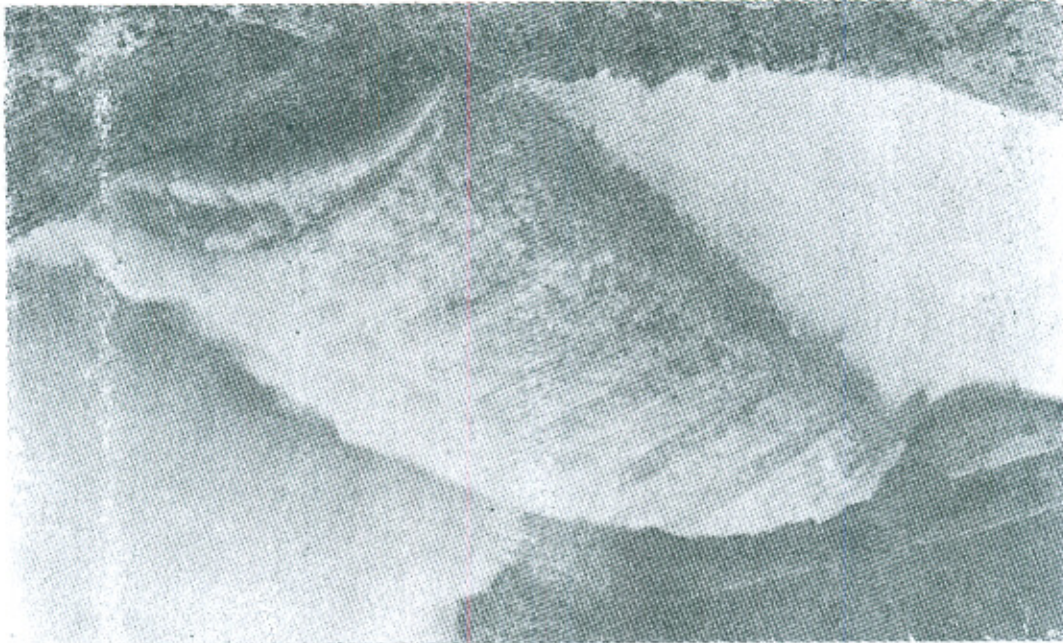
Fig. 45 (a)

The plung pool has formed some distance away from the flip bucket.

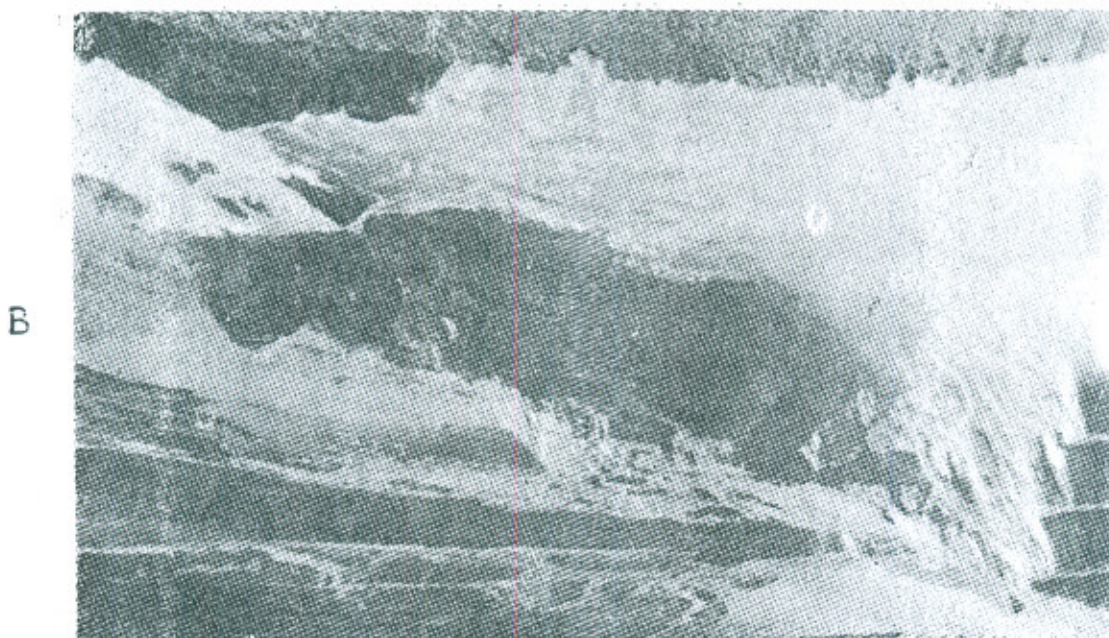
Fig. 45 (b)

Notice erosion on both flanks in the plunge pool area in the tail face of service spillway. The basic rock 'B' is still holding where the poor rock upstream of it has gone.

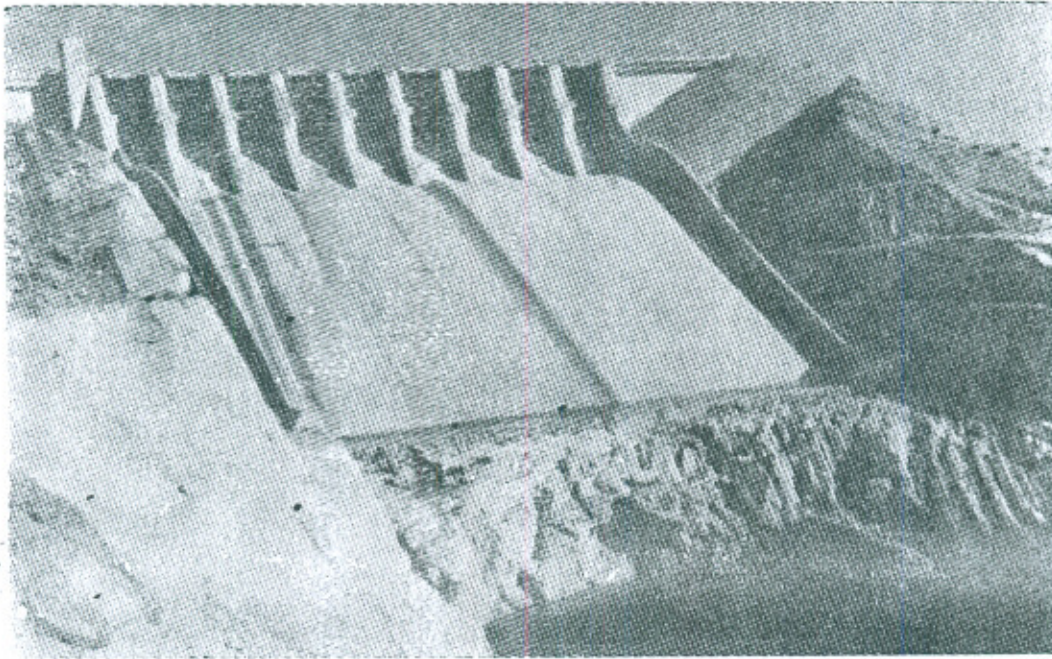
Fig. 46 (a)

The plunge pool has formed some distance away from the flip bucket.

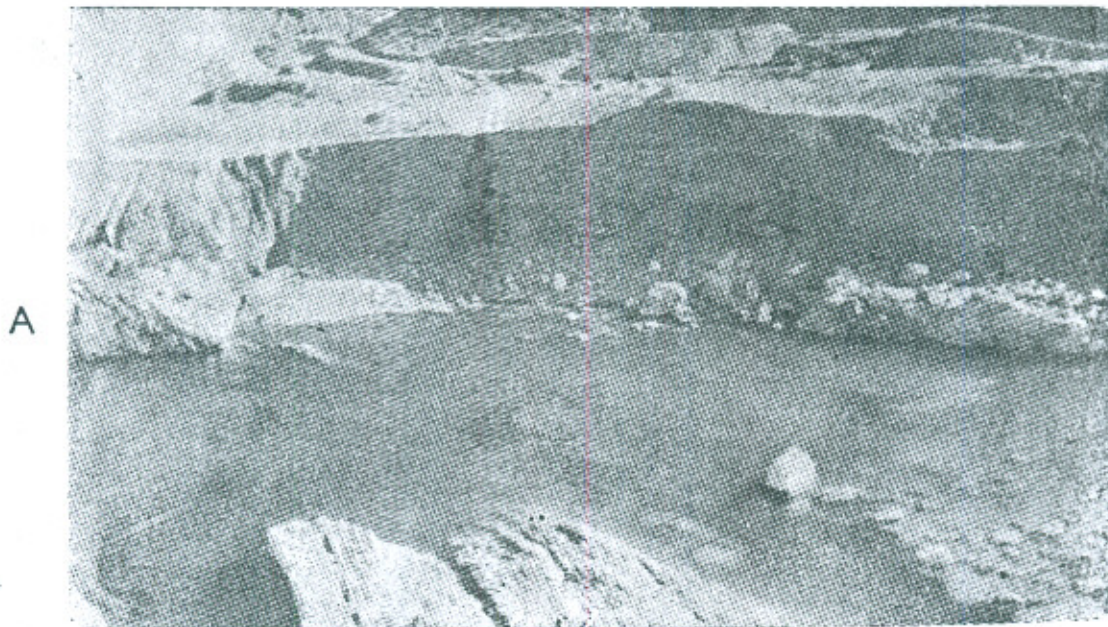
Fig. 46 (b)

Notice erosion on left bank immediately D/S of the flip bucket. The flip bucket at its left end is protected by rock at 'A'

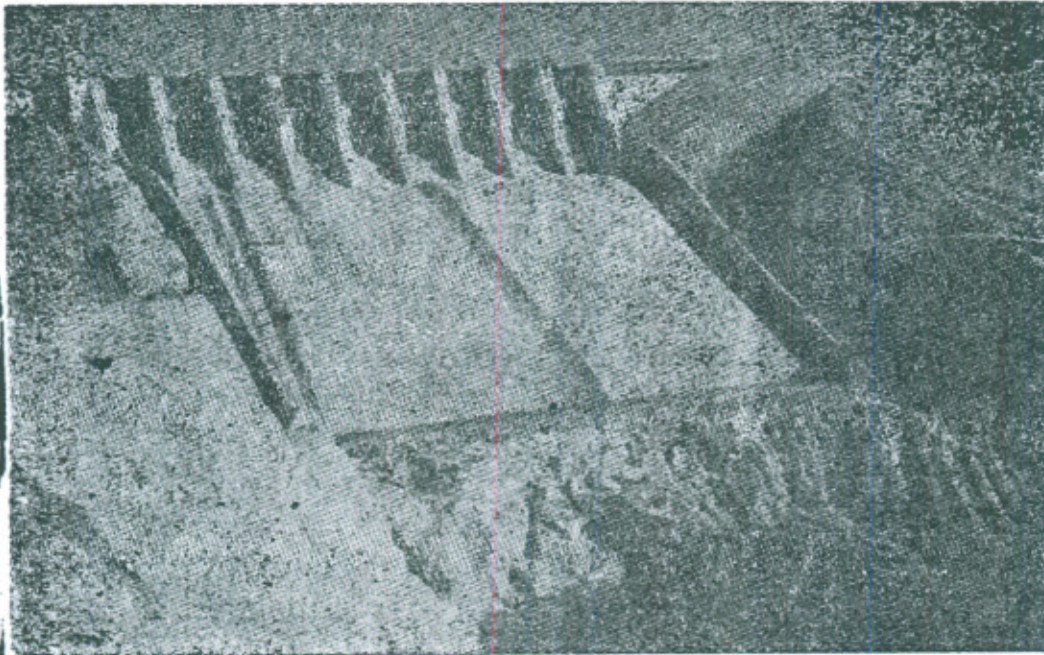
Fig. 46 (a)

The plunge pool has formed some distance away from the flip bucket.

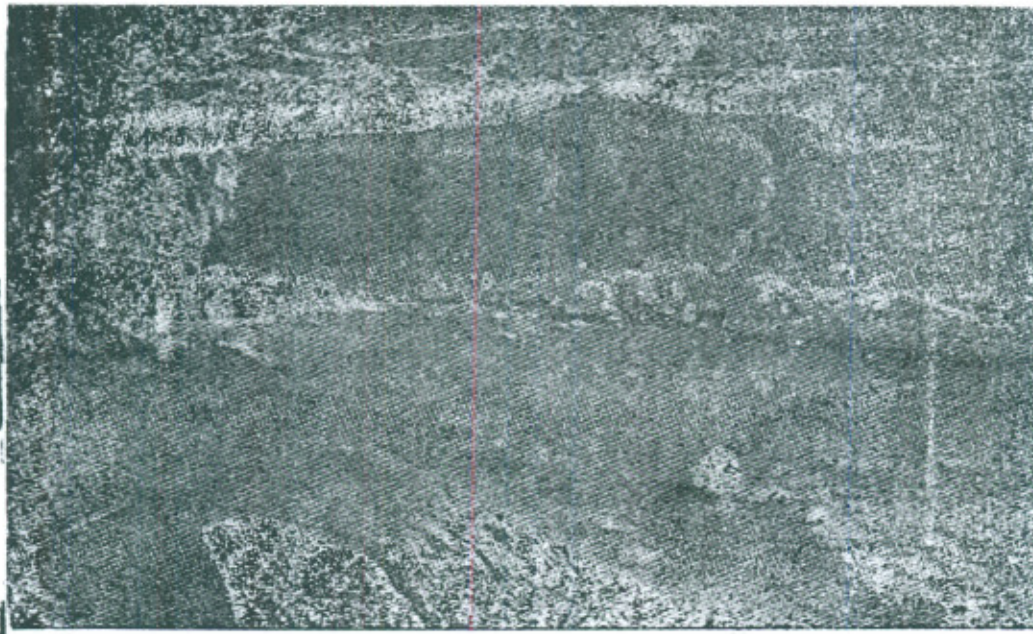
Fig. 46 (b)

Notice erosion on left bank immediately D/S of the flip bucket. The flip bucket at its left end is protected by rock at 'A'
