PAPER NO. 210.

REMODELLING UPPER CHENAB CANAL
HEAD REGULATOR 1936—37.

By C. L. HANDA, I. S. E., ASSISTANT EXECUTIVE ENGINEER.

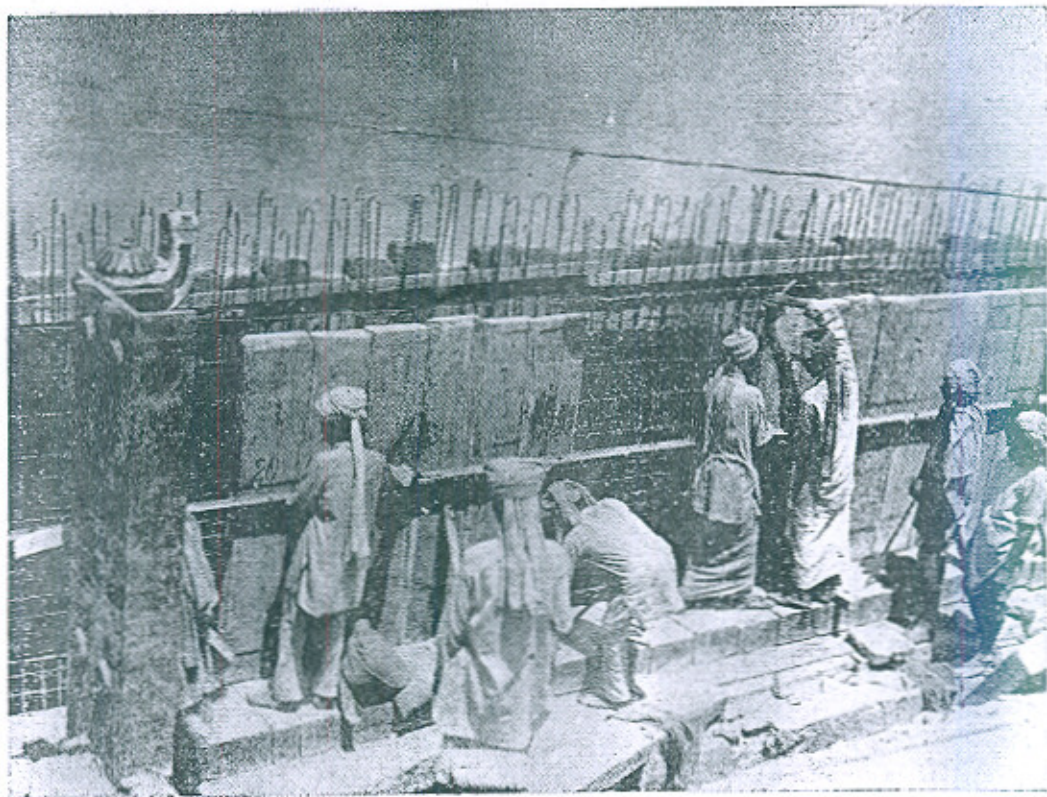
Inside Shuttering.

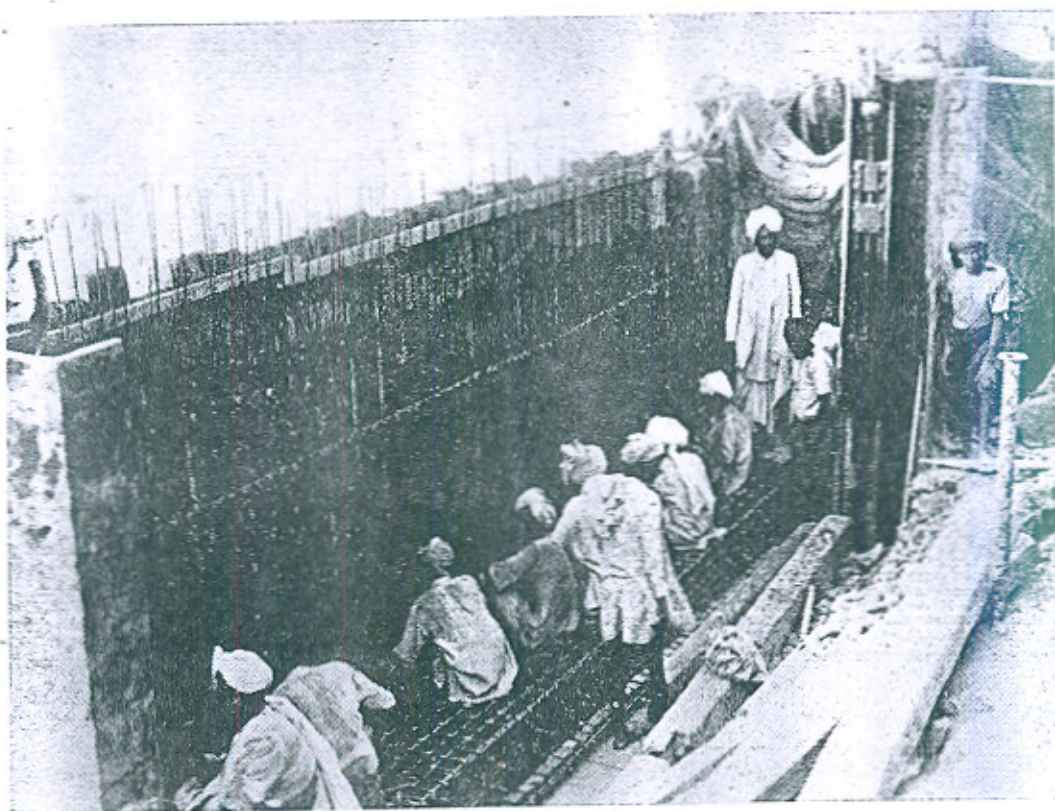
Bottom Beam Reinforcement.

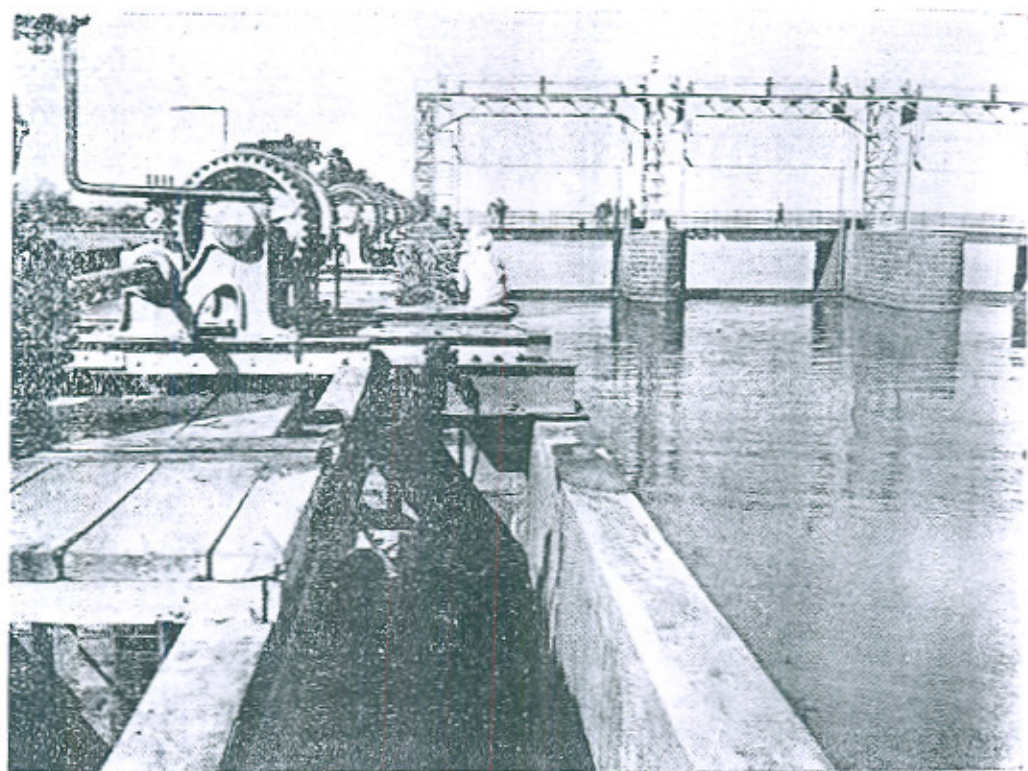
Interim arrangements for Regulating Old winches fitted on temporary brickwood footings.

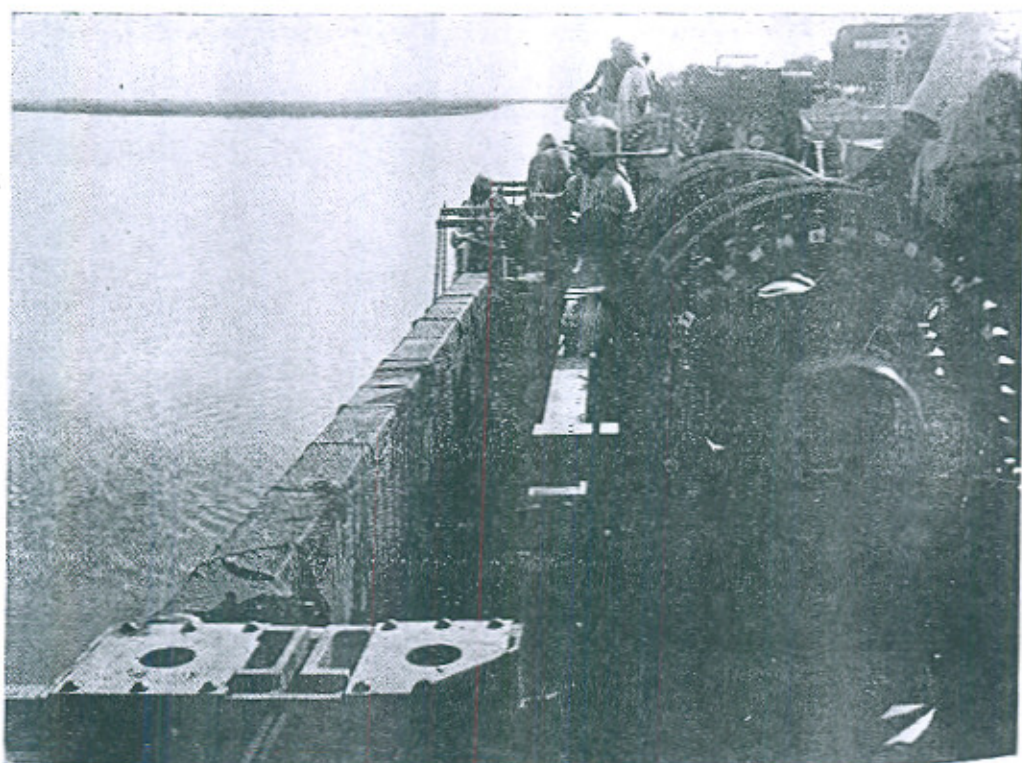
Final raising of Breast Wall.

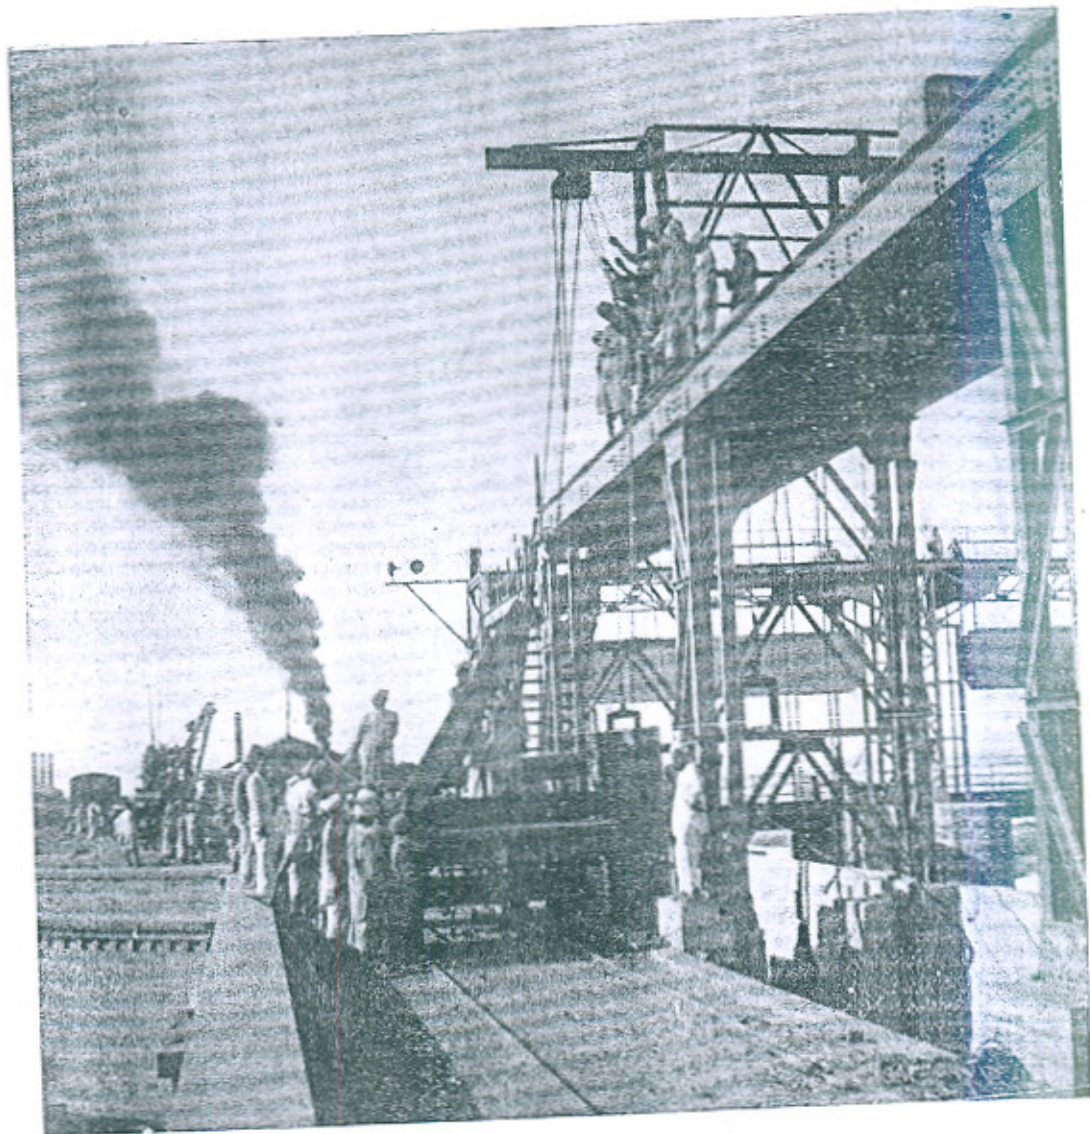
Erection of superstructure : Special gantry in operation
lifting a groove.

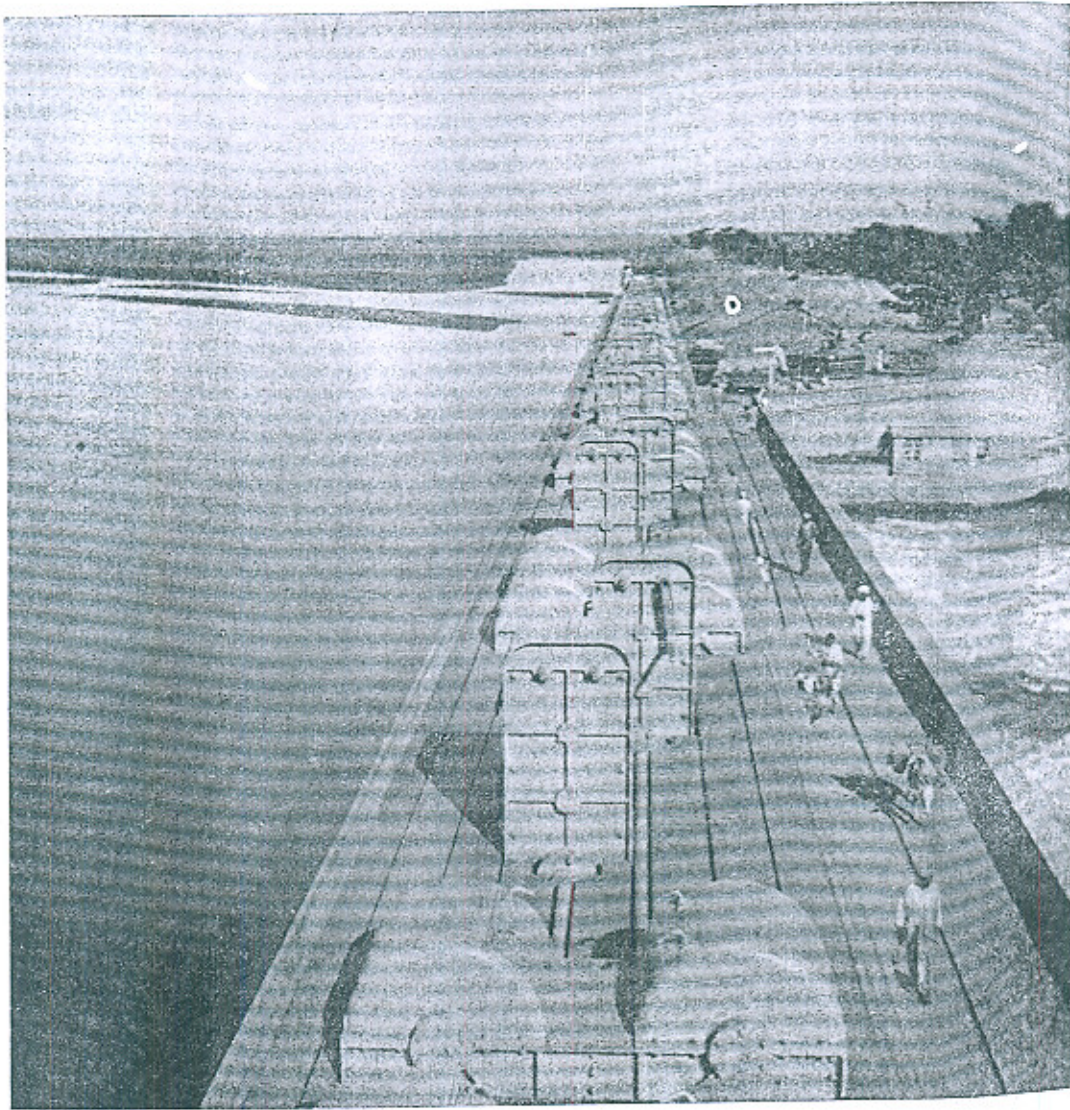
New winches in position. The winches are fitted with the operating lever in a longitudinal direction. This does not obstruct the over-bridge and is an improvement on old designs.

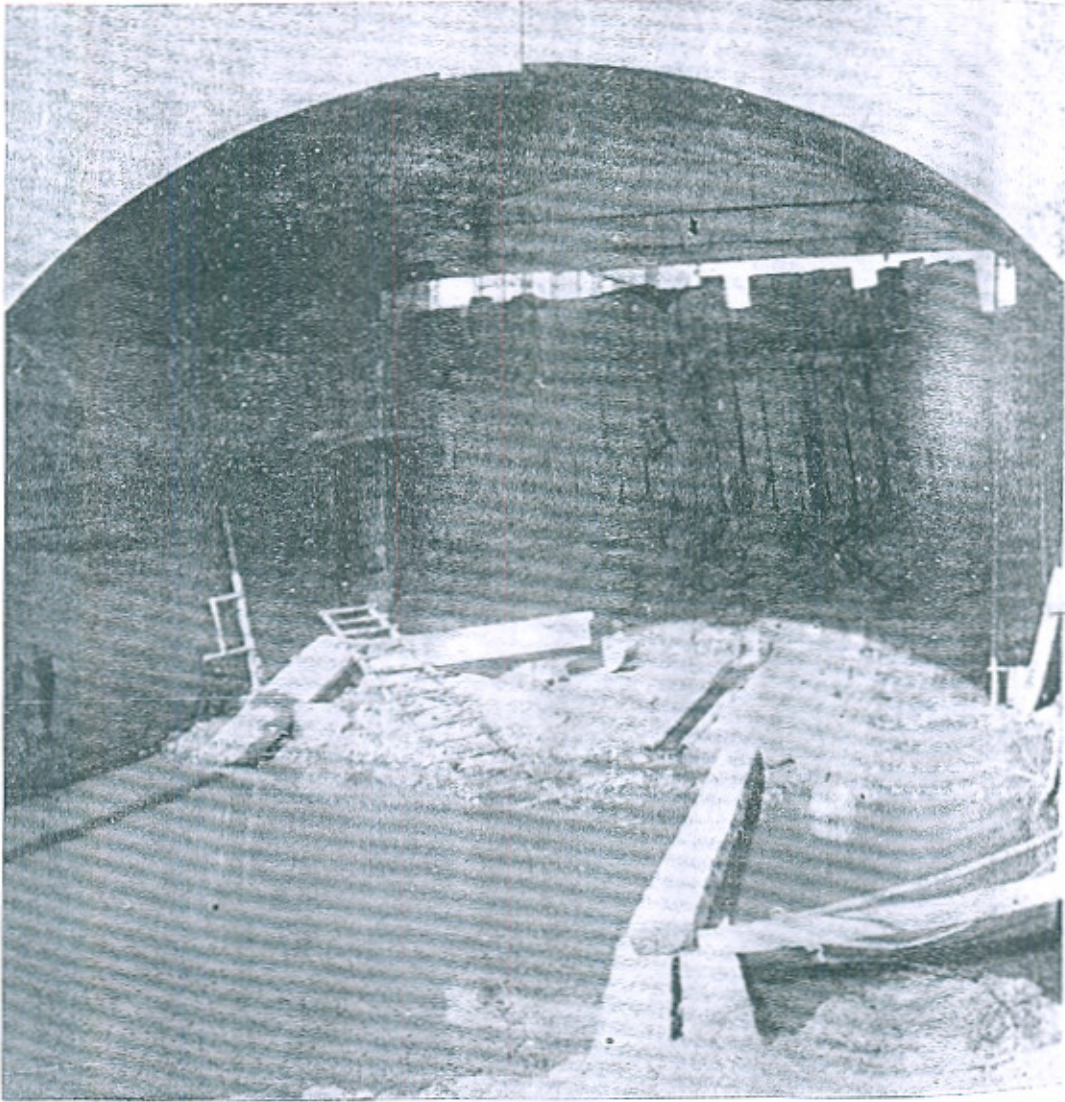
In the absence of gates, the canal was closed off with a needle dam.
(View from downstream).

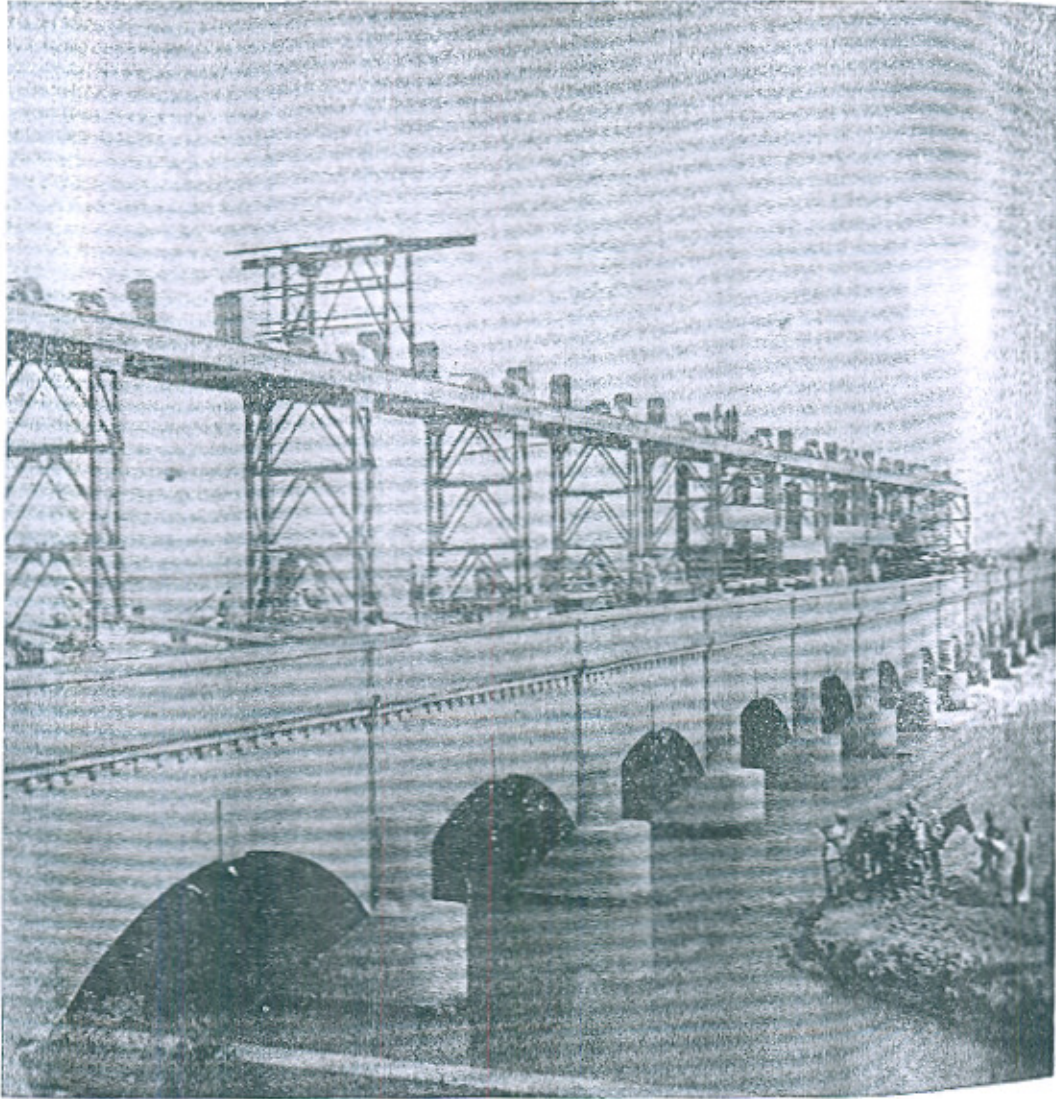
Ring bund being made for enclosing bays 12-8.
Depth of water in canal 10 ft.

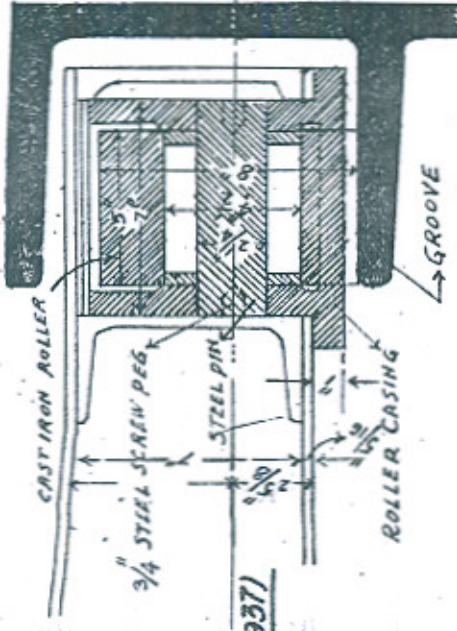
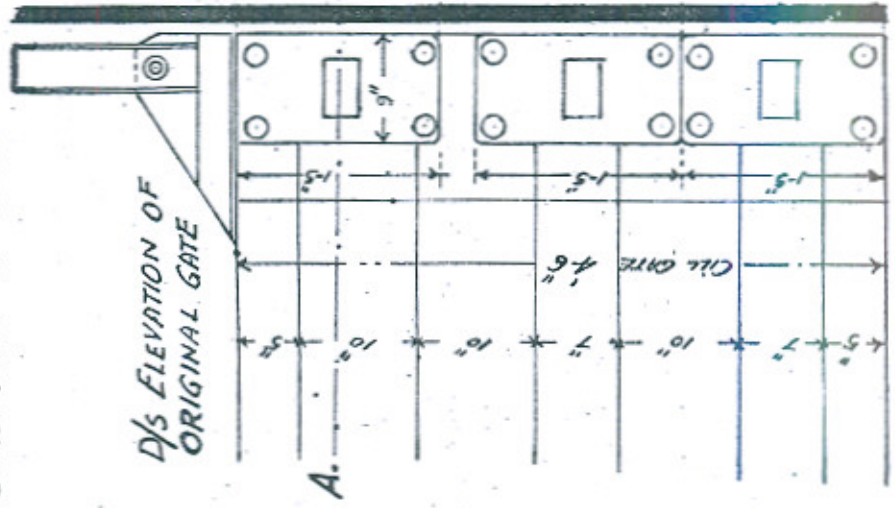
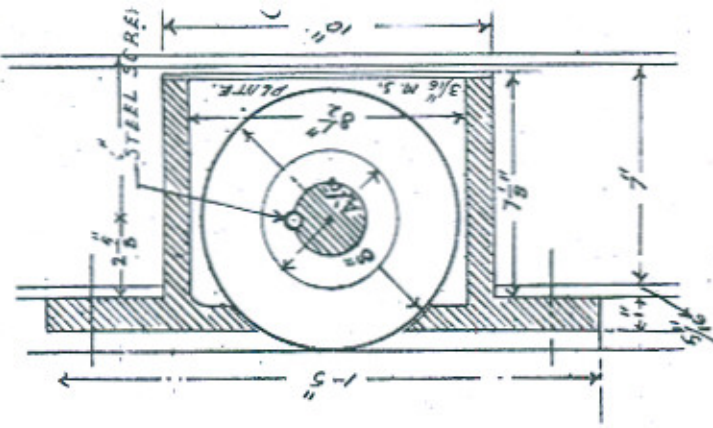
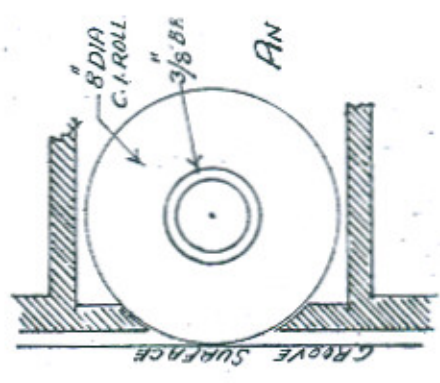
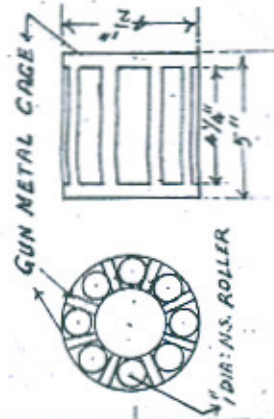
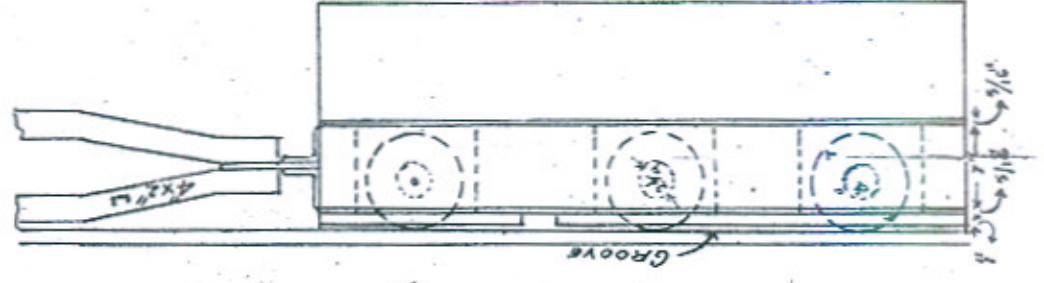
PAPER NO. 210
PLATE NO. I

The rollers originally fitted to both the cill and the upper gates were Mr. Ashford's design, and of the cage type (see plate 1). Each roller unit was housed in a box of size 10" x 7" studded on to the downstream side of the gates. The roller had a central steel pin, around which there was a brass cage containing 8 small cylindrical rollers, which served as bearings for the main roller. These rollers gave satisfactory service for over 15 years, but as described further, they suffered from the disadvantage of being inaccessible for inspection and greasing purposes unless the gates were taken out of the grooves, which process involved dismantling of the entire lifting machines and a cumbersome arrangement of crib work, screw jacks and pulley blocks.

In the year 1932-33 the rollers were thoroughly examined and 80 % of those on the upper gates were found to have worn flat. These were therefore removed and replaced by new rollers of the pin type. These were designed by Mr. Charles the then Superintendent, Central Workshops, Amritsar, and consisted of a hollow roller fitted internally with a gunmetal bush, which revolved round a steel pin 2" in diameter. This pin was to take all the pressure amounting to over 100 lb. per sq. inch. These new rollers proved less satisfactory than those which were replaced, and the upper gates had frequently to be worked undershot, from 1930 to 1935.

The chief defect of the new rollers was that they used to get stuck due to silt collecting in the clearance round the pin, and also due to the
