PAPER No. 215.

RECONDITIONING OF MARALA WEIR.

By E. O. COX, M. B. E., I. S. E., SUPERINTENDING ENGINEER,

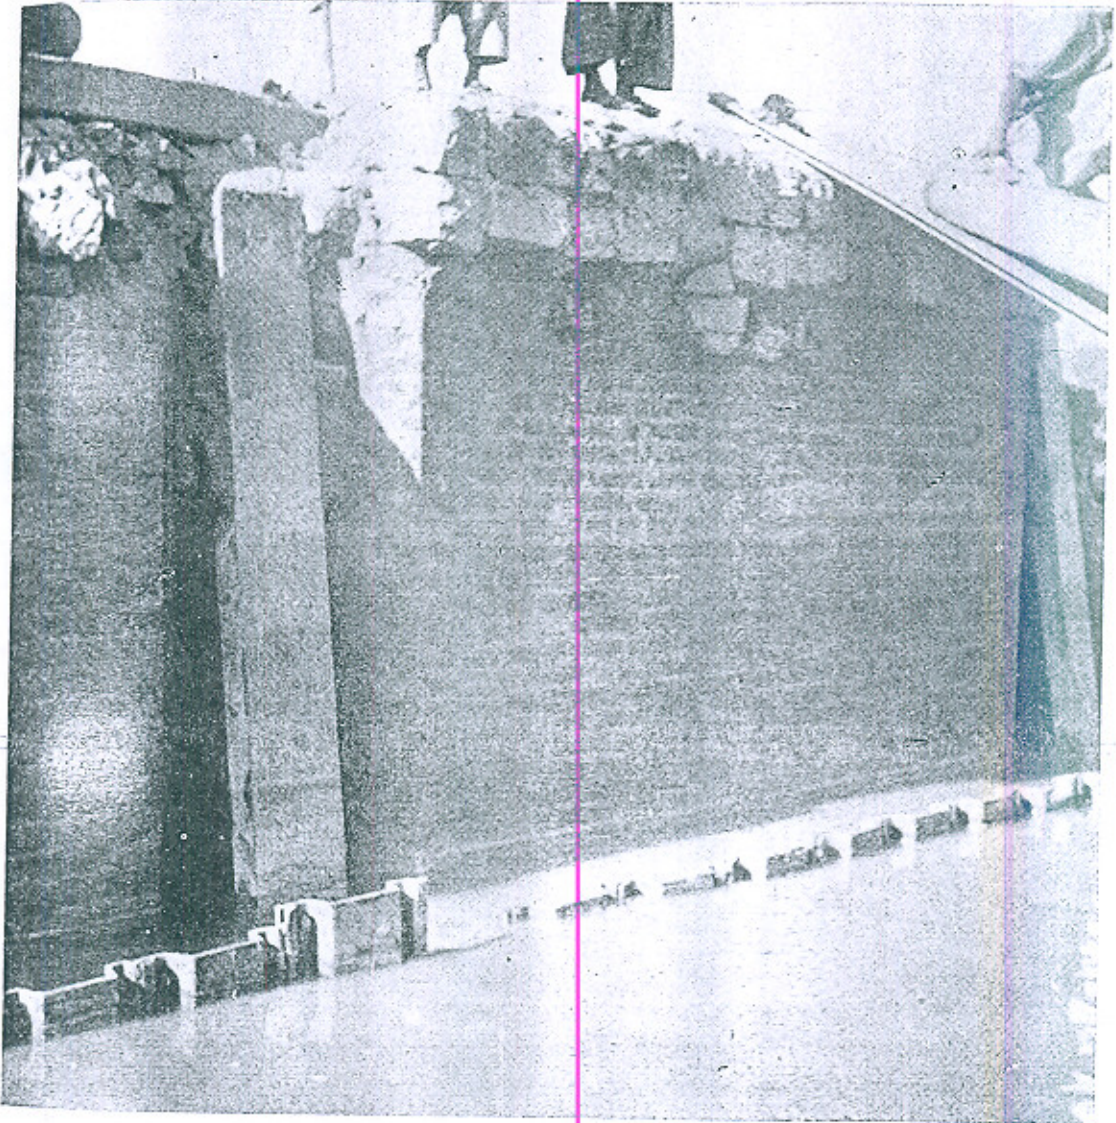
Photo No. 1.

Badly staunched well *Jhiri*. Nov. 1936.

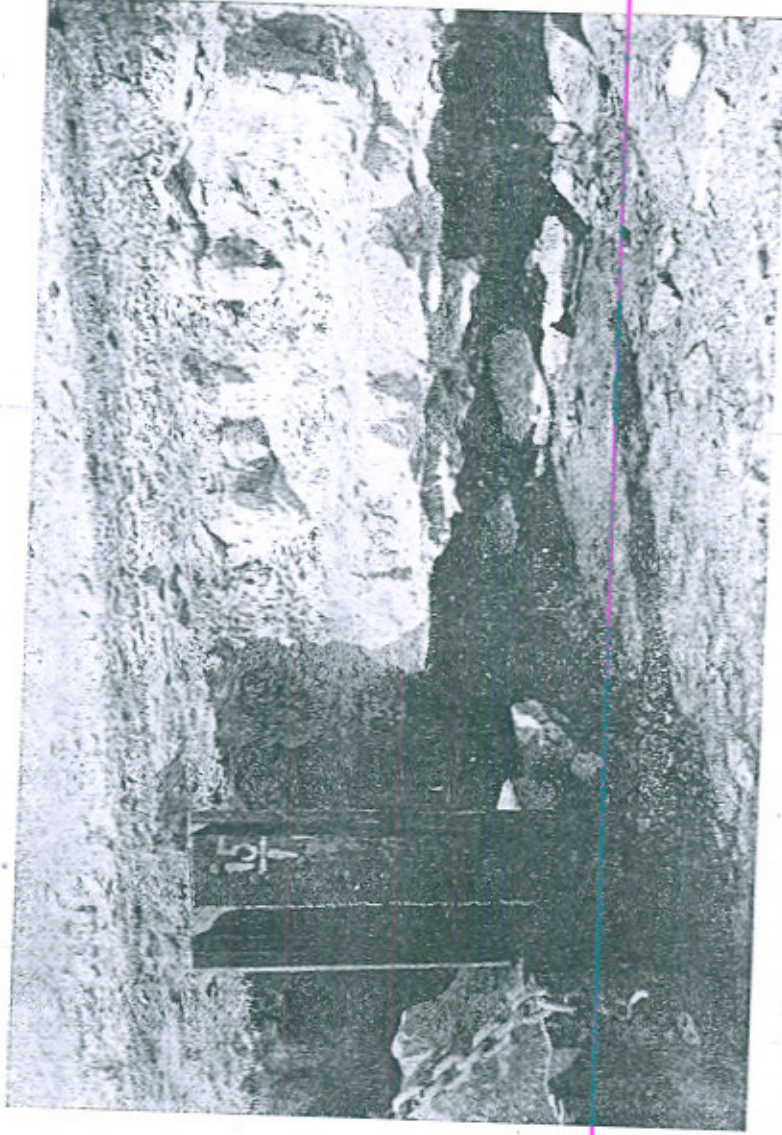
Photo No. 2.

First pile in Bay No. 3 and hollow under old glacis between
B and C lines of wells. Nov. 1936.

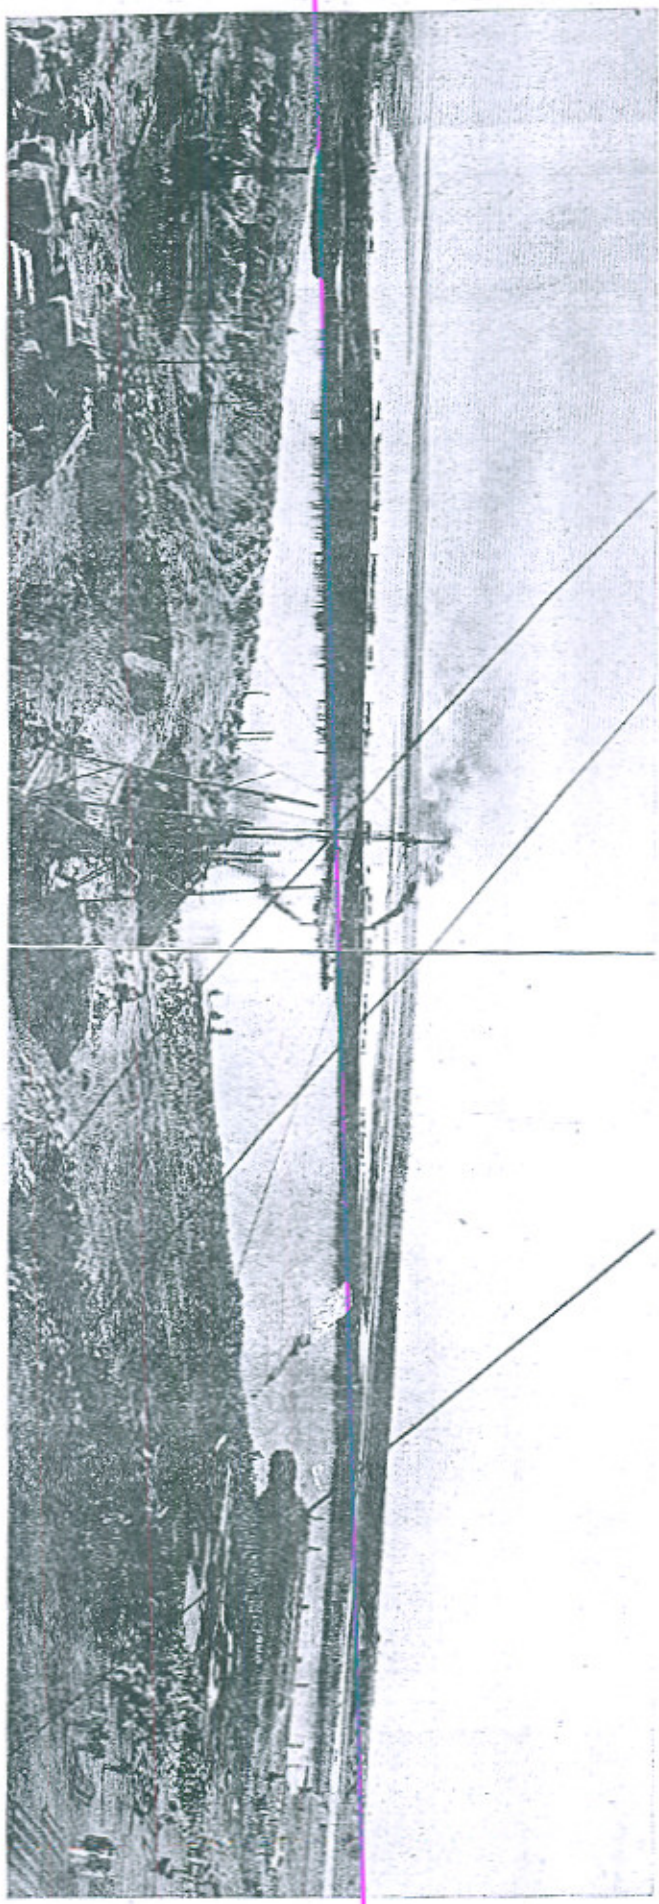
Photo No. 6.

Panoramic view of Bays 3, 4 and 5 showing the large and deep pool which it was necessary to pump before work could be commenced. Dec. 1936.

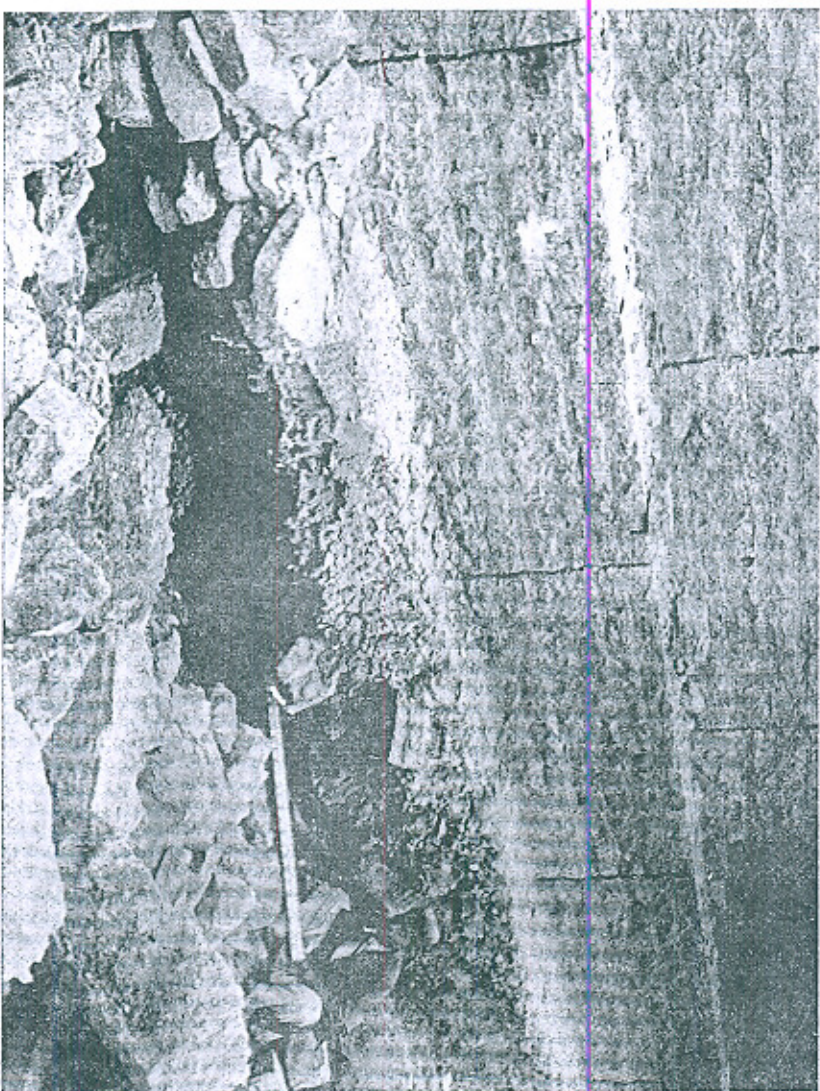
Photo No. 7.

As already stated, the driving of a 15 feet deep line of sheet piles above the C line of wells was an important item in the reconditioning of the weir. It was originally proposed to have the piles four feet above the upstream edge of the wells in the C line but in view of the extent of the overhang of the hammer of the pile driver beyond the track over which the pile driver moved on the C line, it was decided that two feet would be a more convenient distance. Plate VII shows the position of the pile line in a weir bay. Near the left flank the line was given a right angle turn downstream and was taken just past the fish ladder so as to abut against the foundation wells under the right flank wall of the undersluices. (Plate No. VIII). On the right flank of the weir it abutted against a well under the right flank wall. In addition, as shown in Plate VII, a line of piles was driven under groyne No. 4. This groyne had failed in both the record floods of 1928 and 1929. On dismantling the block and loose stone protection on either side, it was found that the foundations of the groyne had been undermined. (Photo No. 7).

Six feet cavity under Groyne No. 4.
Date of photograph. 10-12-36.

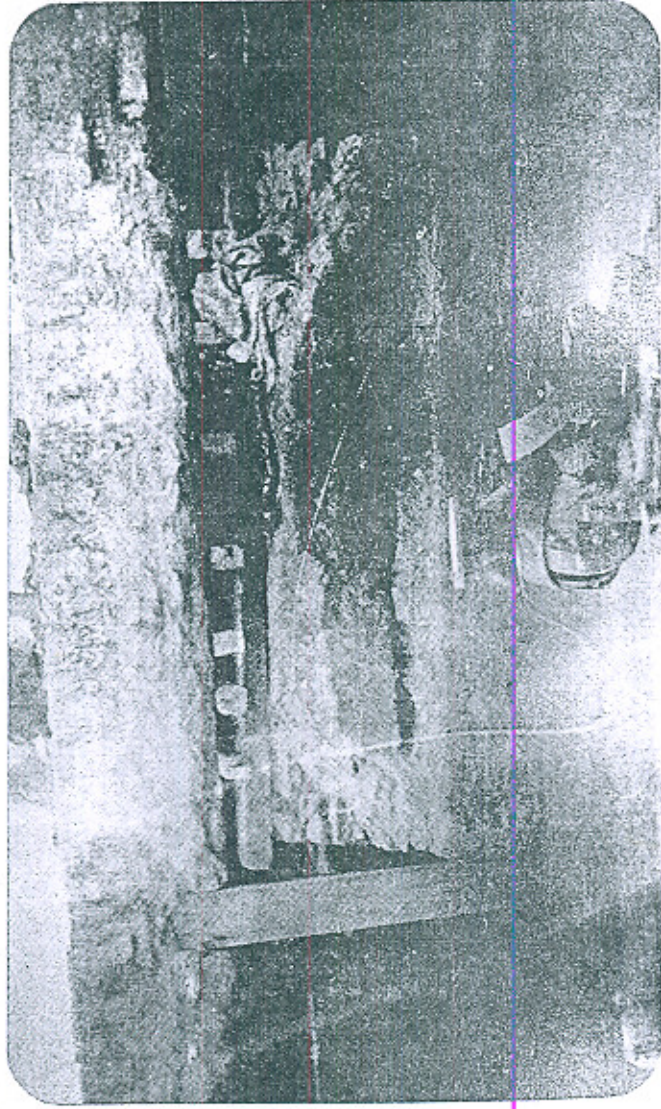
Photo No. 8.

Tilted wells in C line in Bay No. 4. Dec. 1936.

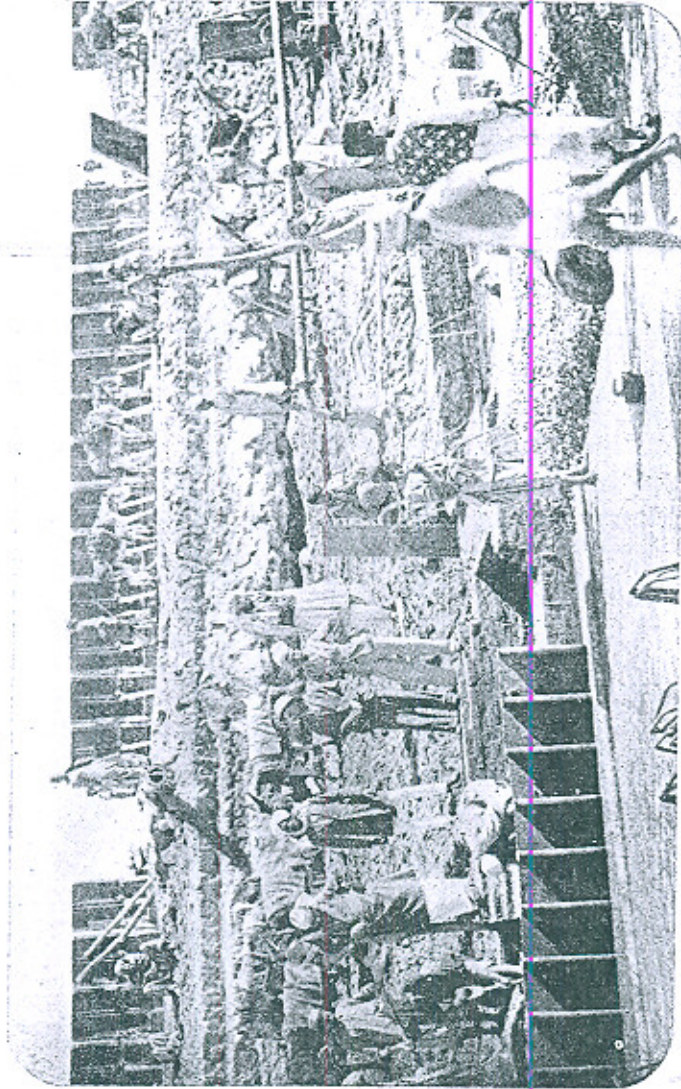
Photo No. 12.

Universal sheet piles driven in a gap in B line of wells.
Three of the wells were missing.—Date 15-2-37.

For the reasons mentioned above, Universal piles had to be driven in a length of about 150 feet in the right half of bay 4 where the glacis between the B and C lines of wells had been completely washed away in the record flood of 1929 and where some wells in the C line had become tilted. (Photo No. 8). As already stated, groyne No. 4 had been damaged twice before and here also in a length of about 50 feet at the downstream end, Universal piles had to be driven. Again on dismantling the weir floor in bay 5 it was found that three wells in the B line on which the safety of the old weir depended were missing. These wells, it appeared, were omitted originally owing to the presence of stone, the remnant of an old construction bund, in the river bed, and for the same reason new wells could not be sunk here. As there was considerable sloughing of wet sand between the crest and this gap which might have undermined the crest, it was decided to put in a line of Universal piles across the gap a little below the downstream edge of the B line and join it to the latter. (Photo No. 12).
