## RECONDITIONING OF MARALA WEIR.

PLATE IIa  
PAPER NO. 215

PUNJAB ENGINEERING CONGRESS  
1938

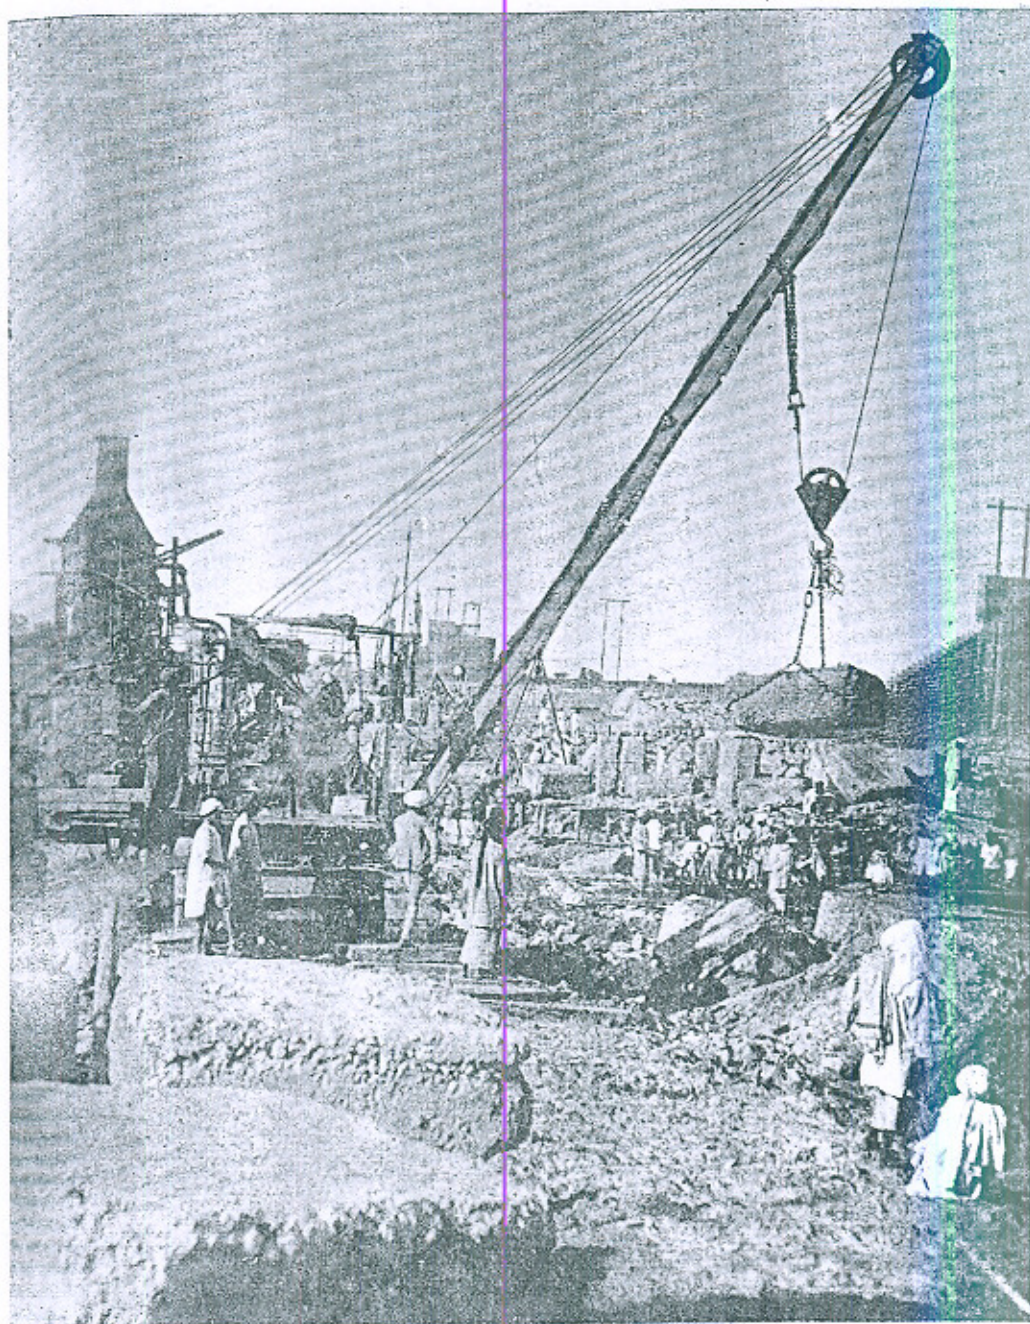
Photo No. 11.

Excavator lifting 3-ton block.—November, 1936 .

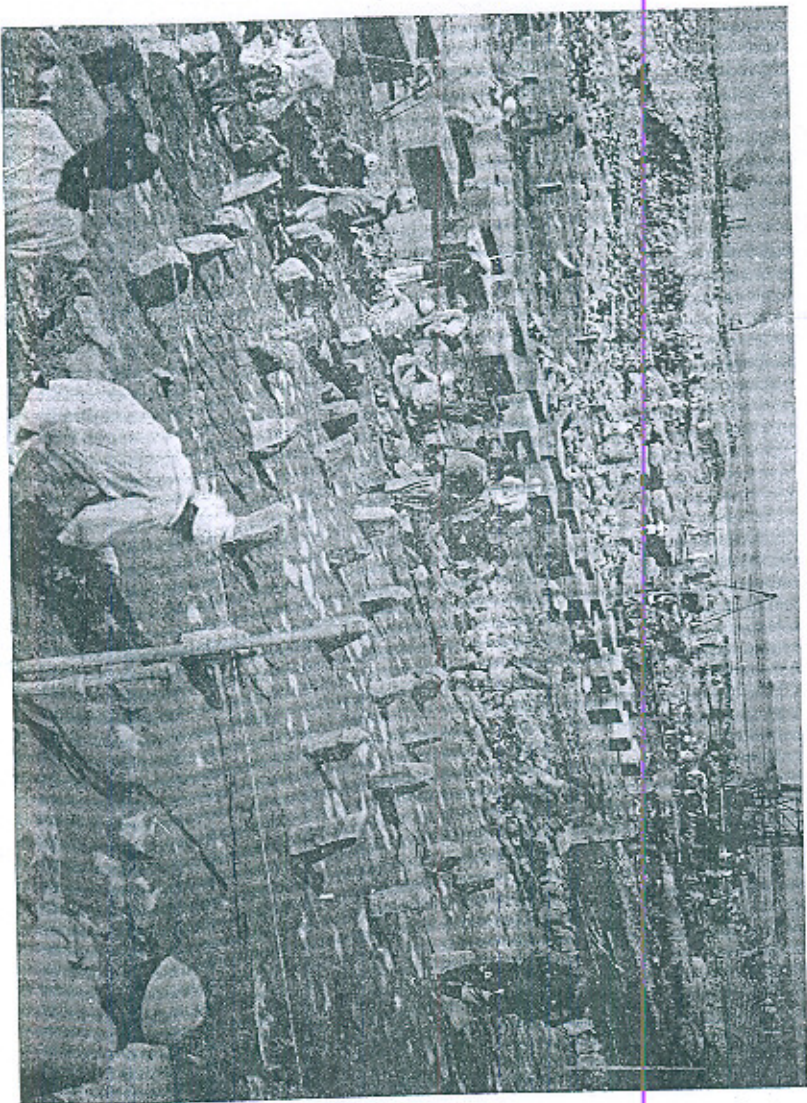
Photo No. 9.

covered by 1'0 foot of toothed *kharwanja* in 1 : 3 cement mortar. As shown in Photo No. 9 the necessary bond between the different layers was provided by the use of binder stones, also the stones in the lower layer were cleared of all mortar before the upper layer was put on. At the B line the requisite bond has been provided by having a layer of concrete at the top of the wells and in the gaps in between and carrying it above and below the well line in one continuous operation. Short reinforcement bars were provided on either side projecting from the concrete inside the wells into that under the sloping floor upstream and the horizontal floor downstream. The latter consists of a mass concrete section 4 feet thick, the bottom 3 feet being a 1 : 4 : 7½ mix and the top one foot a 1 : 2 : 3½ mix. Concrete was laid in layers as at Khanki, the bond between the different layers being provided by stone plumb obtained from dismantling the old floor and by mild steel vertical stirrups. The top layer is reinforced for temperature stresses by ½ inch bars spaced 9" centres both longitudinally and transversally to the weir, the latter being tied to the sheet piles by means of triangular stirrups attached to each pile.

Masonry of glacier. Mark binder stones and cleaning of layers.—January, 1937.

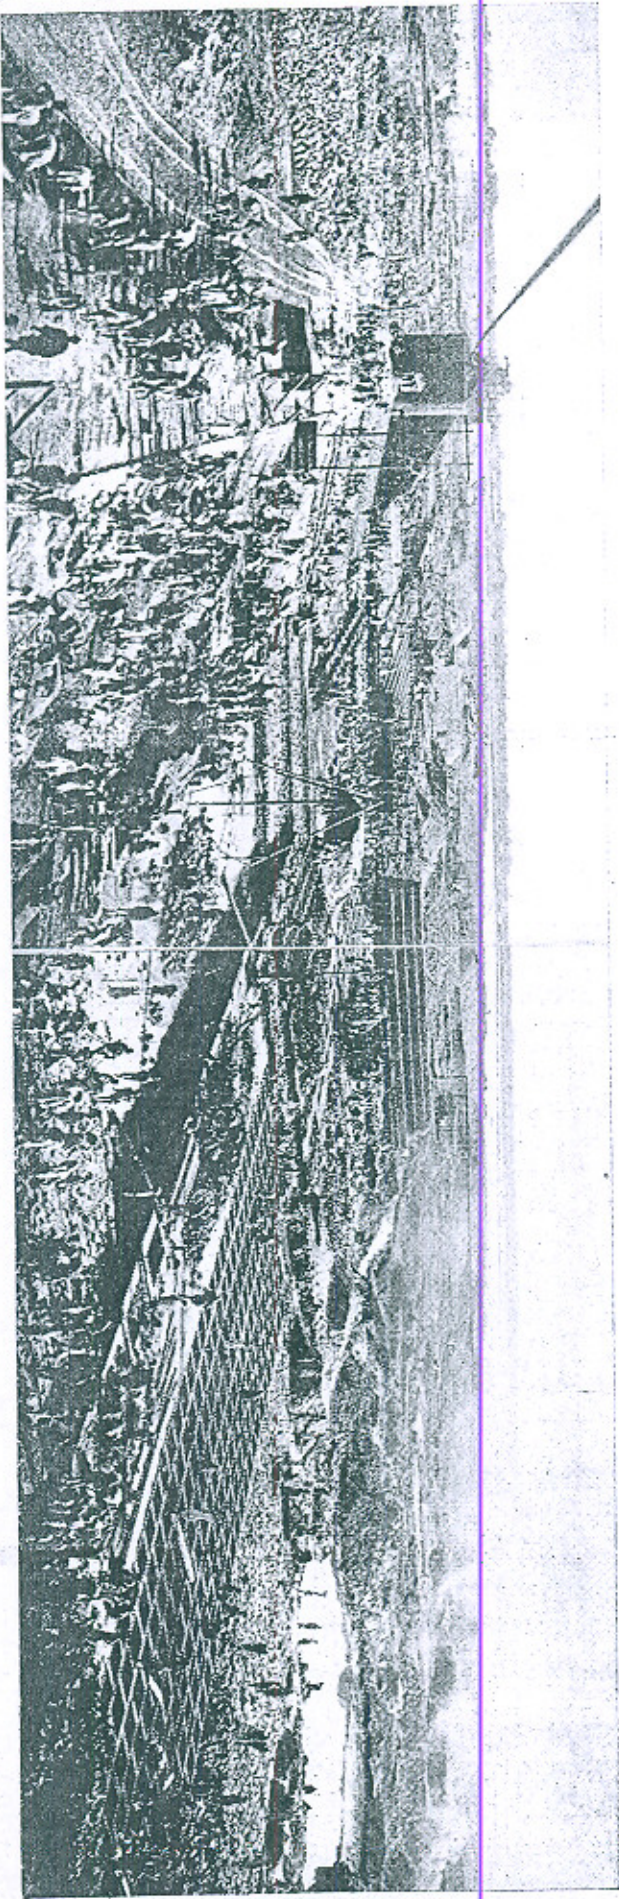
Photo No. 13.

Groyne No. 7 had failed in the record flood of 1929 and been subsequently rebuilt in stone masonry on a thin slab of concrete with foundation R. L. 792, i.e., two feet above the new depressed floor. As it was in good order it was decided to underpin it by encasing the foundations in concrete carried down to R. L. 784.8. To rebuild this groyne would have cost about Rs. 6000 more, and there was no time to do the work in any case.

Photo No. 13 gives an idea of the pressure under which work in bays 5 to 8 was carried on. Photo No. 14 shows a view of the completed work from the right flank. Groyne No. 7 appears prominently in both the photographs.

Panoramic view of Bays 5 to 8 showing work in progress, Groyne No. 7 in centre being underpinned. The artificial sump prepared in bay No. 8 is clearly visible. Date 5-3-37.

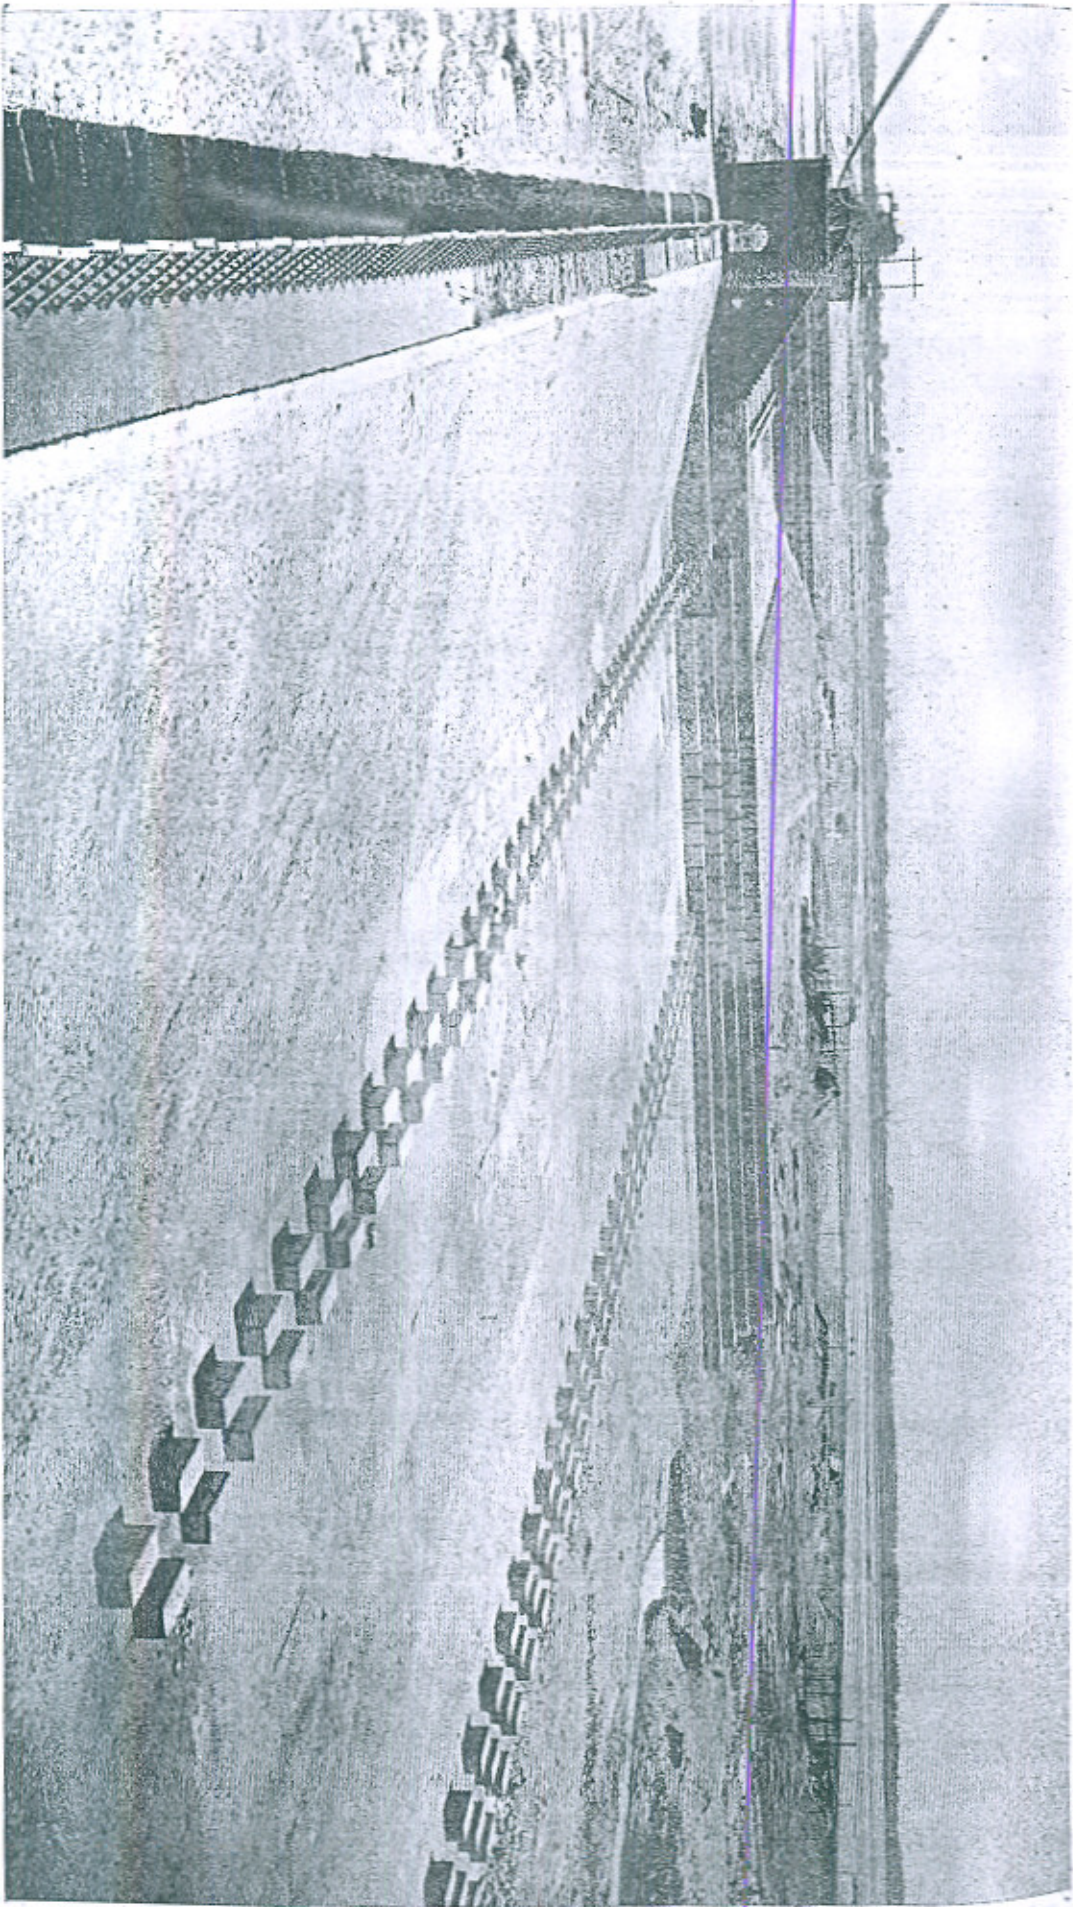
Photo No. 14.

Panoramic view of completed work from right flank.

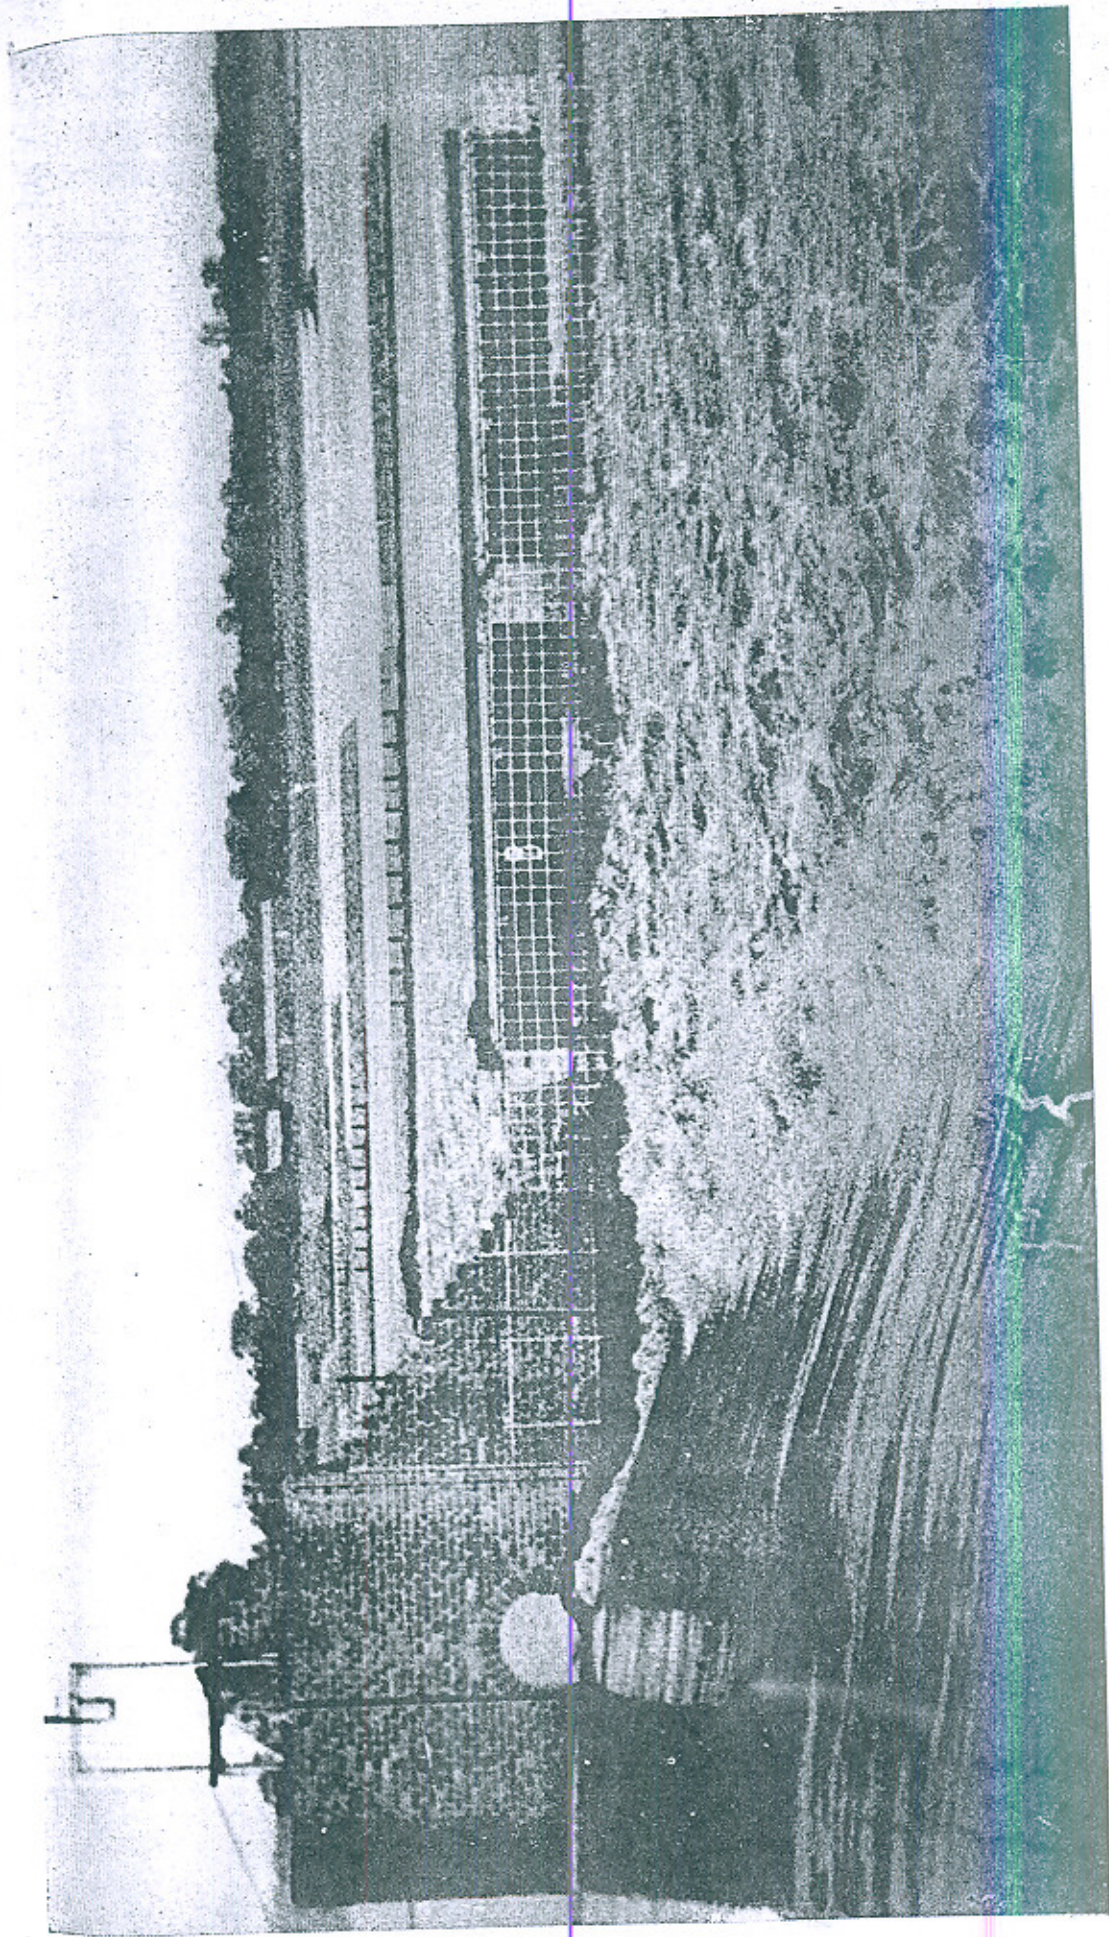
Photo No 15.

It has been stated above that observations were made during the record flood of August, 1929 of the profile of the standing wave but during tests made subsequently on a model of the weir the field observations could not be reproduced. In view of the great importance of the subject, arrangements were made to determine the position of the standing wave, after the weir had been reconditioned, by photographing an actual wave against Groyne No. 4 on which horizontal and vertical lines at one foot intervals had been painted. Owing to the absence of floods during the last monsoon, however, it has not been possible so far to do more than take a photograph with the supply above the weir headed up to the top of the shutters (R. L. 808). Photo No. 15 shows the wave under such conditions. The intensity of discharge per foot run of weir was then about 50 cusecs and the downstream water level at R. L. 801. It will be seen that the wave formed about half way between the shutter line and the B line of wells. In the old Weir the wave under such conditions used to form over or a little below the B line. The change is due to the downstream glacis having been reconstructed with a slope of 1 in 4 against its previous slope of 1 in 15.

Standing wave after Reconditioning. Upstream R.L. 808, downstream 801.—Date 15-8-37.
