RECONSTRUCTION  
OF  
MARALA WEIR  
PLAN OF WEIR (BAY NO. 3)  
SCALE 1/500

EXECUTIVE ENGINEER  
MARALA DIVISION U.C.C.  
PUNJAB ENGINEERING CONGRESS  
1938

RE-CONDITIONING OF MARALA WEIR  
PUMPING DIAGRAM

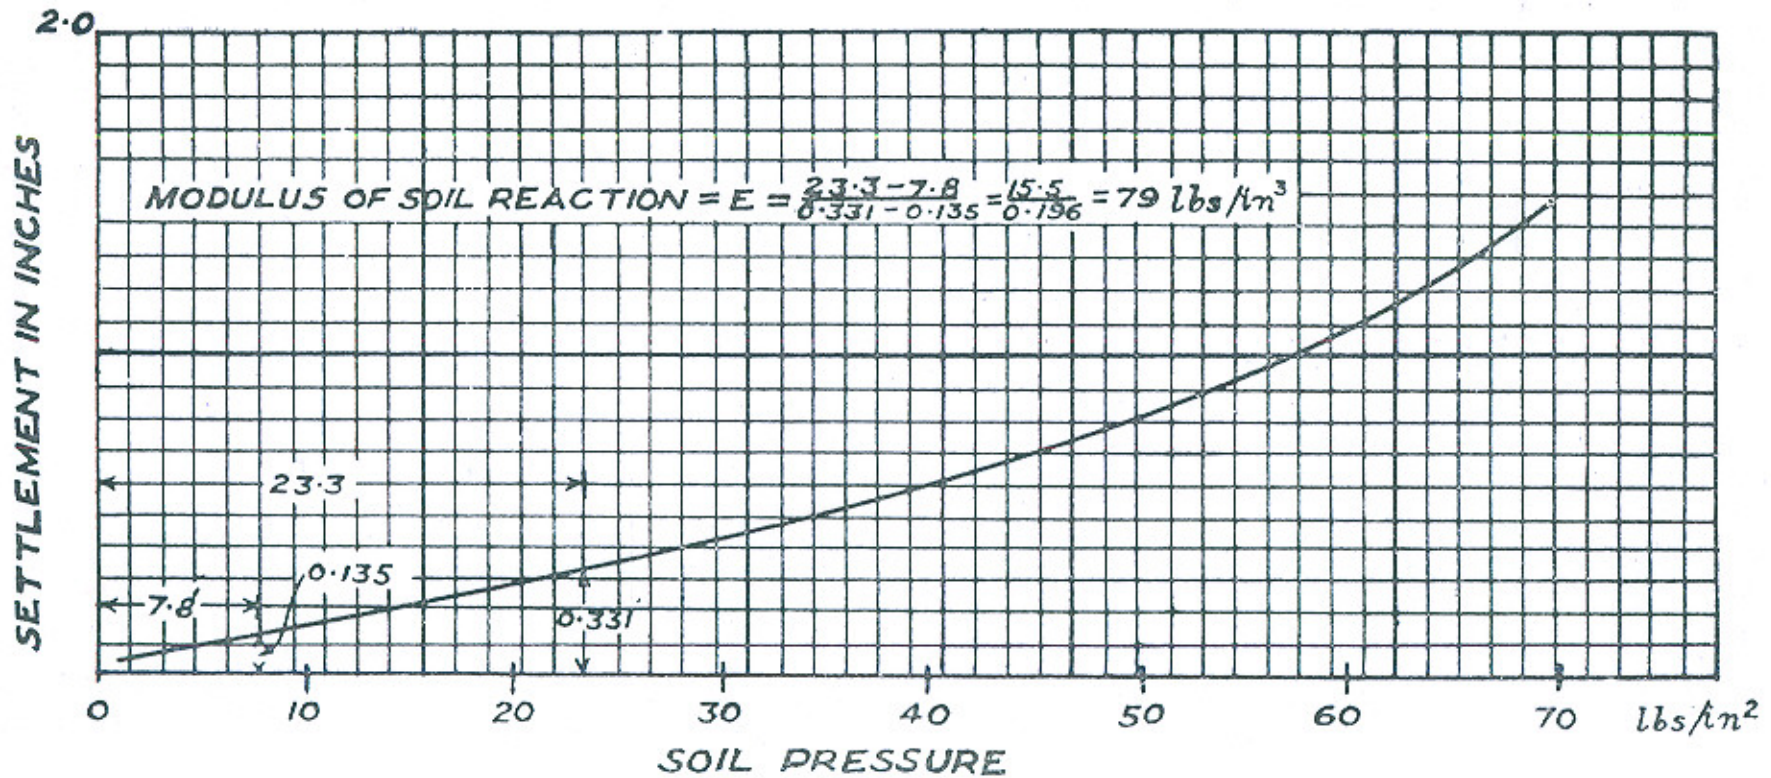
FIG. 2  
PAPER NO. 215

This constant  $E_1$  was termed the Modulus of Soil Reaction and its value for average sand in a dry condition was about 600 lb. l in<sup>3</sup>. Its value for sand under weirs had been worked out to be 79 lb. per in<sup>3</sup>. by experiments carried out at Trimmu under the supervision of the Director, Central Designs, Irrigation Secretariat, Lahore. The load settlement curve as obtained from the observation had been shown in Fig. 2.
