PAPER NO. 251

PERFORMANCE OF MASONRY BUILDINGS
DURING 8TH OCTOBER HAZARA-KASHMIR
EARTHQUAKE IN PAKISTAN

PROFESSOR DR. M. ILYAS AND S. H. FAROOQ

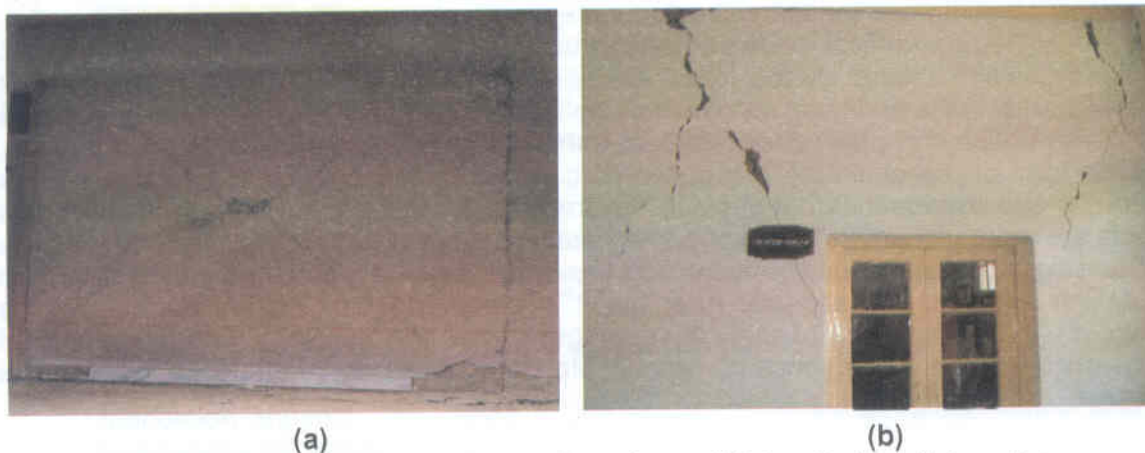
Shear cracks appeared in the load bearing and masonry infill due to severe ground motion during the earthquake. The load bearing members and masonry infill at the right angle to the direction of ground acceleration showed shear cracks due to accumulation of shear stresses in the member. Fig.2a shows the shear cracks in load bearing wall as the wall was in the perpendicular direction with respect to earthquake motion. Fig.3b shows cracks in the masonry infill.

Figure 2: (a) Shear cracks in masonry load bearing wall (Muzaffrabad University)
 (b) Shear cracks in masonry infill in shopping plaza at Abbottabad

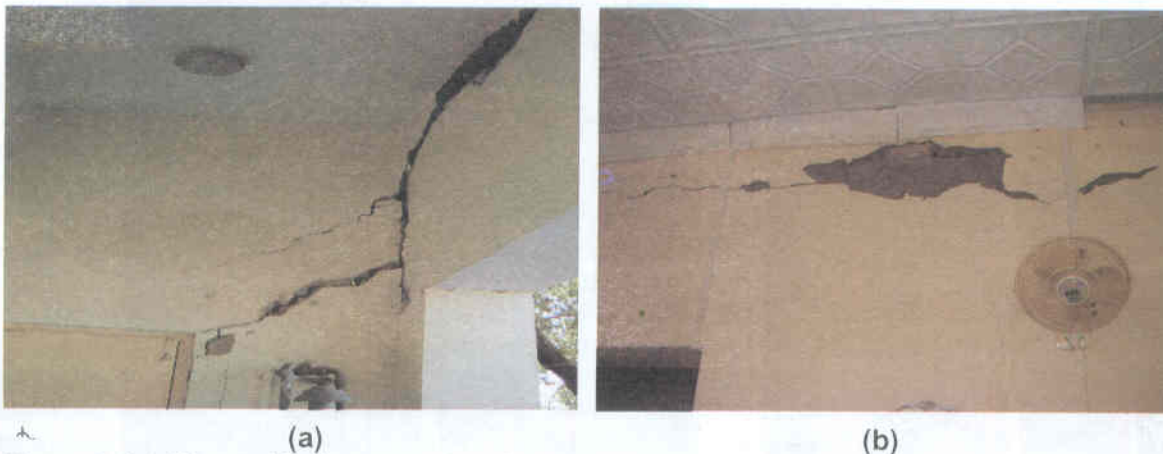
Figure 3: (a) Flexural & shear cracks along with separation of wall from wall connection
 (b) Shear & flexural cracks along with separation of wall from roof

Flexural as well as shear cracks were observed in most of the building due to excessive stresses induced by in plane vertical and horizontal forces. As the affected area was very close to the fault surface the vertical and shear component of the seismic wave had combined significant affects on most of the buildings. Figure 3(a) & (b) shows the horizontal flexural and shear cracks in brick masonry load bearing wall along with joint failure due to movement caused by earthquake vertical and horizontal forces.

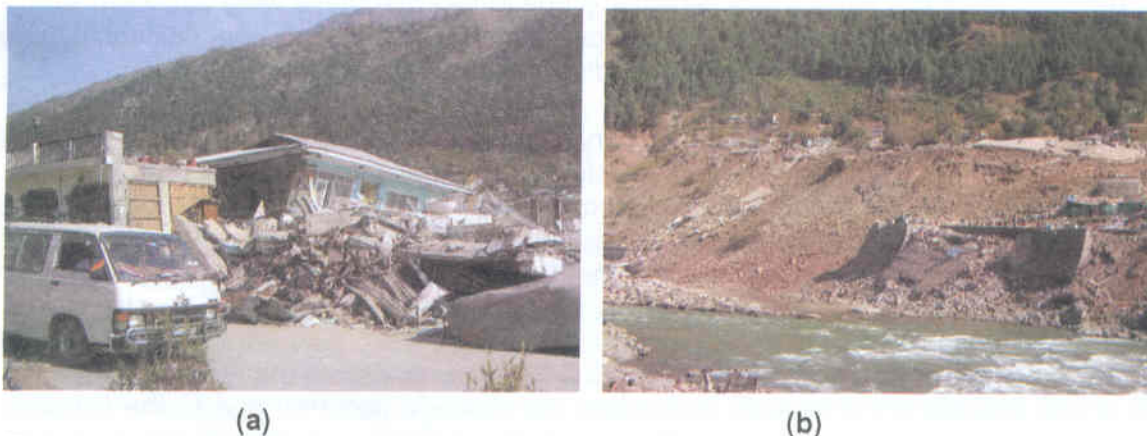
Failure of masonry structure was also observed due to settlement and slope failure. Most of the buildings were constructed without any prior soil investigation and situation got worsened by constructing the structures on the fill land with shallow and improperly designed foundation. In the eve of the catastrophic earthquake the earth shaking destabilized the soil beneath the structures and they collapsed. Figure 4(a) & (b) shows the collapse of brick masonry building due to settlement due to shear / settlement failure of soil beneath the foundation.

Figure 4: (a) Collapse of masonry building in Muzaffrabad due to settlement
 (b) Collapse of masonry building in Balakot due to settlement

5.2- It was observed during this visit that a number of masonry structures were damaged due slope failure and improper foundations. It is strongly recommended to carry out proper soil investigation and proper footing type according to soil investigation. Construction on unstable slopes should be avoided; otherwise it is necessary to stabilize the slope before constructing any structure. Mat/Raft foundation should be made mandatory for residential buildings or pile foundations and unstable slopes will be the most appropriate solution.

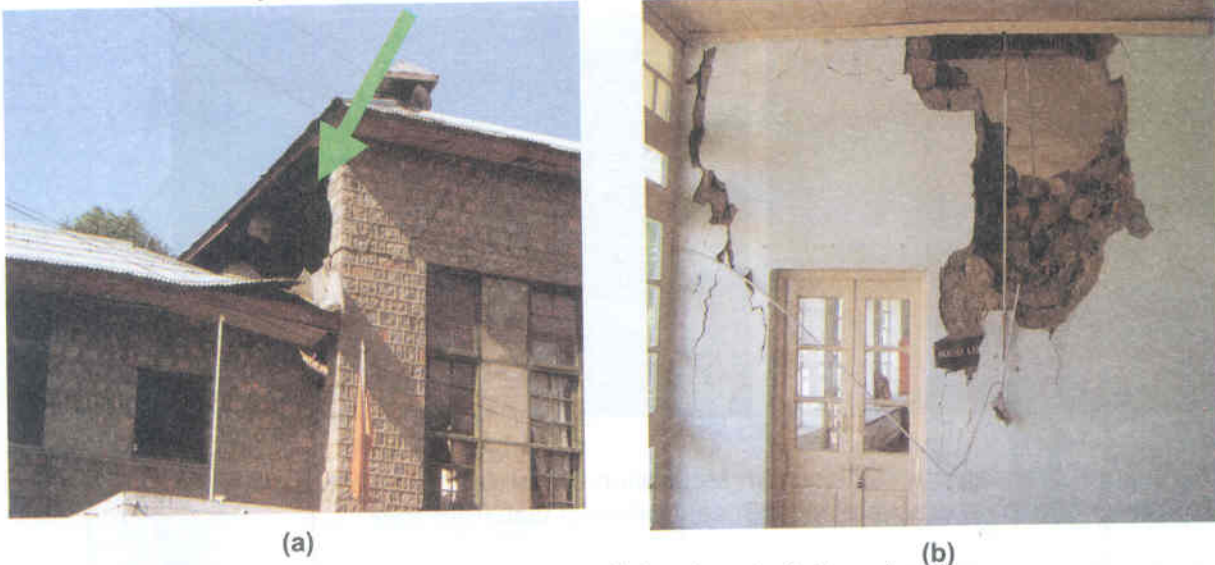
Figure 5: (a) & (b) Collapse of load bearing wall due to out of plane loading

Collapse of buildings due to out of plane movement was also observed in the affected areas. All the walls having less flexural strength and minimum stiffness in the perpendicular direction of seismic waves were collapsed causing the failure of complete structure. Figure 5(a) & (b) shows the collapse of load bearing stone masonry wall due to out plane earthquake forces.
