Nature and Extent of Damage

The Design of Tando Masti Khan Fall

PAPER No. 331

Tando Masti Khan Rohri Canal.

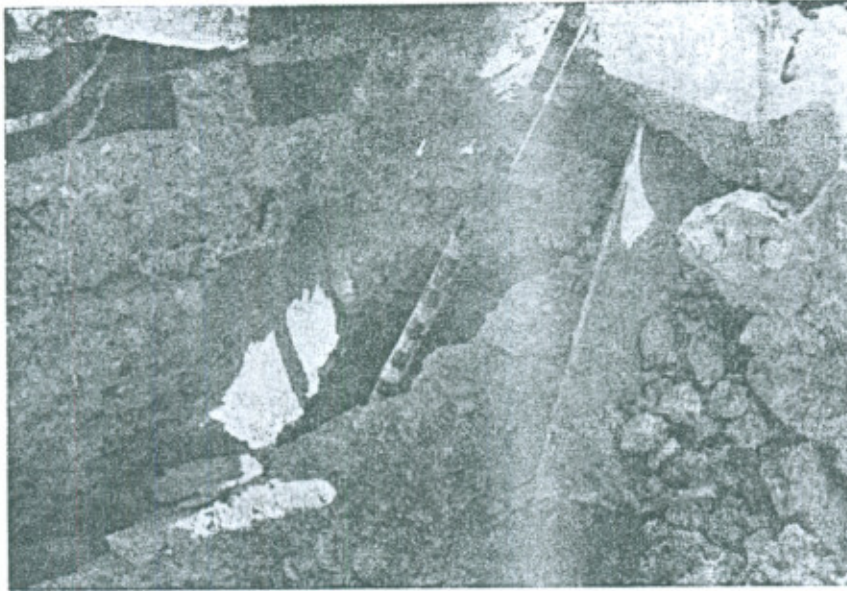
The extensive damage to the fall can be visualized by photographic exhibits Plate II & III. The concrete glacis had severed off the crest at its junction in all the bays 1 to 6, wide cracks having developed and cavities as deep as 2.5' were measured below the glacis. These cracks continued in the vanes being almost vertical in the first three vanes and increasingly oblique in the next three. The cracks continuously widened with the passage of time and extended beyond bay No. 6. The cistern floor downstream of baffle wall settled by about 4.5 ft. at the deepest portion. This settlement commenced from the left wing wall and continued beyond the centre line of the structure. Later the cracks also appeared at the junction of upstream glacis and the crest. The left wing wall ultimately collapsed from where it has cracked due to earth slipping from behind.

*Showing cavities under the glacis slope in Bay 6.
The depth of cavity is 2'6'.*

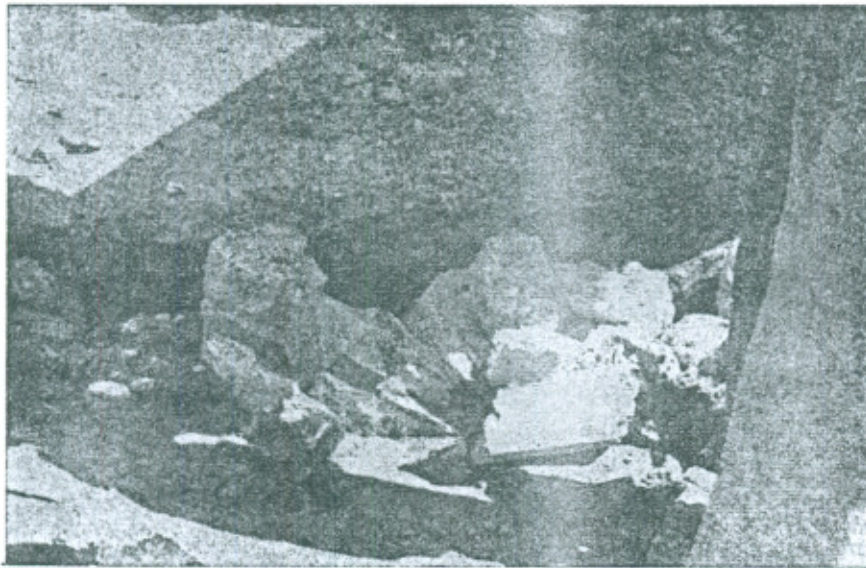
Cavity under the glacis slope.

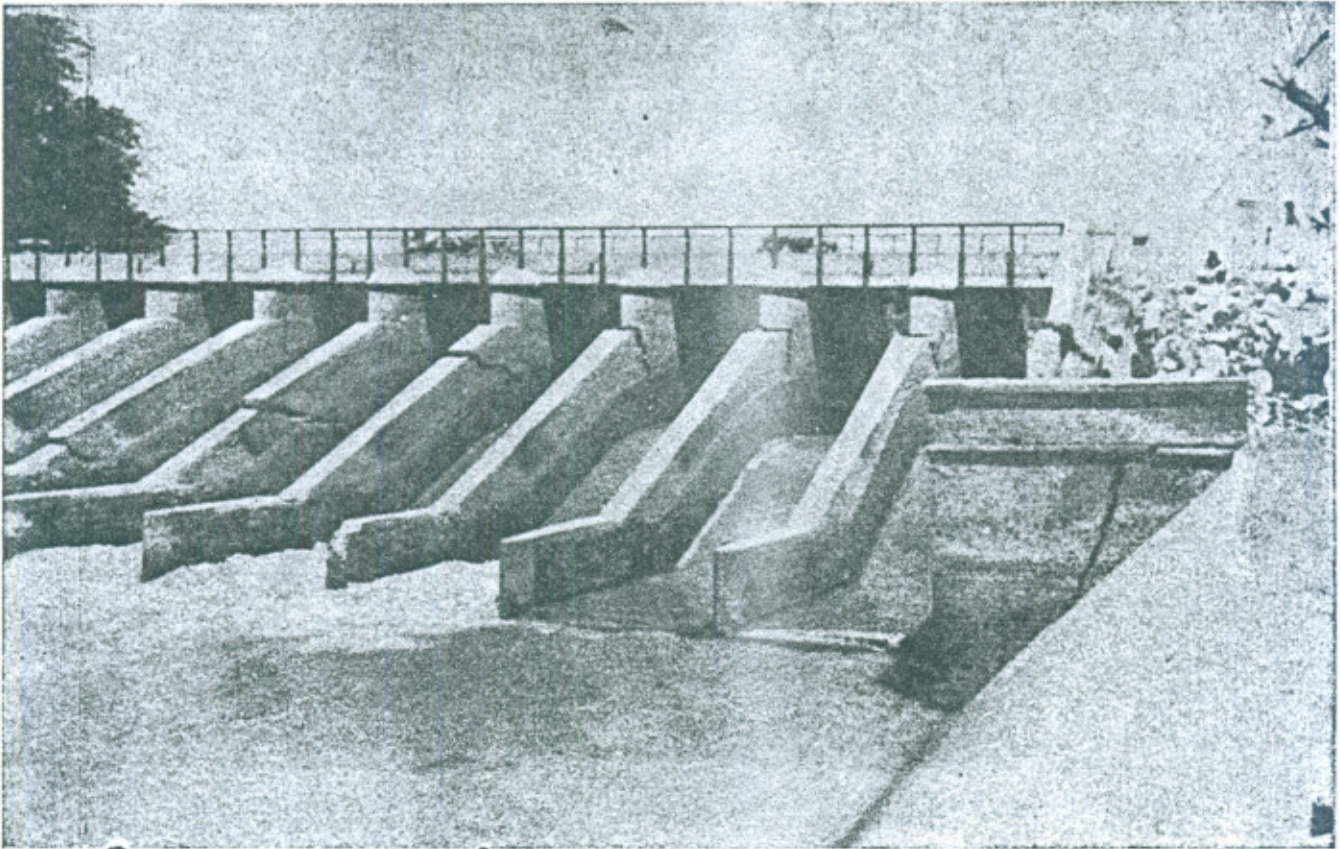
Showing cracks in piers and flank walls. These cracks are continuation of horizontal cracks on the crest.

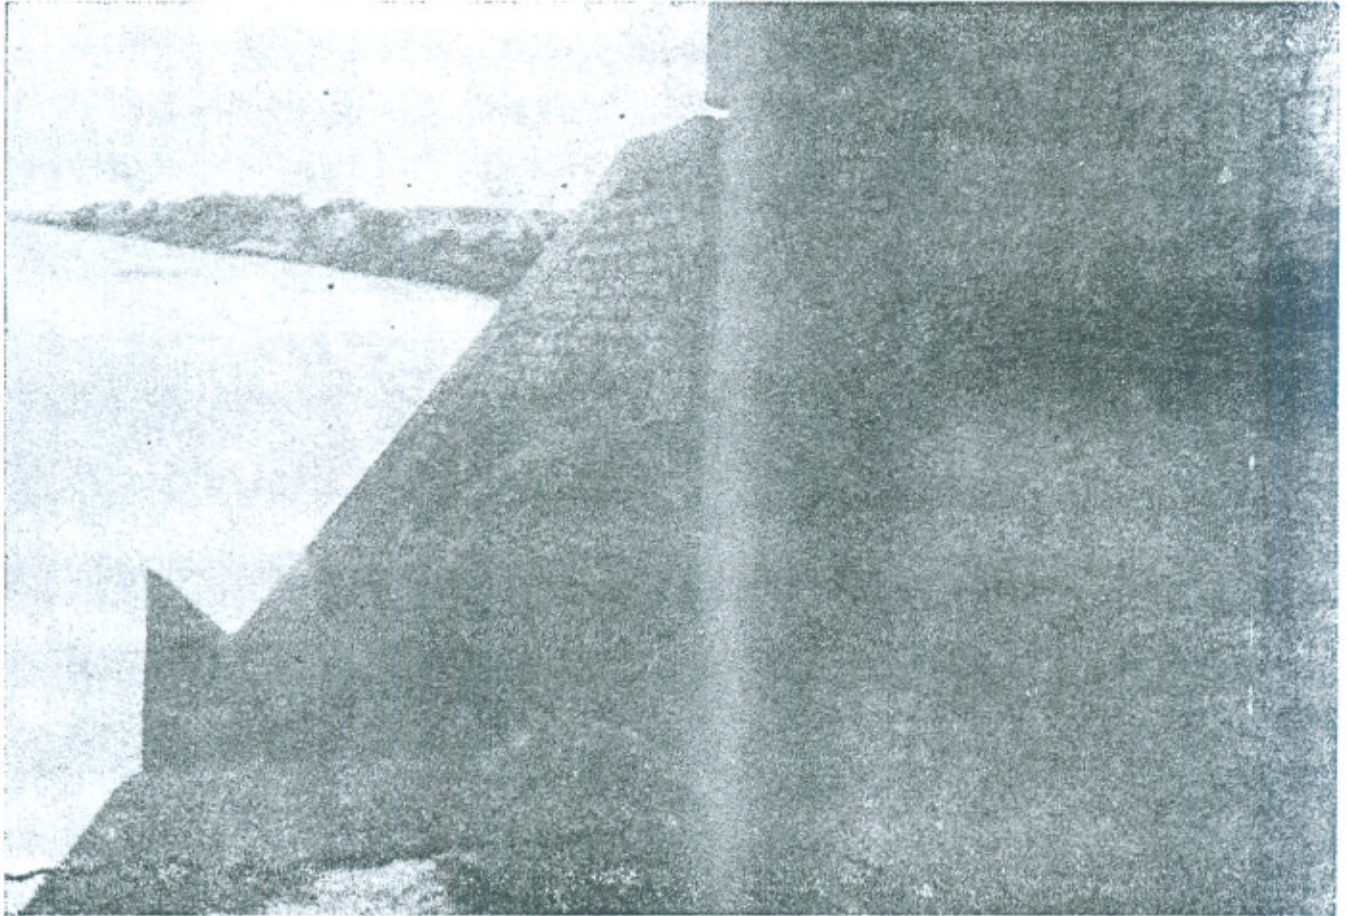
Showing cracks in piers and joint of crest and glacis Bay No.

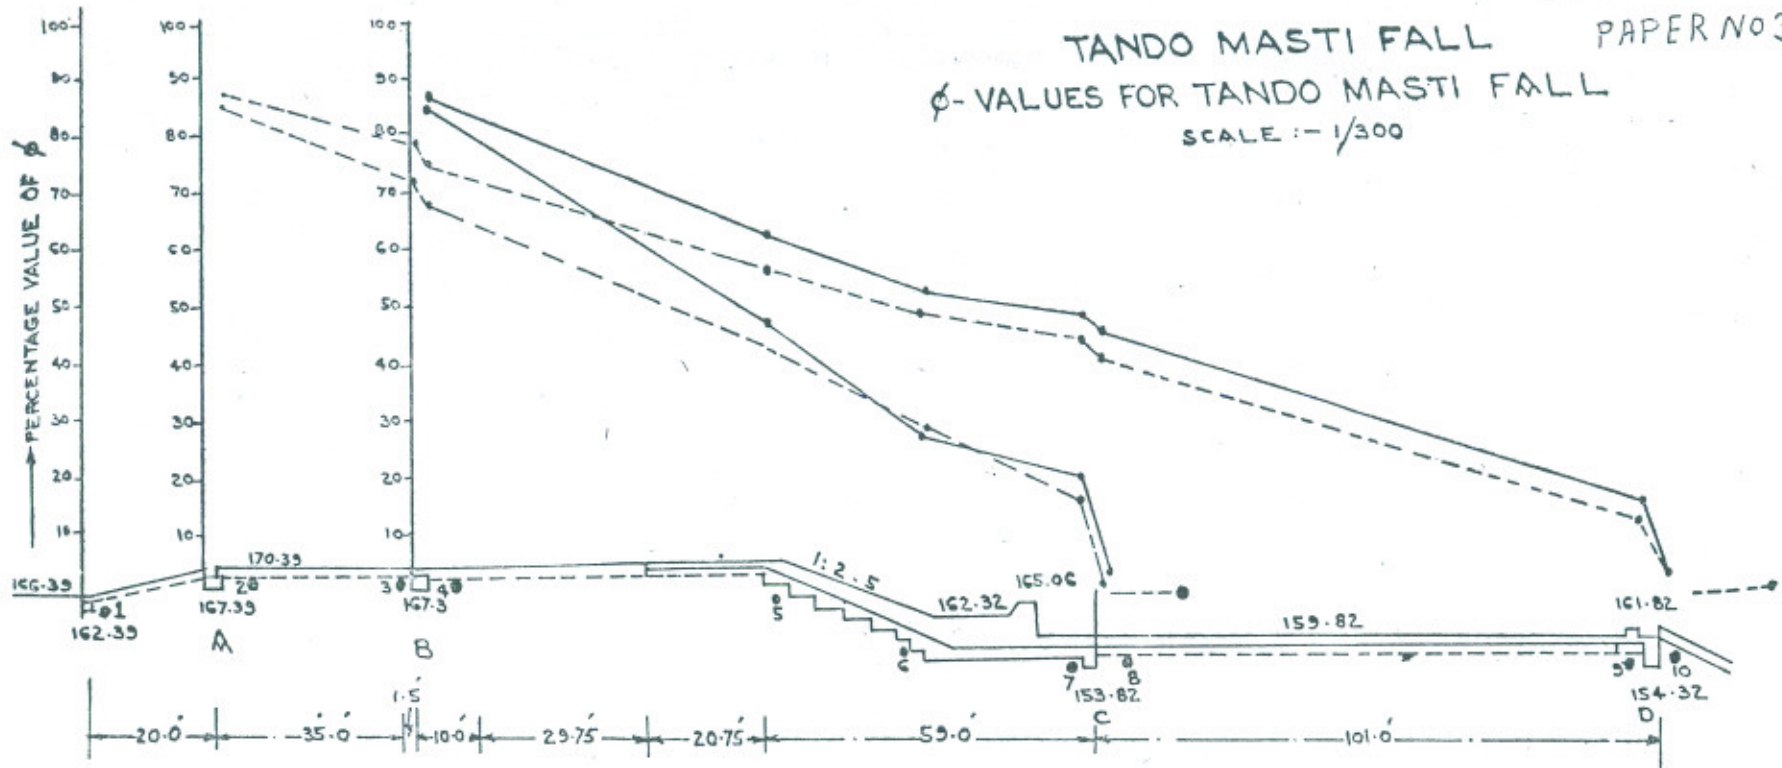
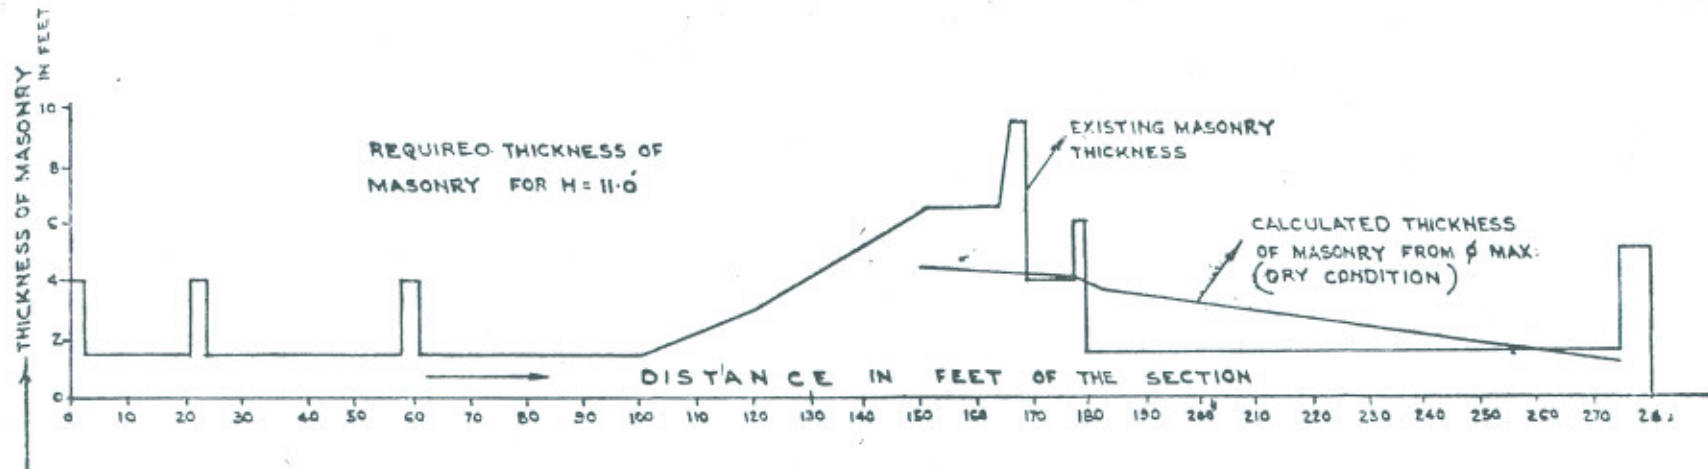
φ-VALUES FOR TANDO MASTI FALL

- (3) The thickness of floor down-stream of baffle wall is not adequate to withstand the uplift pressures caused by the actual working conditions. It has been indicated earlier that the prevailing conditions subjected the structure to a differential head of 11.2 ft. instead of the designed head of 8.1. Plate IV gives a comparison of the required thickness of floor to those existing at site. Actually the critical conditions occurred during closure. Data observed during the last closure of the ill fated fall gives upstream water level as 173.04 and downstream water level as 161.3, the head across being 11.74. Hence the worst condition occurs during closure when there is only 2' of water in the cistern downstream of baffle wall against 12 ft. under running conditions.

The soundings and probing of the cistern floor taken after the failure showed that a portion of the floor has settled downstream of the baffle wall. This observation interpreted in the light of calculation of Appendix I indicates that failure has taken place in the portion where the cistern floor was weakest from the point of view of uplift pressure. The probable reason for the failure of the work appears to be the development of cracks in the cistern floor downstream of baffle wall. The cracks remained unnoticed for a long time and continued blowing out sand from underneath the structure, due to excessive exit gradient with the result that cavities were formed under the work. The cavities progressively worked their way up-stream towards the junction of crest and glacis slope and when the vanes could no longer be supported, the glacis collapsed resulting in cracks which developed along lines of weakness such as the junction of crest and glacis slopes. The question can be asked why the structure has stood for the past 26 years if it was unsafe against uplift pressure? At the time of construction of the Fall, the subsoil water levels in the area were very low. As the subsoil water level rose due to the running of Rohri Canal, the structure was subjected to a cross head during closures which was even more than the head during flow. Another very important point was that the subsoil water levels on the left were higher than those on the right which also
