# **PANJNAD HEADWORKS AFTER 1973 FLOODS**

**MR. MOHAMMAD ASLAM CHOCHAN**

Superintending Engineer

Panjnad Headworks Repairs Cirele, PANJNAD.

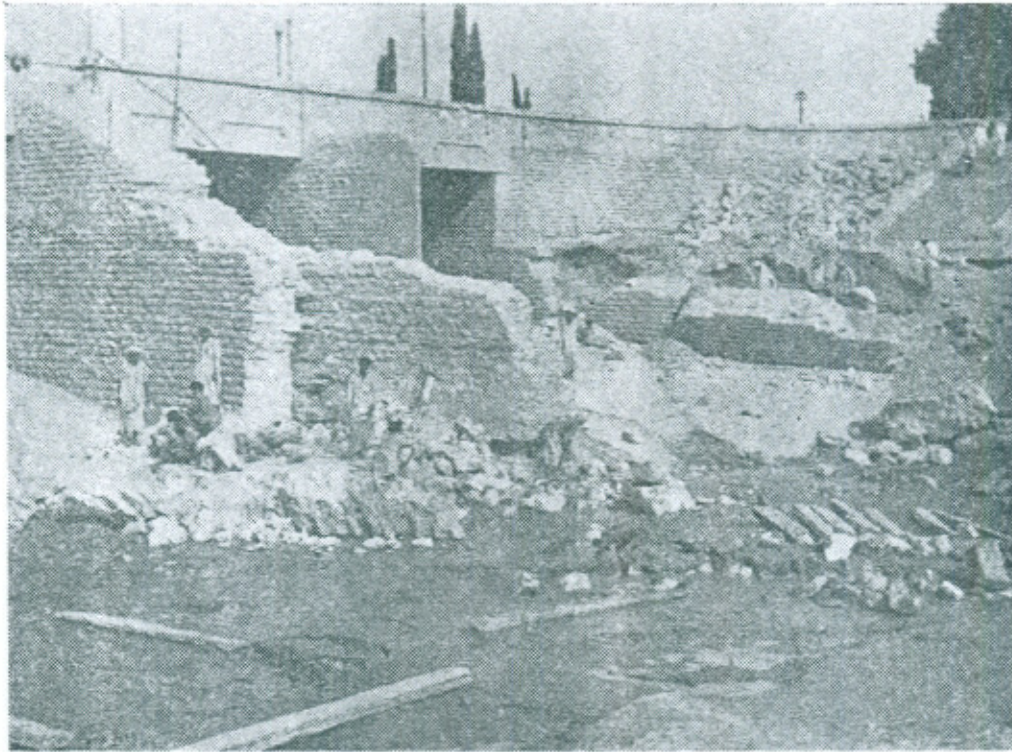
**PHOTOGRAPH NO : 2**

*Nature of damage to Panjnad and Abbasia Canal  
Regulators by 1973 floods*

- (a) The divide wall segregating the Abbasia and Panjnad regulators collapsed in the portion which was not resting on well foundation. This part broke into pieces and got settled in the deep scour holes. The well on the downstream end of the divide wall settled and cracked. This caused the balance portion of the divide wall also to tilt and crack at a number of places (See photograph No. 2).

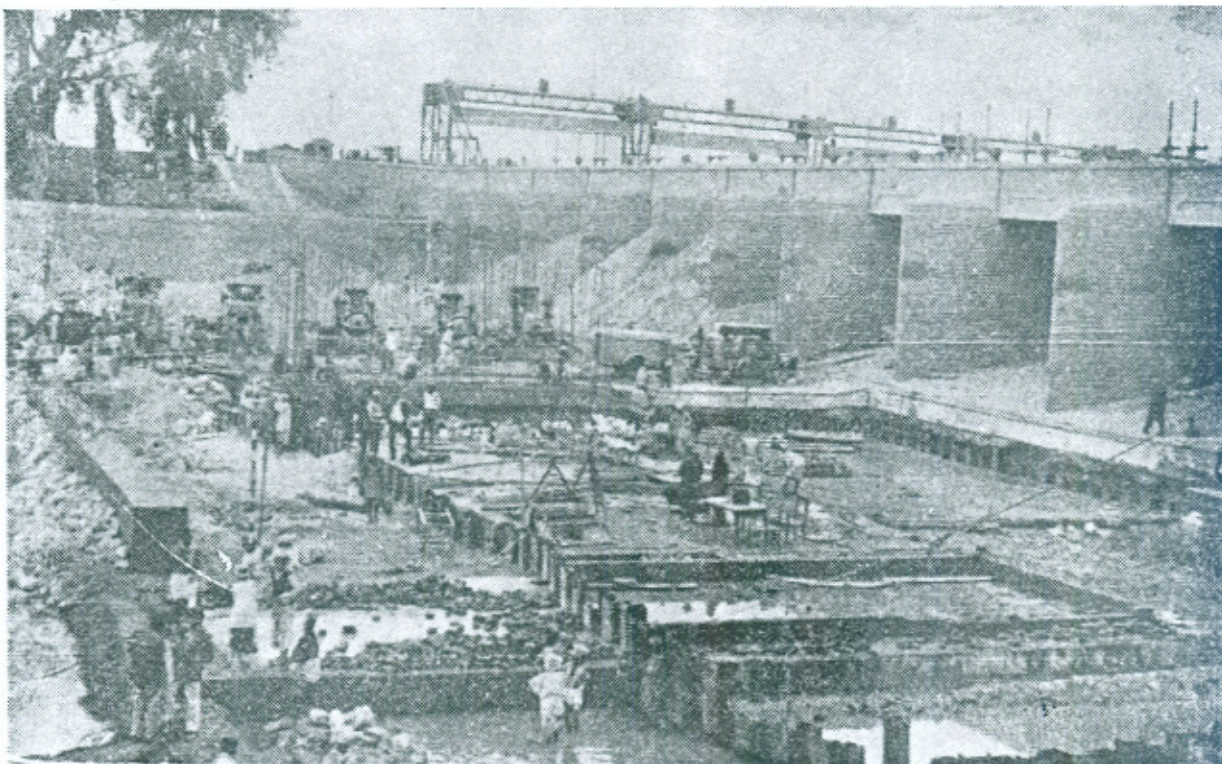
**PHOTOGRAPH NO : 3**

*Reconstructing damaged Regulators  
of Panjnad and Abbasia Canals*
