PLAN SHOWING NATURE OF DAMAGE TO
REGULATOR, BY 1973 FLOODS AT PANJNAD

SECTION THROUGH PANJNAD REGULATOR
(BAYS 9-12)
Scale: 1/200

SECTION THROUGH ABBASIA REGULATOR
(BAYS 1-2)
Scale: 1/200

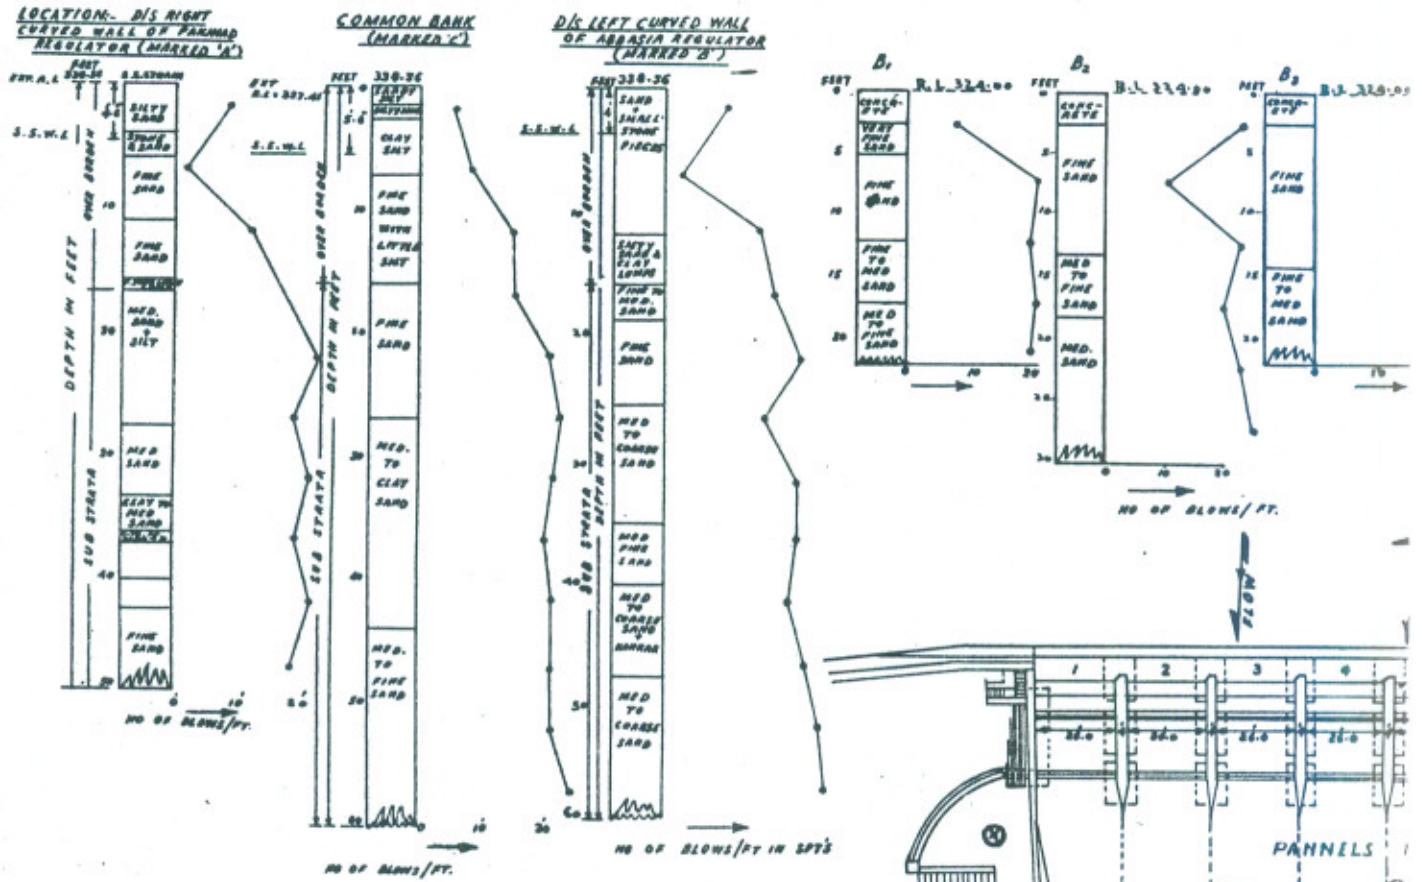
DRAWING SHOWING SUB-SOIL EXPLORATION AND TESTS FOR THE DESIGN OF PANJNAD & ABBASIA AND EXTENT OF DAMAGE TO THE STRUC

Sub-soil investigation as at para 6.74 and Plate No. 10 indicate that there has been some movement of sub-strata possibly due to deep scour in the downstream side. One method of stopping the movement of sub-soil is to provide a deep sheet pile at the end of impervious concrete floor. This will necessitate considerable thickening of the floor, extension of the floor area on the downstream to attain RL 324 corresponding to designed bed of the canal, and relaying of the concrete blocks/stone apron at changed location as required from design consideration. This involved high construction cost and a long time for execution which at the stage of consideration (in March, 1974) did not fit in with the chalked out programme of recommissioning the regulators with effect from 16th April, 1974. Considering all these factors and in view of this regulator having already been tested for discharge more than the
