## **Case study 2 : British Library book depository, Boston Spa**

### **Cause study 3 : i54 strategic employment site, Wolverhampton**

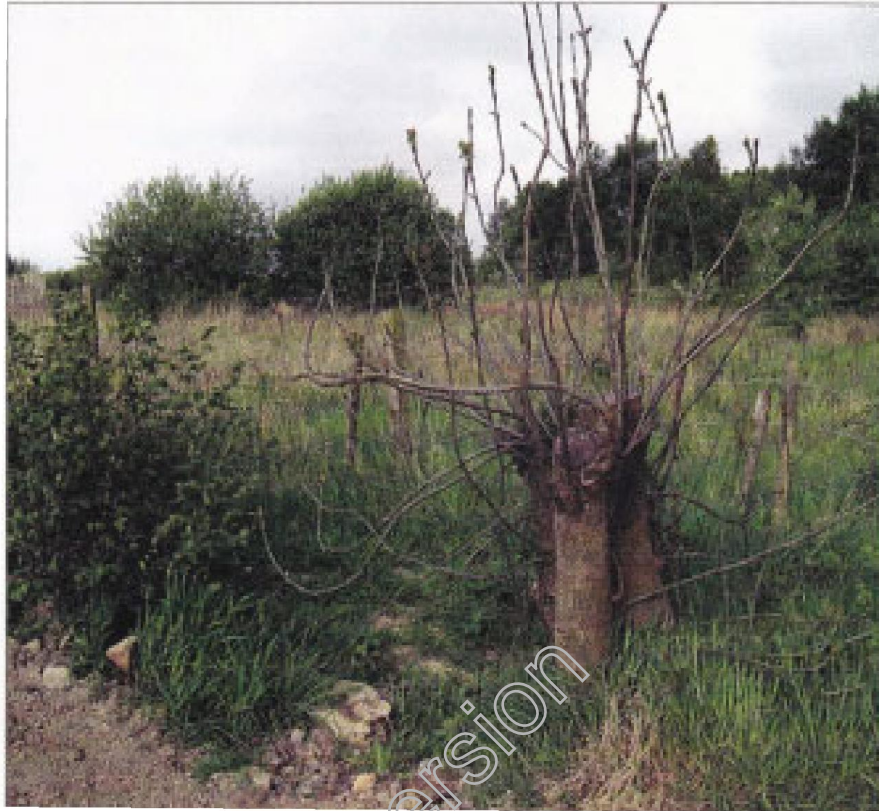
Figure 4. New growth from translocated stump at Lightmoor in May 2008

Monitoring in May and July 2008 found abundant new growth within the translocated hedgerow and the ash tree stump which was translocated as part of the hedgerow (Figures 4 and 5),

although there was evidence of die-back in holly which can be hard to establish once moved. In August 2009, there was extensive new growth on nearly all of the woody plants within the hedge (species include hazel, common hawthorn, holly, blackthorn, ash, field maple, dog rose).

The holly showed die-back in 2008 but in 2009 there was healthy re-growth with an average annual growth of 200 mm in 2009. The old hawthorns with large horizontal stems were showing severe die-back in 2009, but the younger hawthorns show healthy growth. Further monitoring will be undertaken to see if the older hawthorns show re-growth in future.

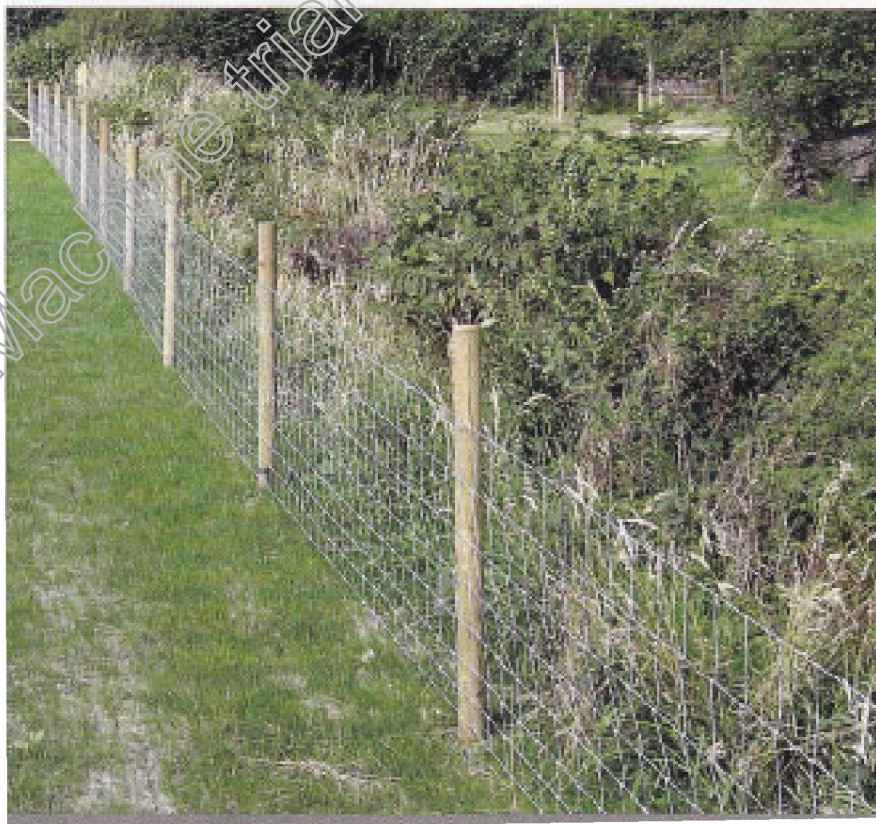
Figure 5. Translocated hedge with protective fence and showing new growth in July 2008

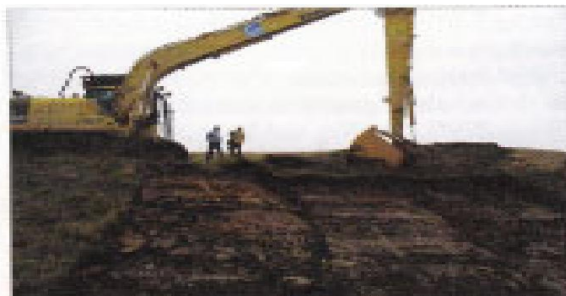
Figure 6. Removing 1 x 0.5 x 0.3 m turfs from the Boston Spa site with a modified bale-cutting bucket in spring 2006

The translocation involved carefully excavating turfs that were 1 x 0.5 m and 300 mm deep using a tracked 360° excavator with a modified bale-cutting bucket (turf box cutter) (Figure 6).

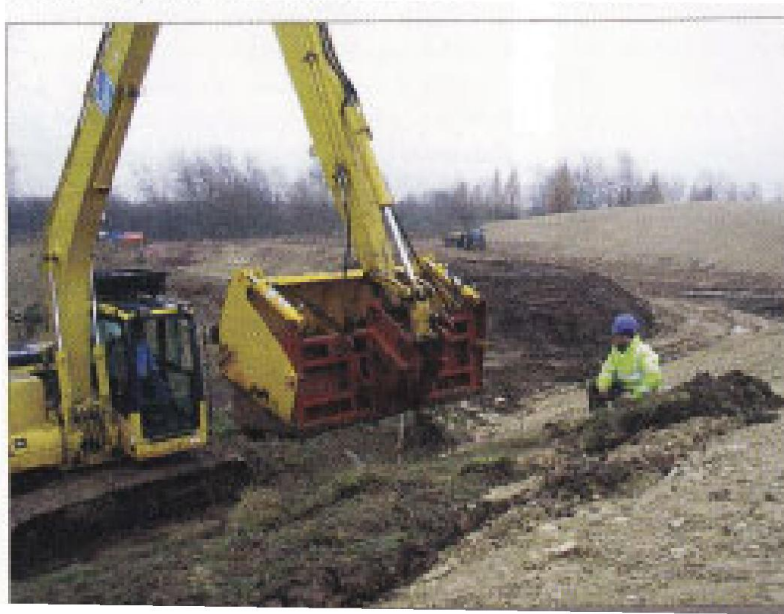
Figure 7. Placing turfs on the new landscape bund at Boston Spa

The turfs were either placed directly by the excavator onto the toe of the south-east face of the bund that was very close to the donor site (Figure 7) or placed on a flatbed trailer for

Each turf was carefully placed to ensure a tight fit with the adjacent turfs and was pressed down by the bucket to expel air from between the turfs and the underlying substrate. Turf off-cuts and soils from the donor site were used to fill any gaps between turfs and along the four external sides of the translocated turfs. Voids between or under the turfs were not permitted because the air spaces would cause drying out of the fragile grassland root system.

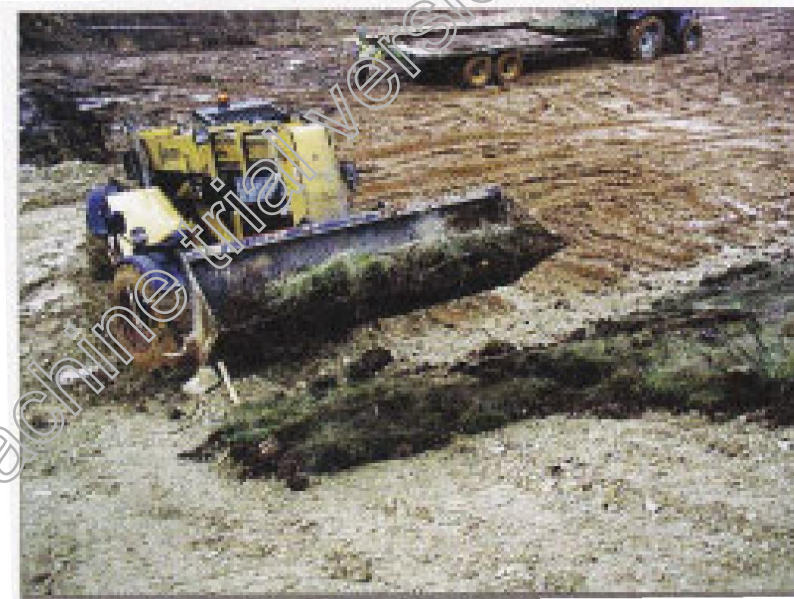
Figure 8. Turfs were also transported by a flat-bed trailer and placed by telehandler

transport to the other bund where they were placed at the base of the north-east face by a telehandler fitted with a wide bucket (Figure 8).

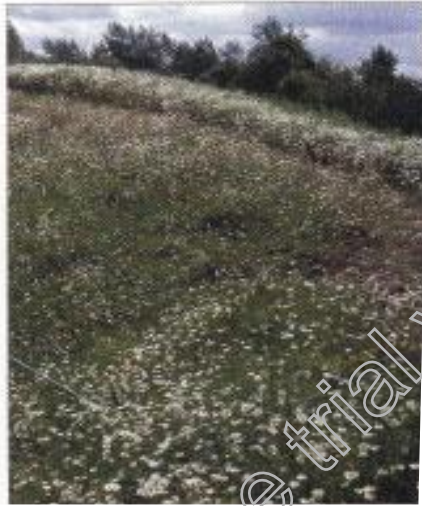
Figure 9. Translocated grassland on the main Boston Spa landscape bund in June 2008

Monitoring the translocated grasslands in June 2008 found that many of the targets had already been reached just 2 years after translocation. There was very little slippage of turfs or gaps between the turfs and the species-rich grassland was flowering well and contained pyramidal orchids, common spotted orchids and cowslips (Figures 9 and 10).

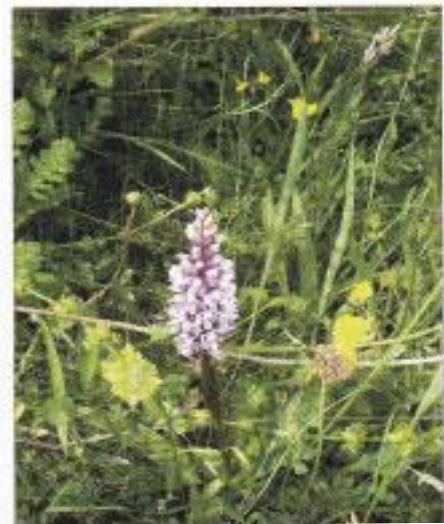
Figure 10. Wild flowers flourishing in the translocated grassland in June 2008
