**COFFERDAM CONSTRUCTION AND DEWATERING  
TAUNSA BARRAGE REHABILITATION PROJECT**

Muhammad Nadeem, PhD, PE

This paper presents the experience of the contractor in the design and construction of the cofferdams along with installation, operation and maintenance of dewatering system used for the construction of permanent structures of “Taunsa Barrage Emergency Rehabilitation and Modernization Project”.

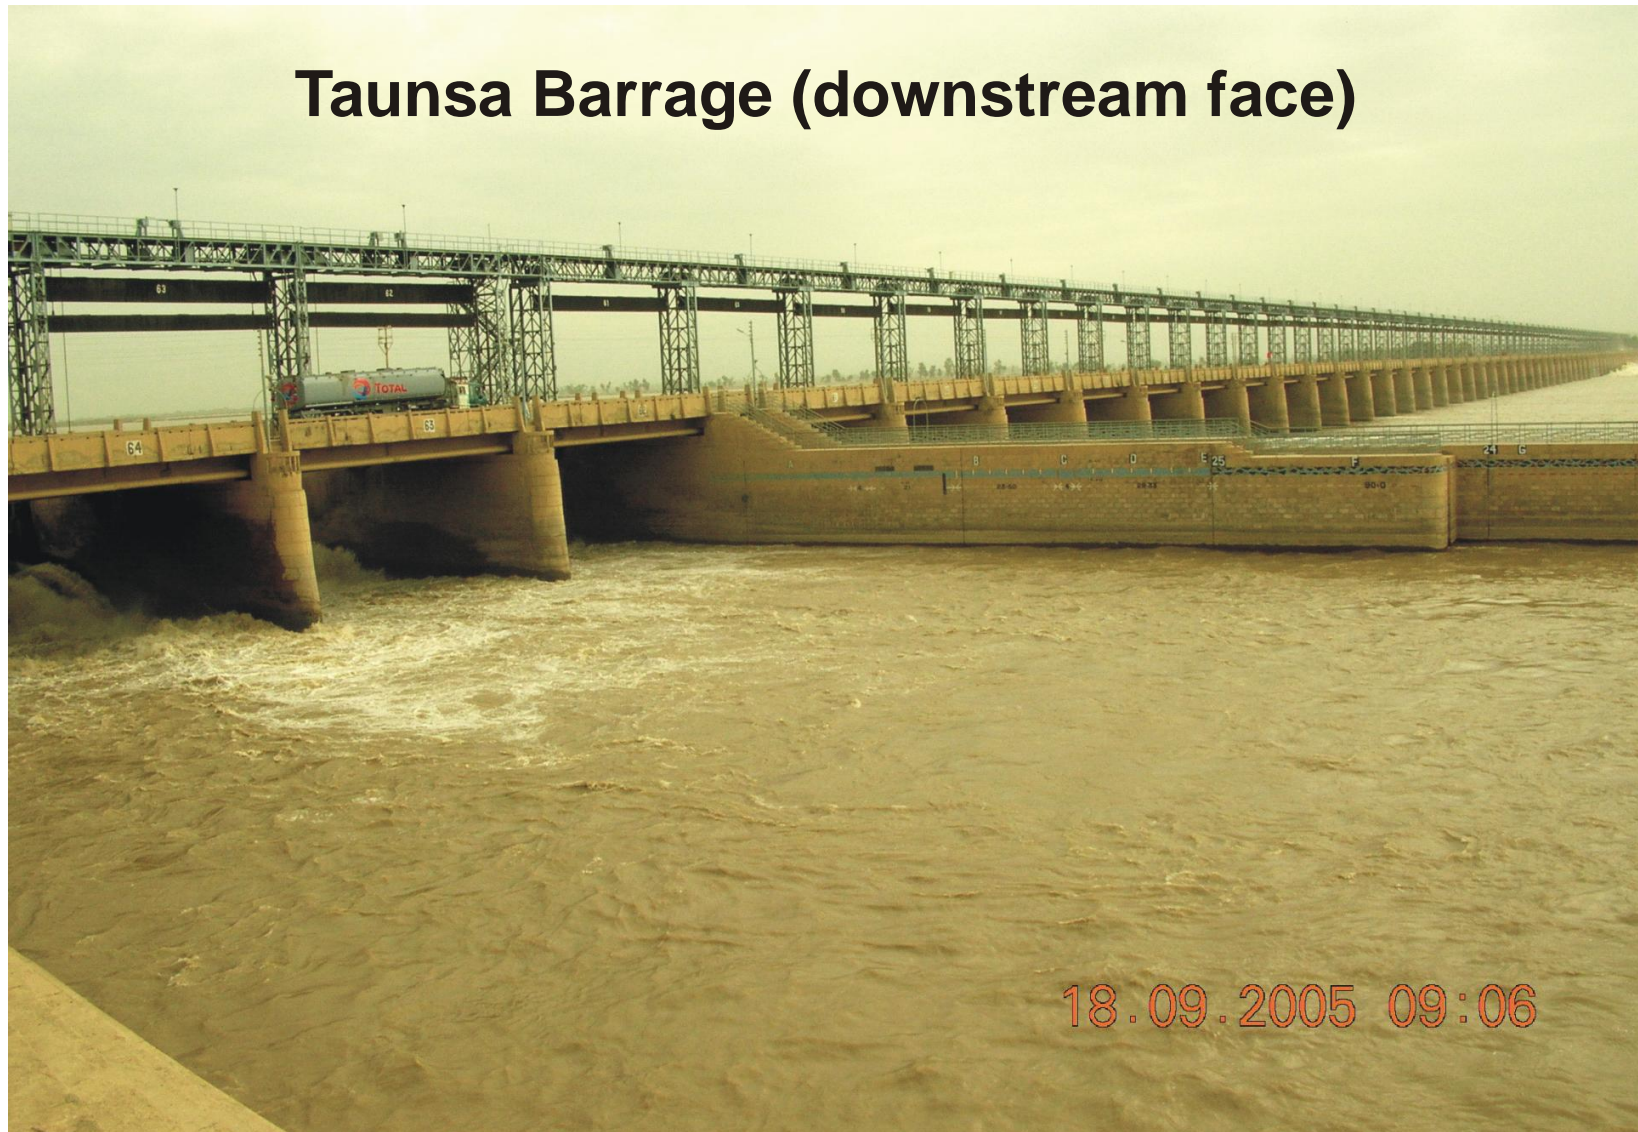
*Figure 1: Flow Through Barrage*

The main structure of the barrage was kept in operation to supply water for irrigation during construction of the subweir which was carried out in the drier part of a year i.e. Oct to Jun. For this reason, the subweir was located at a distance of 925ft downstream of the existing barrage such that silt load from the left and right pockets of the barrage can be released downstream (See Figure 1).

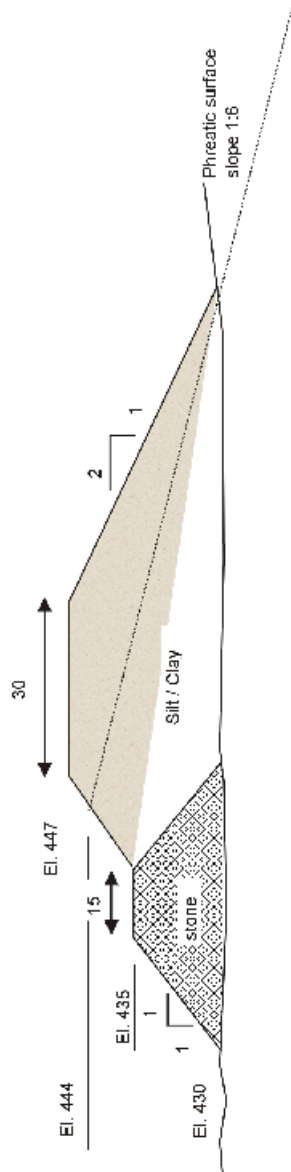
**DESIGN OF U/S COFFER DAMS**

Water Level = 444  
 Top of the Cofferdam = 447  
 Ground level = 432 average

P= gh      873.6 PSF  
 FH      2.73 TONS/FT  
 Weight of material =  
     earthfill      75600  
     stone

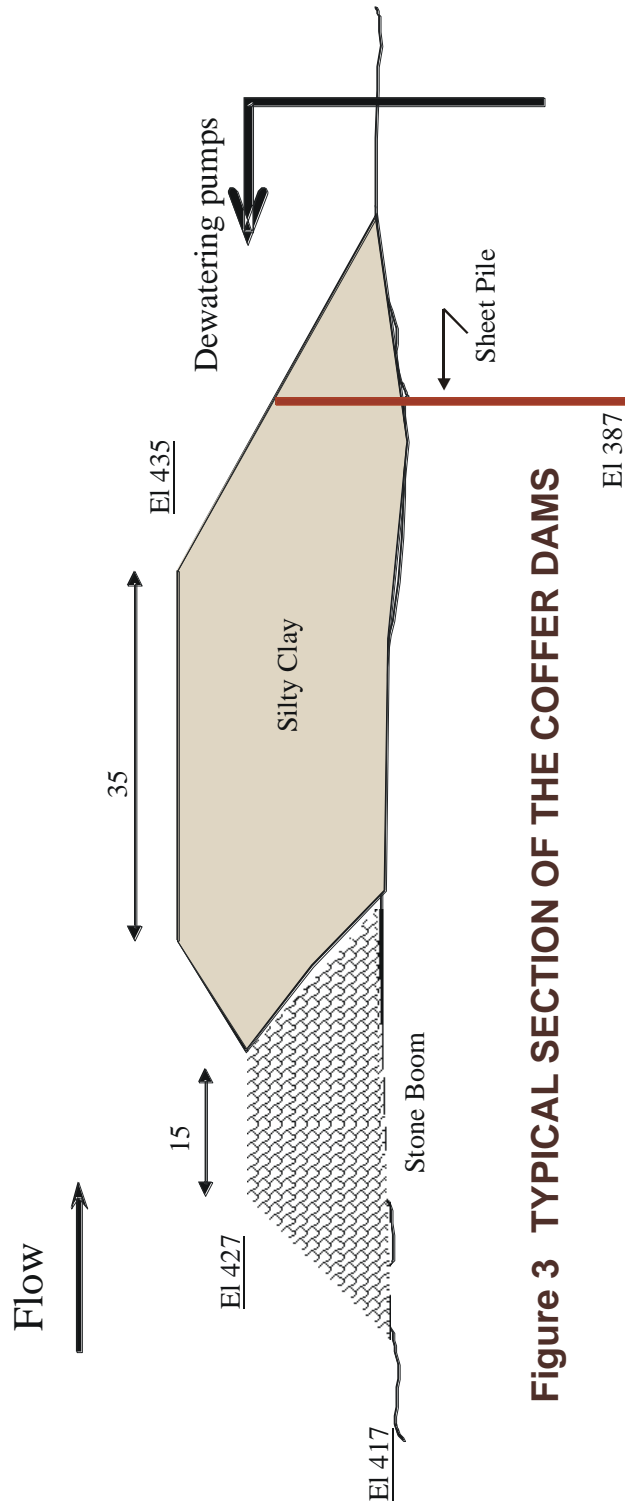
**Figure 3 TYPICAL SECTION OF THE COFFER DAMS**

The preferred design of the cofferdams used in Taunsa were of a hybrid type structure in which two materials were used for different purposes along with sheet piles to provide effective seepage cutoff and to improve the overall stability of the structure. Salient Features of the CD section are:

1. Stone fill is provided to break the erosive action of the flowing river
2. Earthfill is provided for a water tight section minimizing the water flow across CD body.
3. Sheet Piles were installed to cut seepage rate across the earthfill and improve its stability.

Construction of cofferdams is a critical activity for the construction of the project in the flowing river. It required large volumes of the materials like stone and earthfill at site which was dumped in the river on the upstream and downstream for construction of the subweir and also for the repairs of other structures inside the river khadir. Typical Section of the cofferdams is shown in Figure 3.

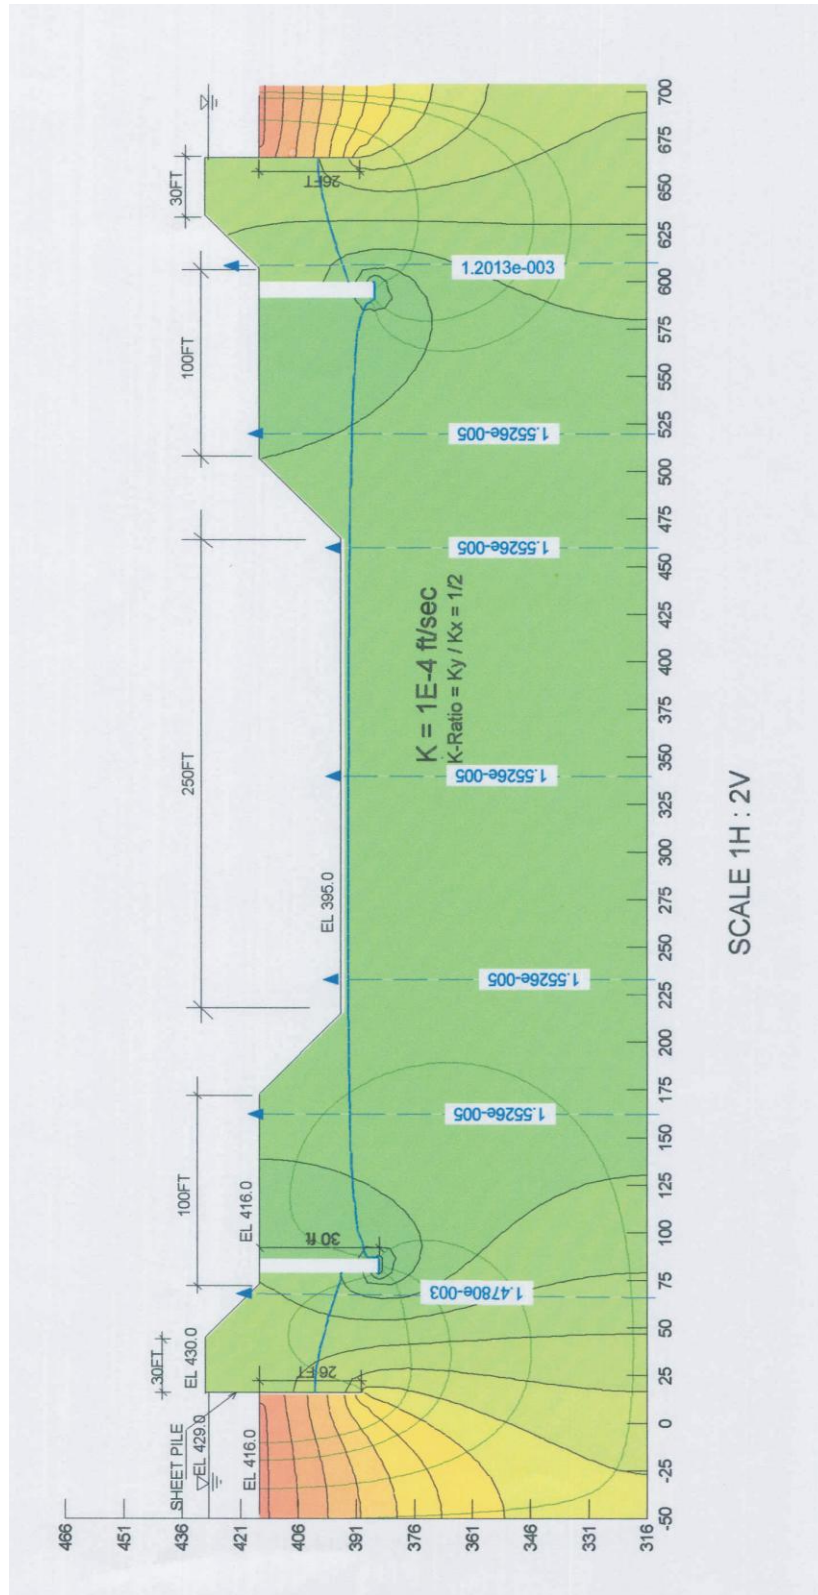
**Figure 6:** FE Model results used for Design of Cofferdams at Taunsa Barrage Project

The quality of results of the model depends on the parameters used for the analyses like the permeability of the soil strata, boundary conditions, etc. However, once a realistic model is available, sensitivity analyses may be carried out to study the impact of different parameters. The decision to install a sheet pile in the cofferdams was primarily based on the results of the model showing that the seepage quantity may be reduced by 30-35% in addition to improved stability and reduced risk of piping.

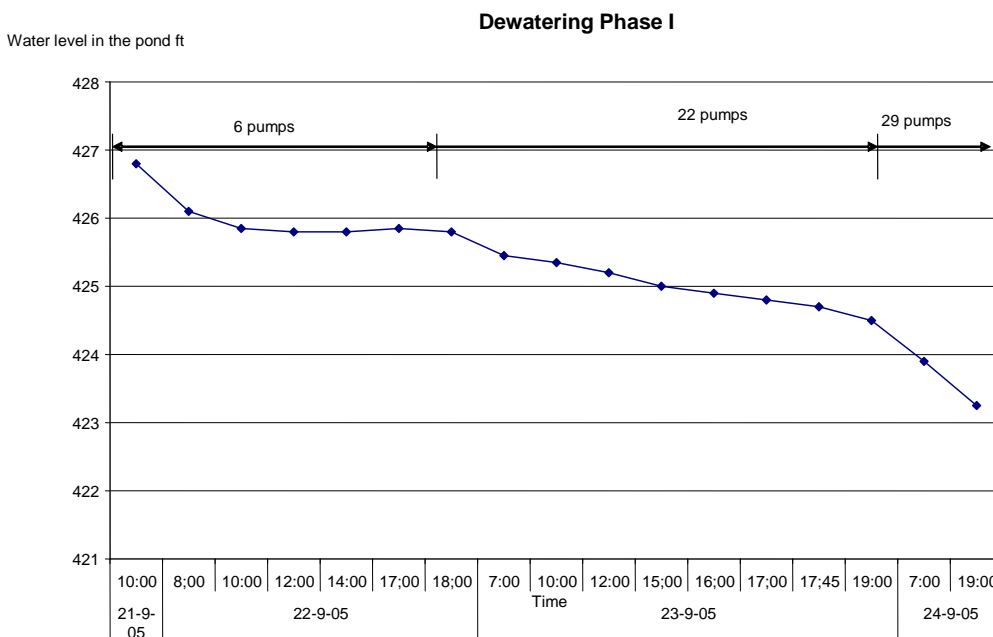
The following Figure shows the rate of dewatering in a 700 ft wide cofferdam compound and its response to different pumping capacities. The data was collected at regular interval during the initial phases of the project. Most of the pumps had 1 cusec capacity. This data was used to optimize the pump sizes and locations.

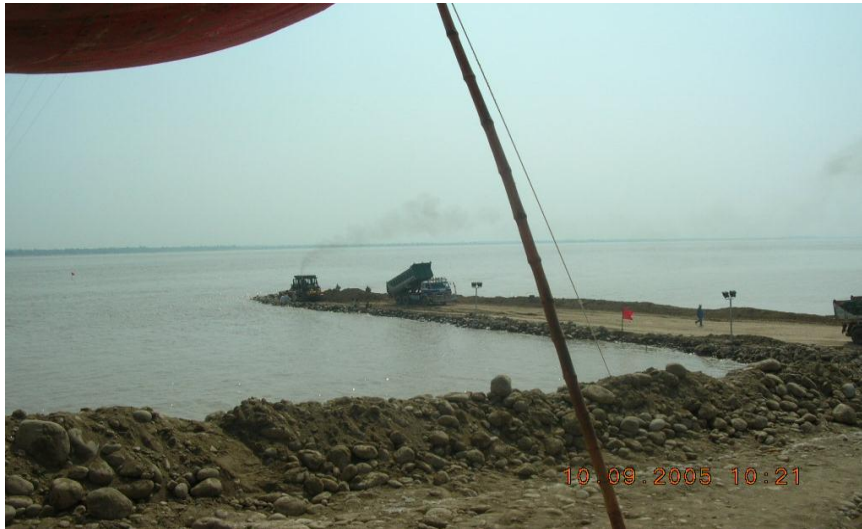
Start of coffer dam

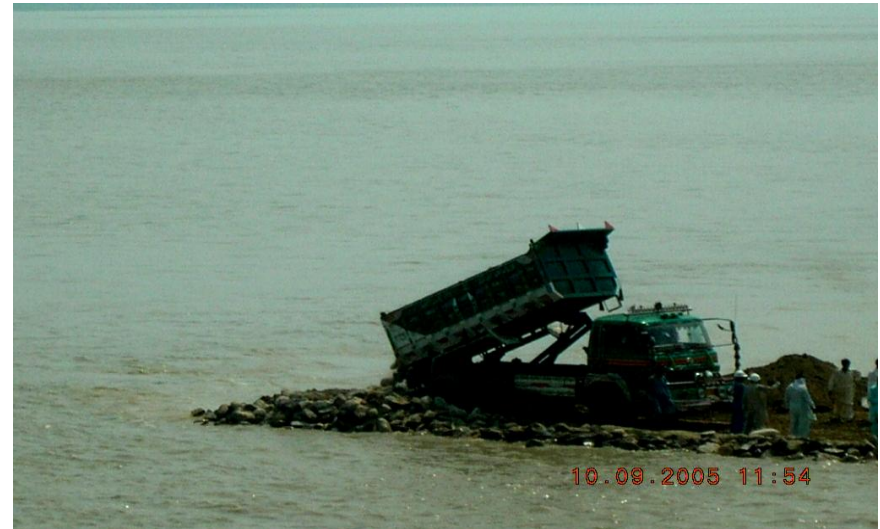
Dump truck unloading stone at the nose of the cofferdam

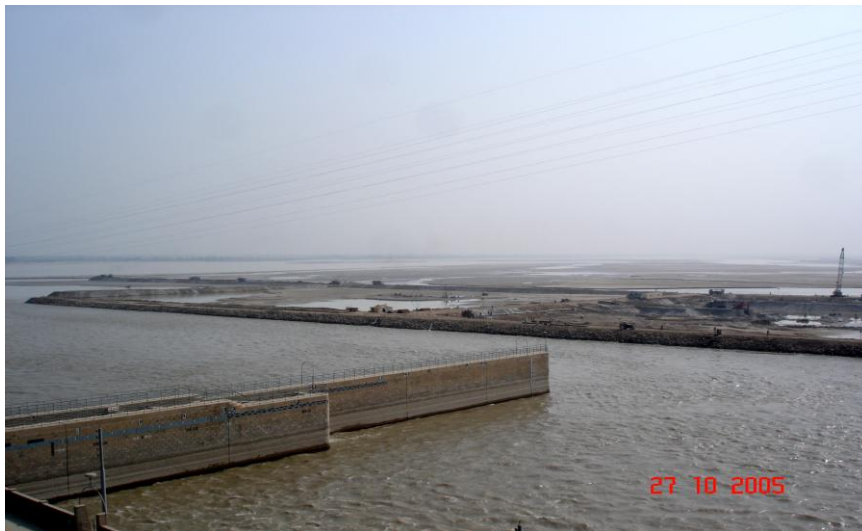
Cofferdams completed in parallel at the front and back of the enclosure

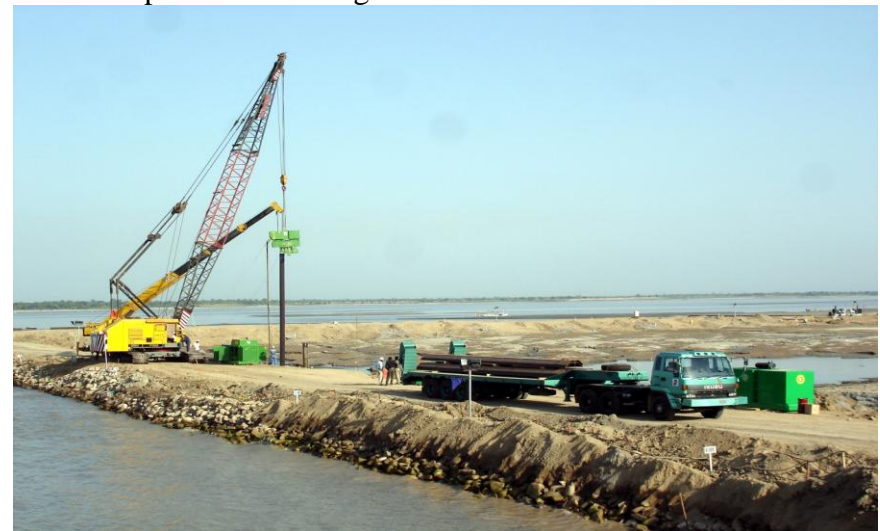
Cofferdams - Sheet Piling in progress

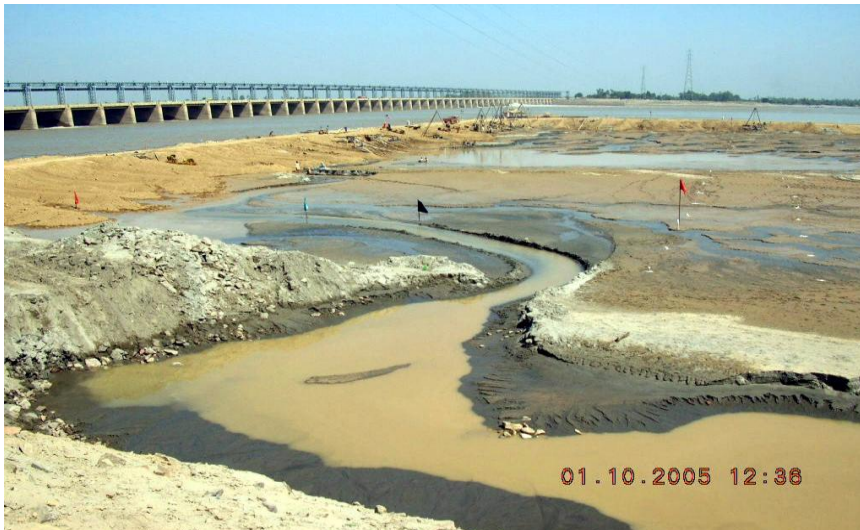
Cofferdams – unwatering of enclosure

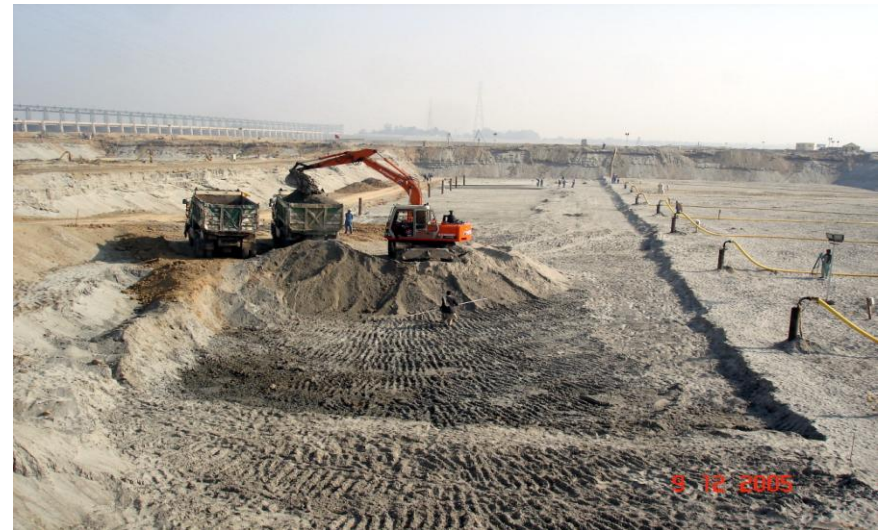
Cofferdams - Subweir dewatering wells installed with simultaneous excavation in progress

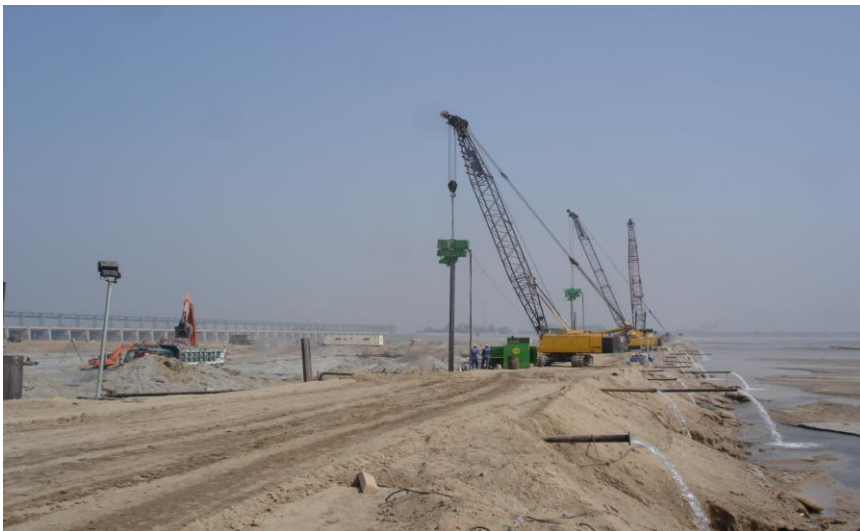
Sheet Piling in the cofferdams with simultaneous dewatering

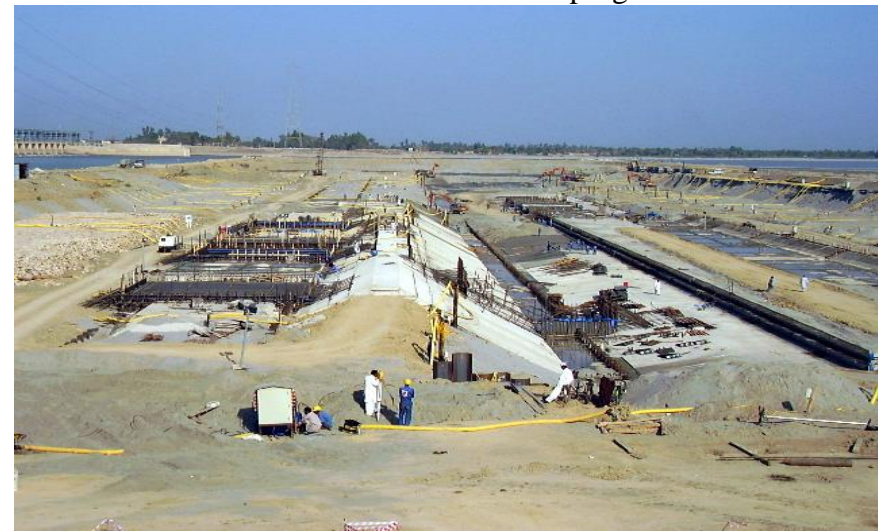
Sub-weir Construction in progress
