**OCCUPATIONAL HEALTH AND SAFETY ISSUES IN SIHALA  
FLOUR & GENERAL MILLS (PVT.) LIMITED IN I-9  
INDUSTRIAL ZONE, ISLAMABAD: A CASE STUDY**

Sajida Rasheed, Zahir-ud-Din Khan

## Abstract

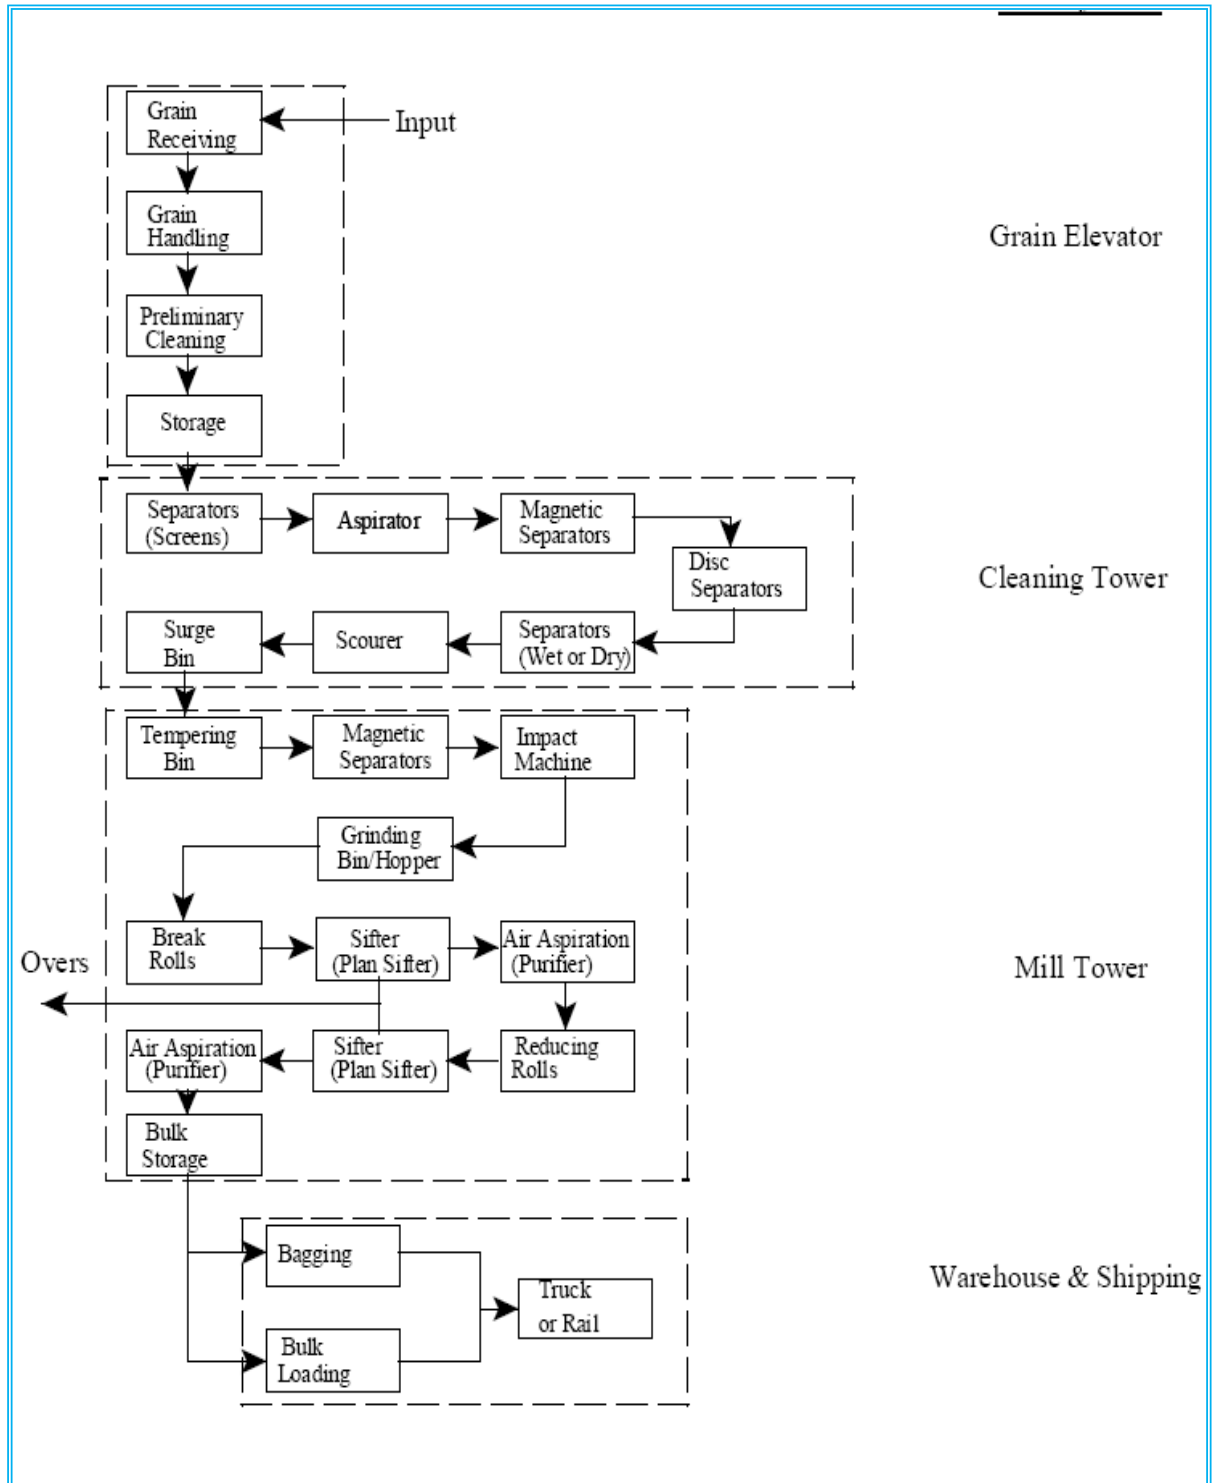
Figure 1: A process lay out of a typical flour mill (Source: ASABE, 2007)

A comprehensive process design and a typical flour mill design is given in Figure 1, and 2, in Annexure 1 and 2, respectively.

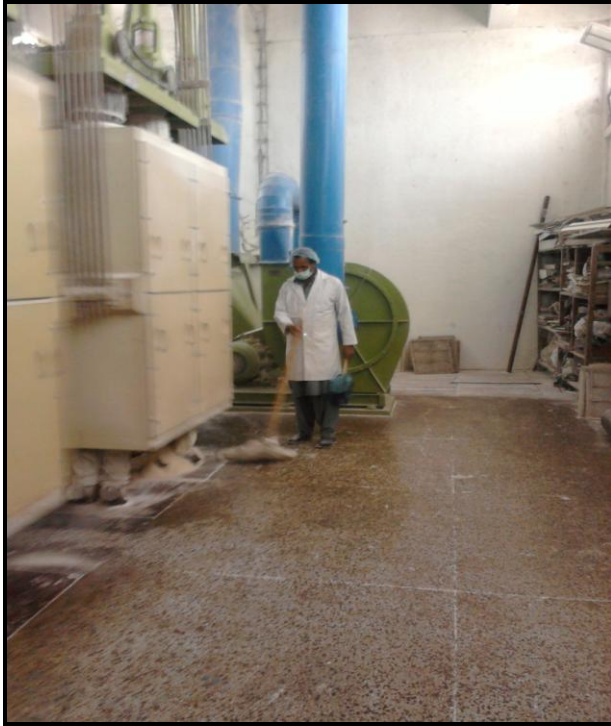
**Figure 4:** Cleaning in process section

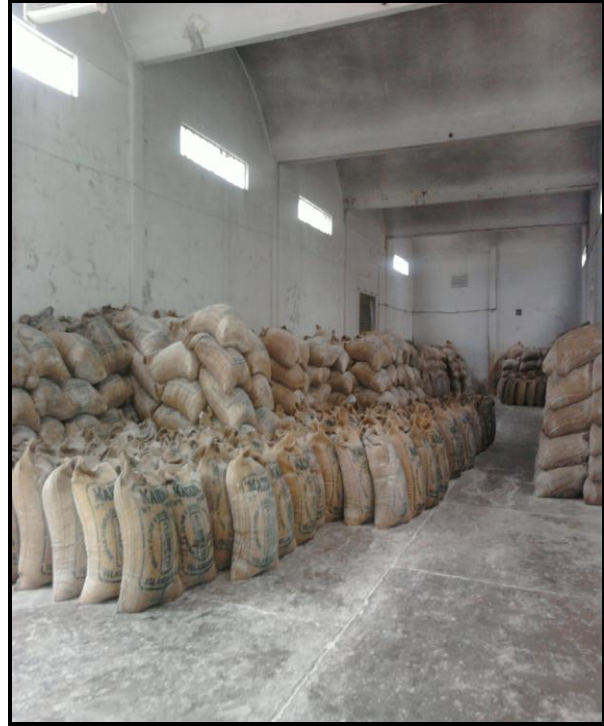
The final product is packed in sacks and bags. These were stored in a proper place. The storage area was provided with proper ventilation and sufficient lighting. Good house keeping practice was achieved in storing the flour bags and sacks. Same practice is done in Bharat Bio Urja, India in the warehouse unit: controlled temperature, hygienic conditions, fire safety arrangements to maintain good quality product.

**Figure 6:** Final storage

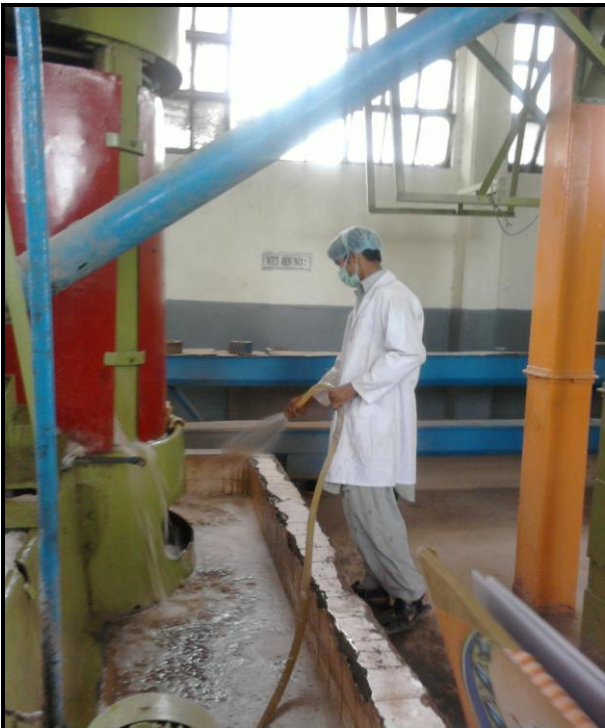
Maintenance of health and safety requires its communication and proper display at different site areas so as to make sure the safety of worker. Proper record keeping of accidents and injuries was maintained and was computerized. Personal Protective Equipment (PPE) was available and was in use. The workers in the work area were wearing masks and caps (Annexure 4).

**Figure 5:** Washing of Grains, proper PPE

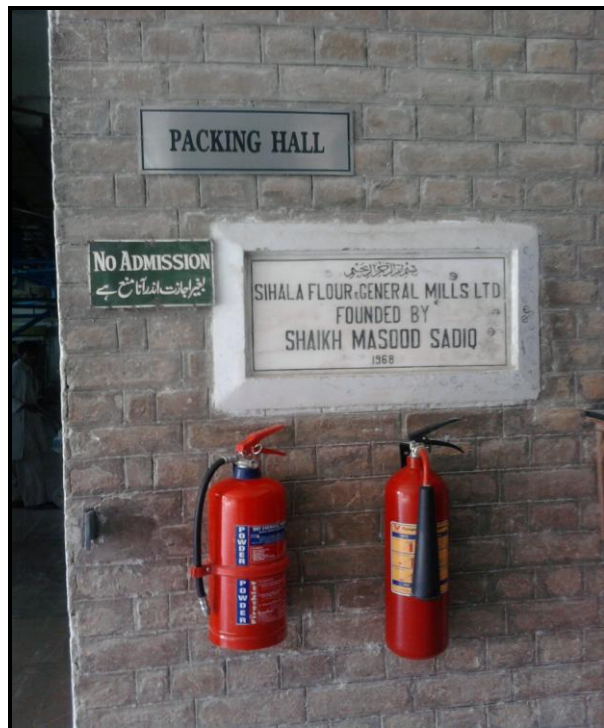
any live wire. Appropriate fire fighting equipments were maintained at proper places (Figure 7 and 8 in Annexure 4).

**Figure 7:** Fire Extinguishers

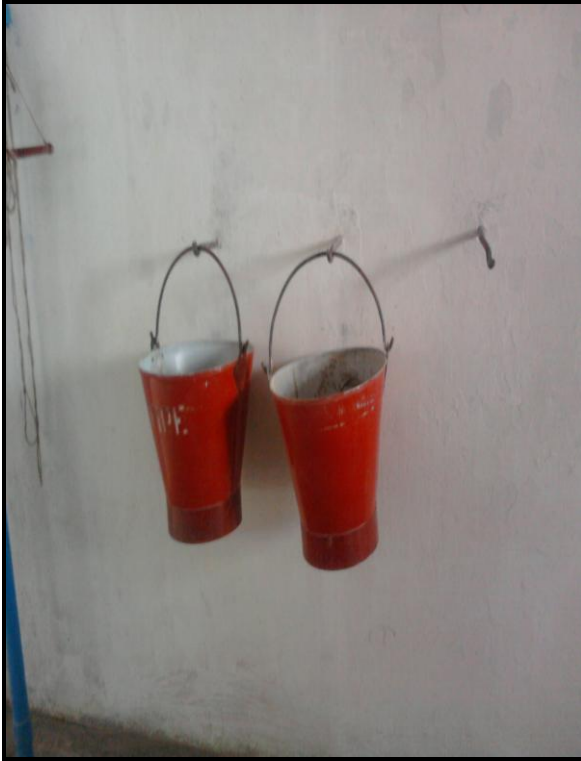
*Figure 8:* Sand Buckets

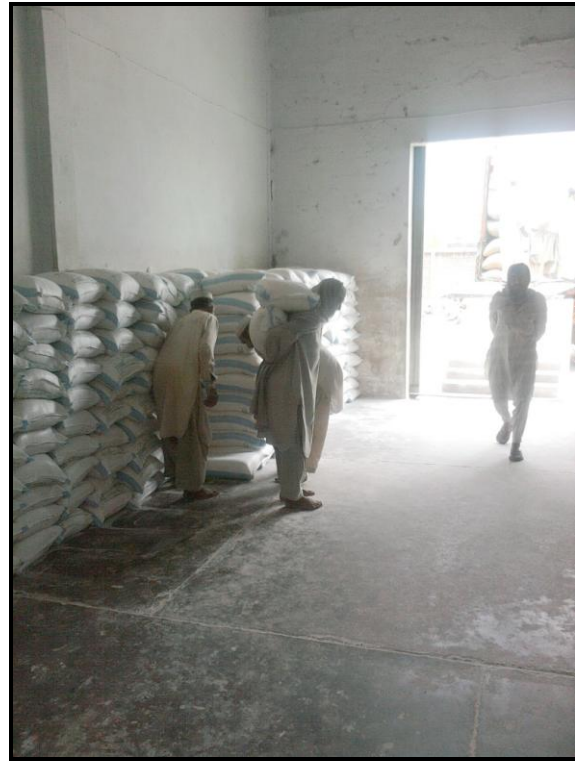
In the main process area, proper hand rails were provided (figure 9, Annexure 4). All the bags and sacks were transported and transferred on the hand rails to the final storage. But at the time of loading to the trucks, the workers were carrying three bags of 20 kg each at a time, on their backs which had a collective weight of 60 kg/worker/unit time of transport to the truck. (Figure 10, Annexure 4.). It was told by the authority that the hazard was communicated to them but there is an inherited ignorance among these local workers and they work in their own style.

*Figure 10:* Lifting and transfer to truck

1. Ear muffs are recommended in the process area in all the situations.
2. Proper lifting hazard minimization is highly recommended.
3. The results of the past study suggest that even with the most up-to-date technology and proper cleaning operations in place, the flour milling industry may not be able to reduce the flour dust levels to below the TLV of 0.5 mg/m<sup>3</sup>. So the face masks in the work area are highly recommended.

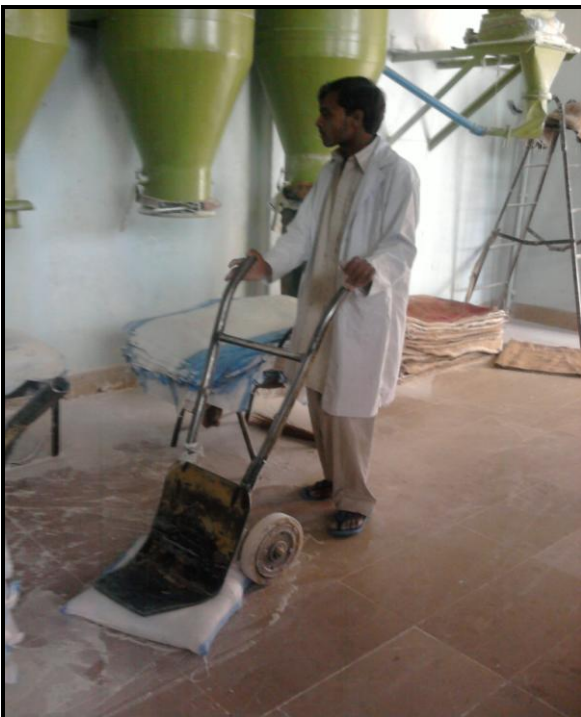
*Figure 9:* Hand rails
