**PERFORMANCE EVALUATION OF TAUNSA BARRAGE
EMERGENCY REHABILITATION AND
MODERNIZATION PROJECT**

Engr. Syed Mansoob Ali Zaidi¹- P.E., Engr. Mehr Muhammad Amin²- P.E. &
Engr. Muhammad Ajmal Ahmadani³- P.E.

SYNOPSIS

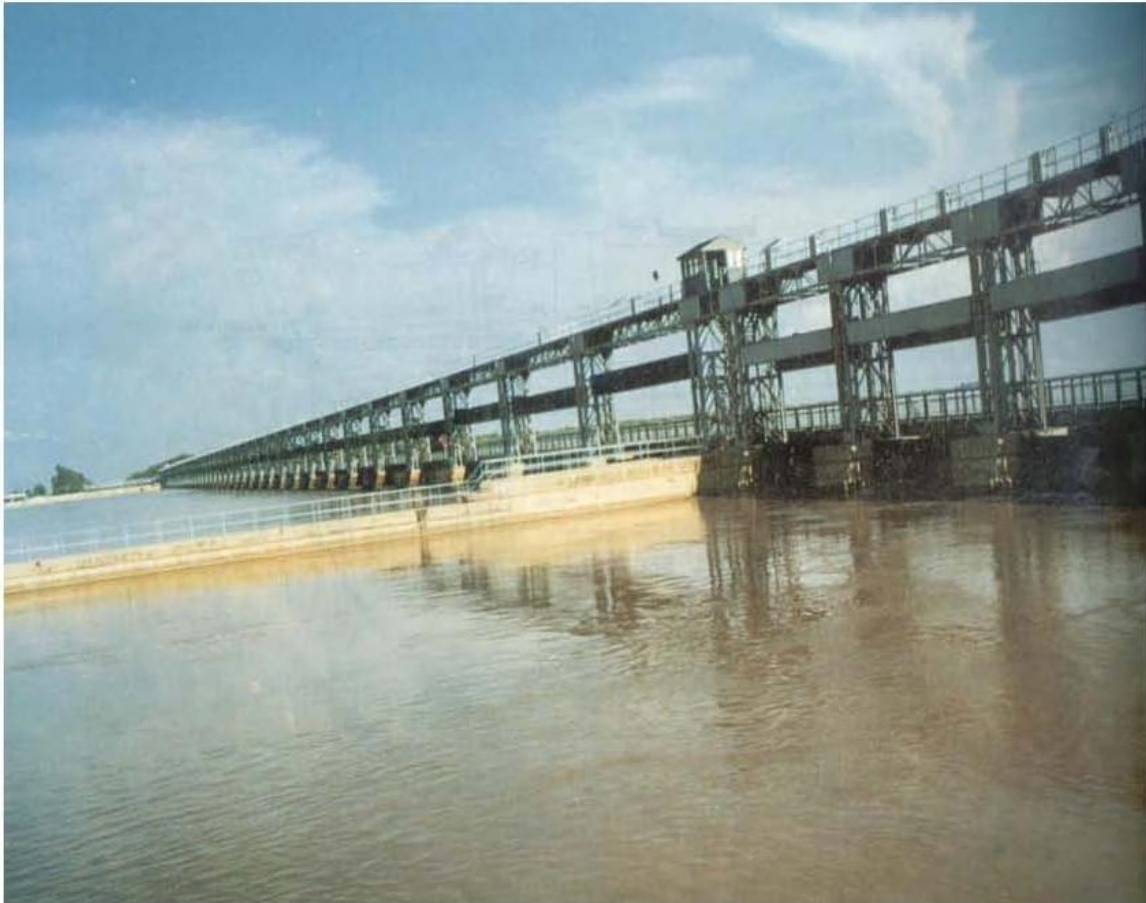
Figure 1: Upstream View of the Barrage

The Taunsa Barrage, built across Indus River is located at about 16 Km from Kot Addu, with location coordinates of 30° 31' N 70° 51' E. The Barrage has 65 bays with a total width of 4,346 ft between the abutments. Width of each bay is 60 ft except for bay No. 8 which is 22 ft wide and serves as navigation lock. Bays No. 9 to 61 constitute main weir and there are two sets of undersluices (bays No. 1 to 7 and 62 to 65) separated from the weir by two divide walls at left and right flanks. The Barrage has 2 fish ladders each 11 ft wide alongside these divide walls.

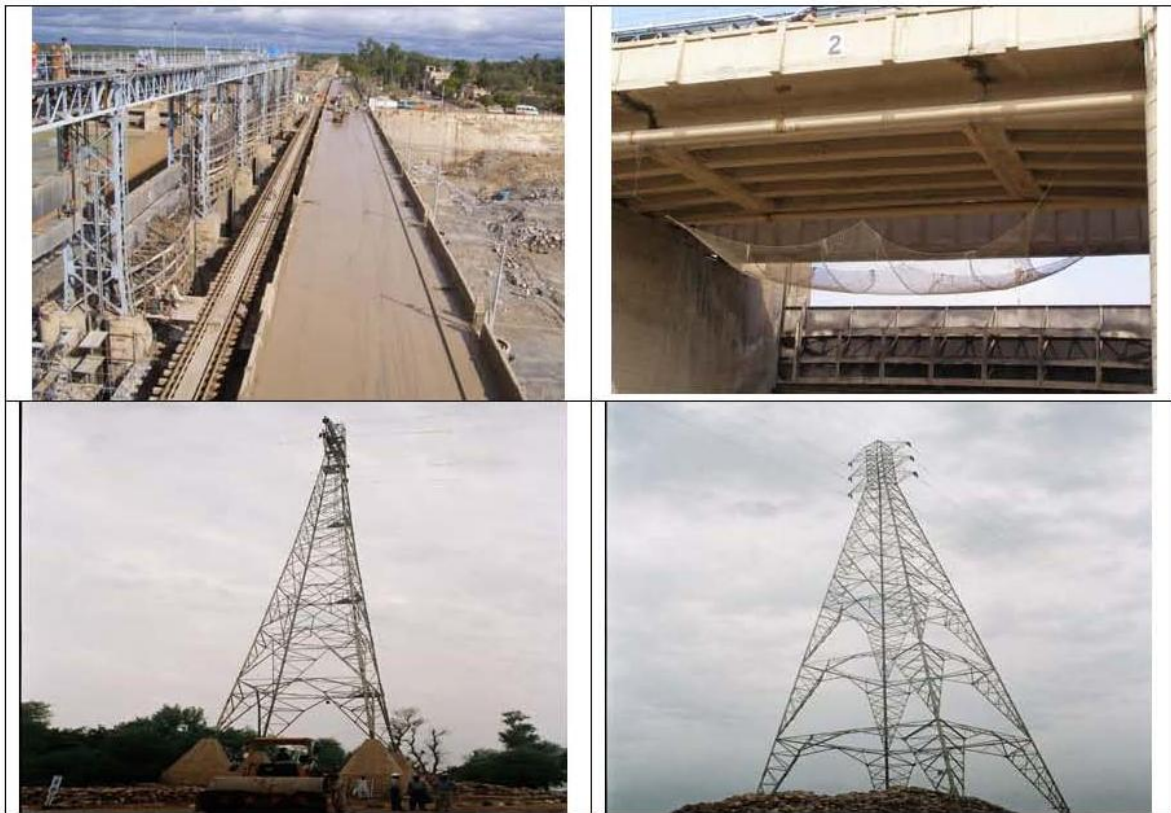
Figure 2: Transport and Energy Infrastructure Accommodated by the Barrage

- a) A Class 70/AA loading Arterial Road Bridge;
 - b) A 16 inch dia high pressure pipeline owned by PARCO for conveying petroleum products from Karachi to the up country storage at Mahmood Kot terminal carried on top of downstream end of the piers.
 - c) A 16 inch dia high pressure natural gas pipeline conveying natural gas from Dhodak gas field to KAPCO and serviceable areas on piers under the roadway deck.
- iii) Facilitates two single span EHV transmission line crossings (Figure-2).

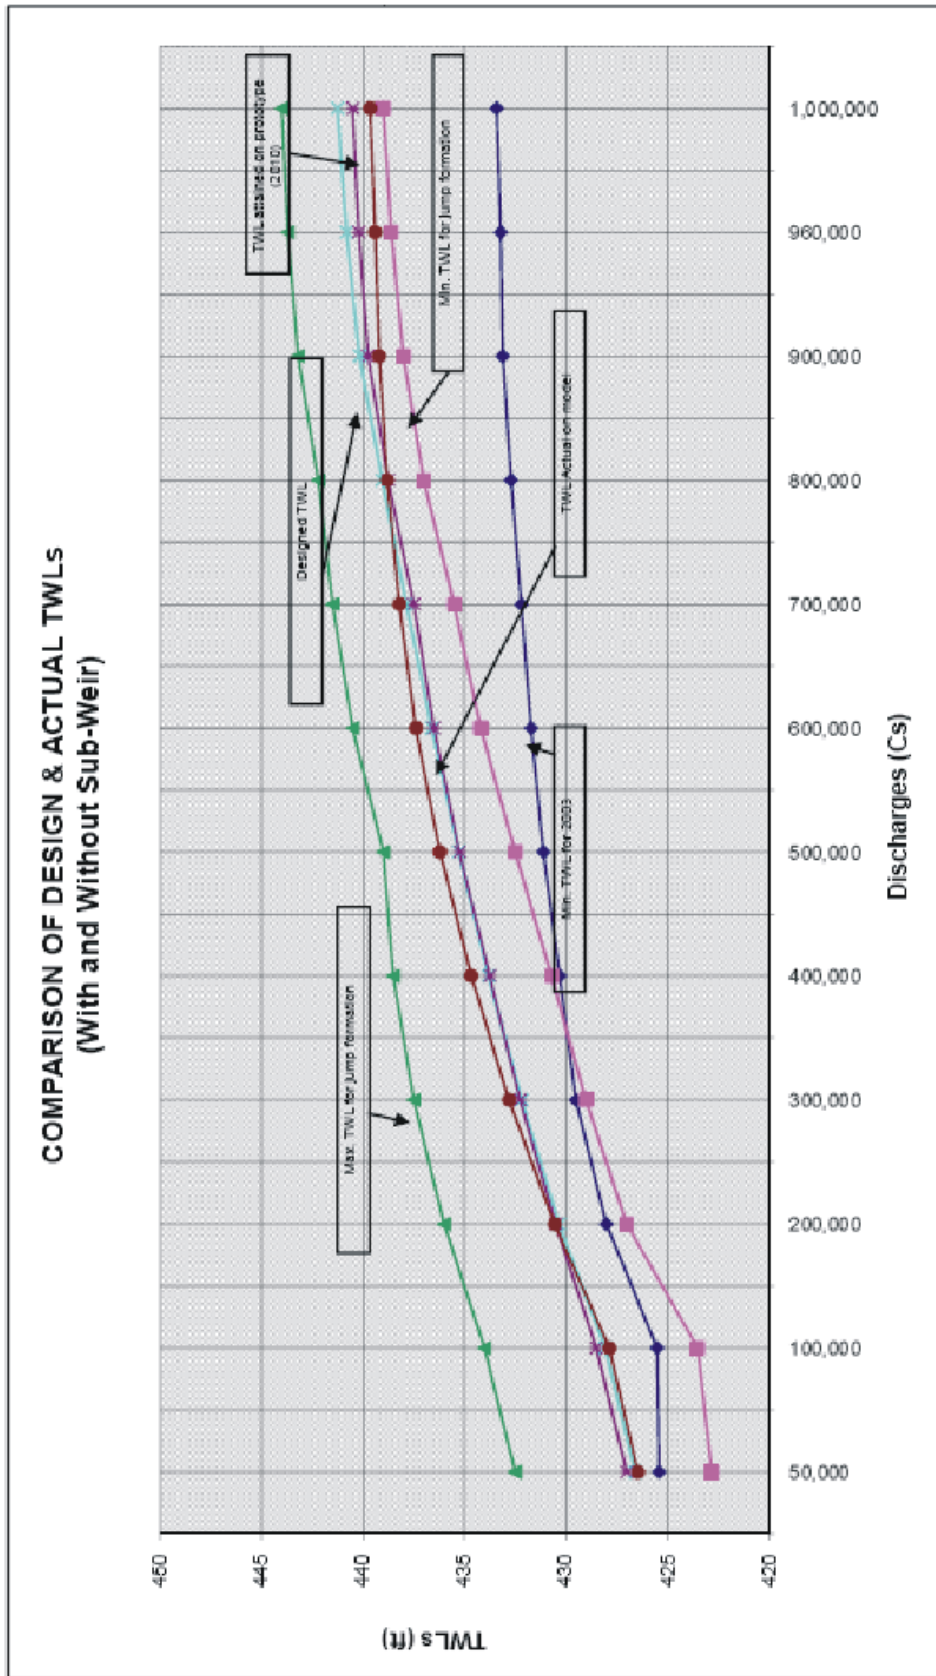
In addition the jump formation was physically observed by a research scholar (working for his Masters) during the monsoon period 2010. The observed data is contained in table 4 and Figure-4. A graphically presentation in figure-3 compares the TWLs for limits of jump formation, design, actual attained on model and the actual prototype observations.

1. It has raised the TWLs to the extent of providing tail water depth (D_2) adequate enough to form the hydraulic jump at the toe of glacis or above.
2. It has restored the discharge capacity of barrage (the barrage has negotiated the design discharge successfully with an HFL of 446.6 against the design level of 447.0).
3. It has created a pool of 7 ft additional depth to restore the head across limit for the barrage.
4. The constraint in maintaining pond level has been removed.

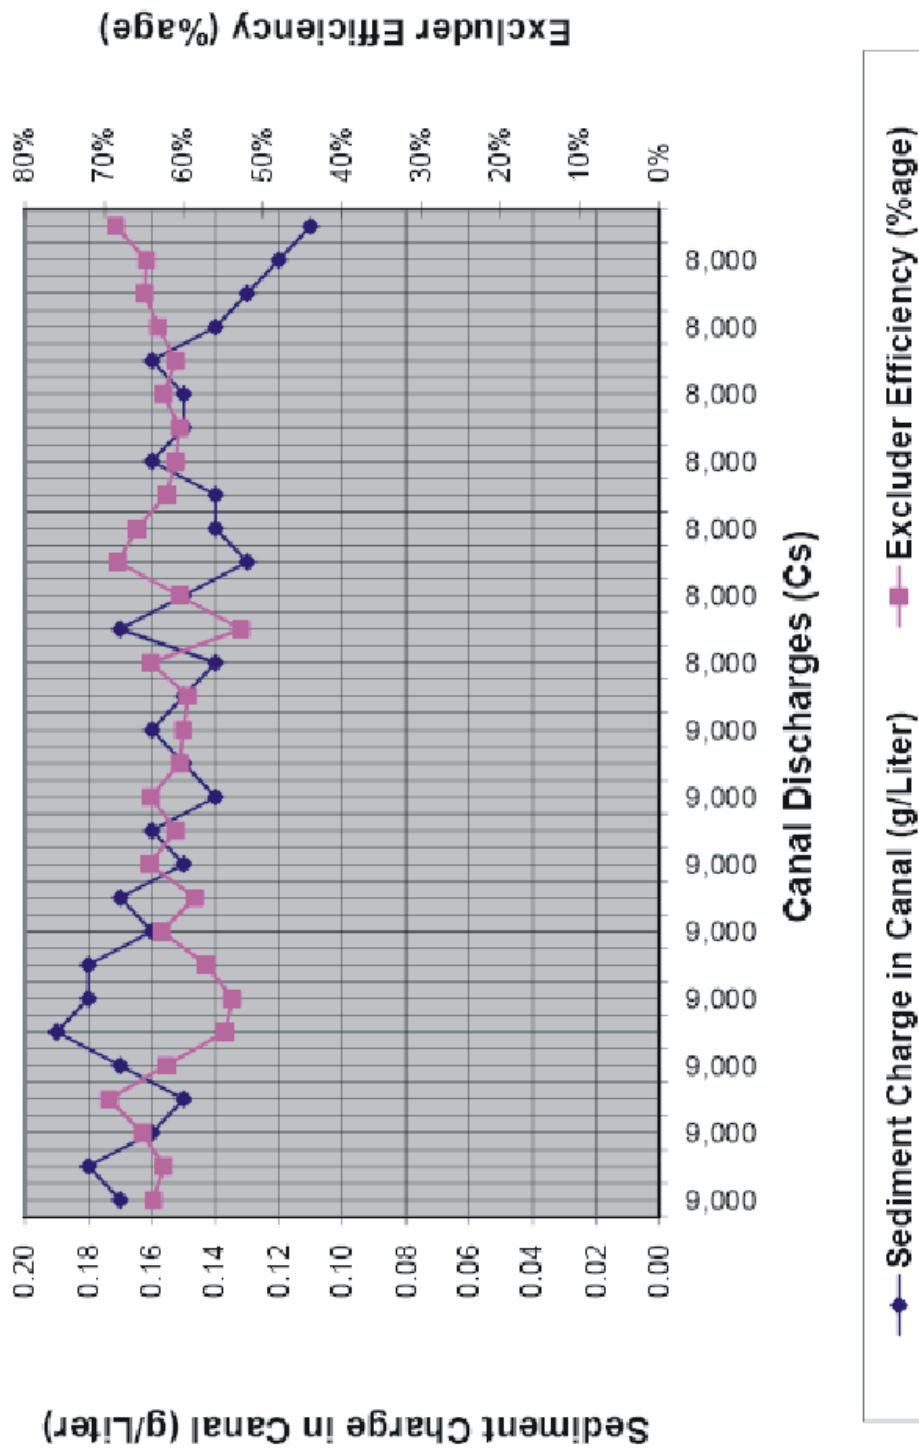
GRAPHICAL PRESENTATION OF SEDIMENT CHARGE AND SILT EXCLUDER EFFICIENCY FOR VARIOUS DISCHARGES IN DG KHAN CANAL

Tables 5 (a to e) and figures 5 (a to c) exhibit the sediment charge data for the monsoon periods of 2003 (pre excluder) and 2009 (with excluder) at the head regulator of DG Khan canal. The sediment carrying capacity of the canal for sediment of 65 to 250 microns is about 250 ppm. The tabulated data and the figures clearly establish that the excluder operation has reduced the sediment entering the canal by about 31% (average), improving the canal capacity to the designed / authorized level and has eliminated the need for canal closures for flushing the accumulated sediment from the right pocket.

The efficiency of this excluder has been quite high and better than the older excluders in service at other headworks, like Khanki, Trimmu and Kalabagh. Typically, the efficiency increases with increase in sediment charge in the river flow.

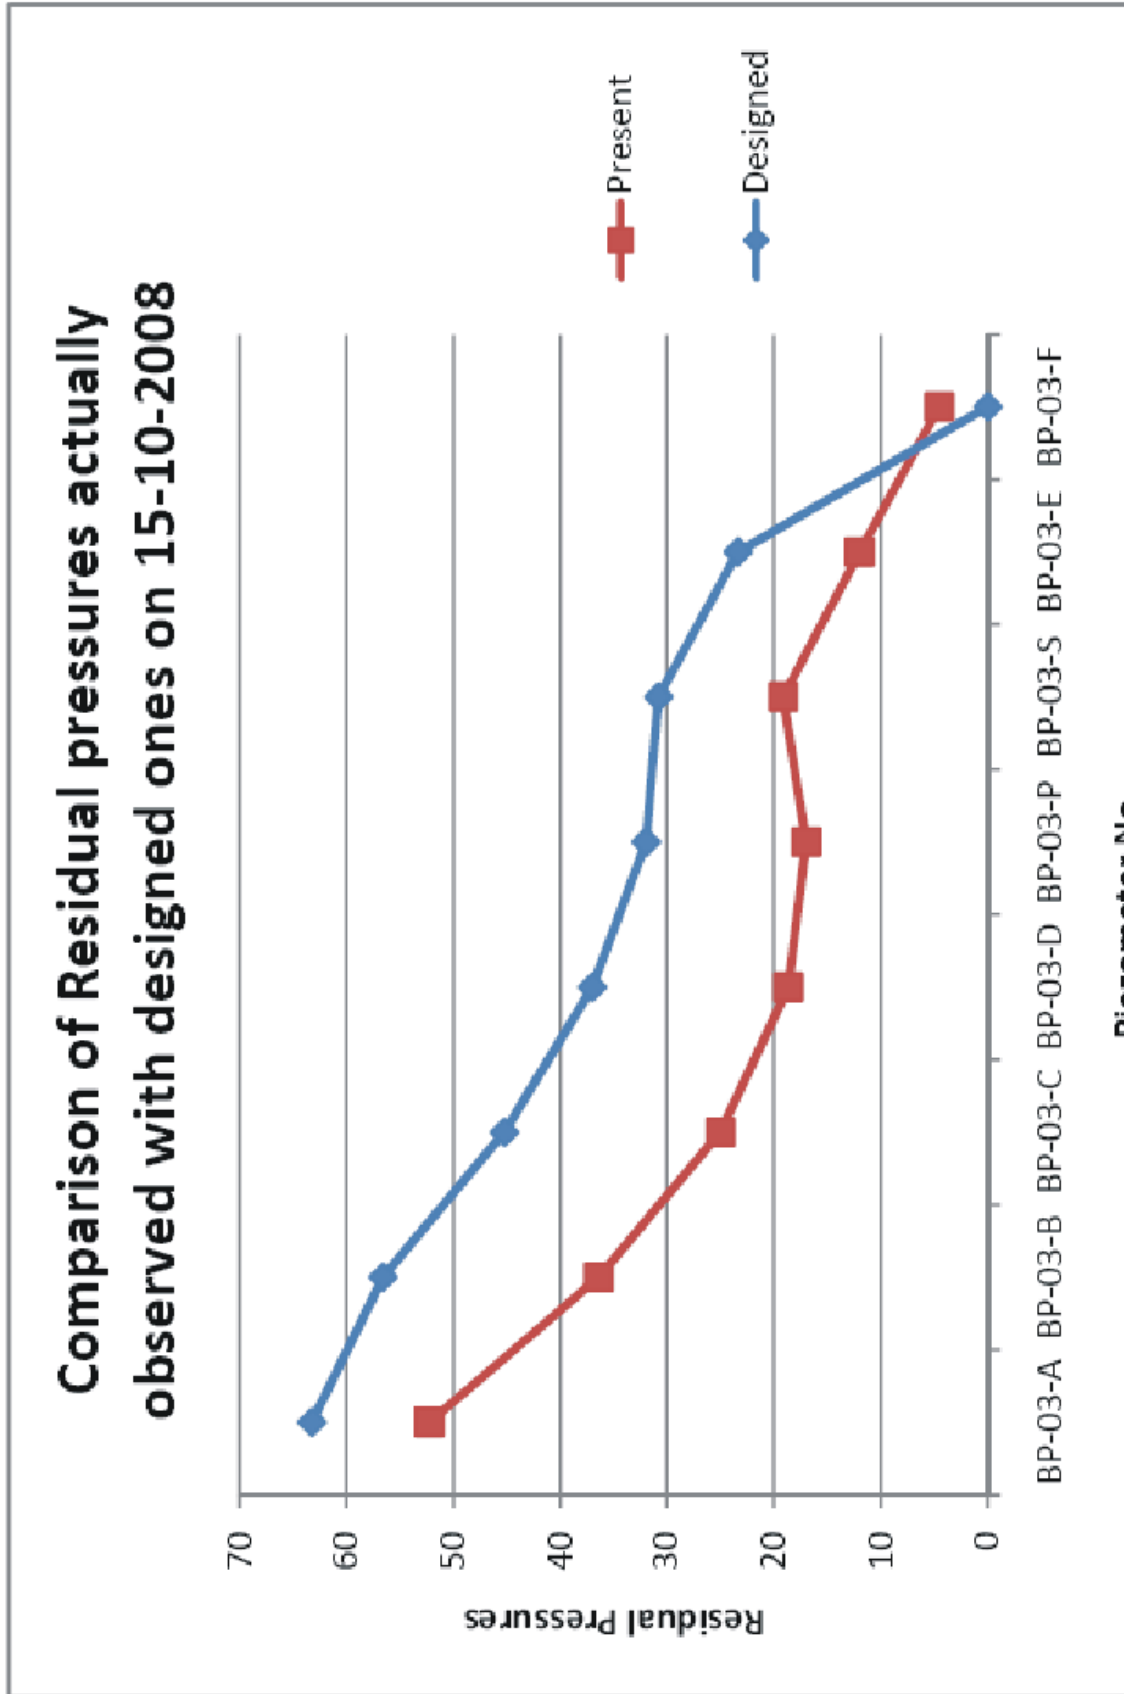
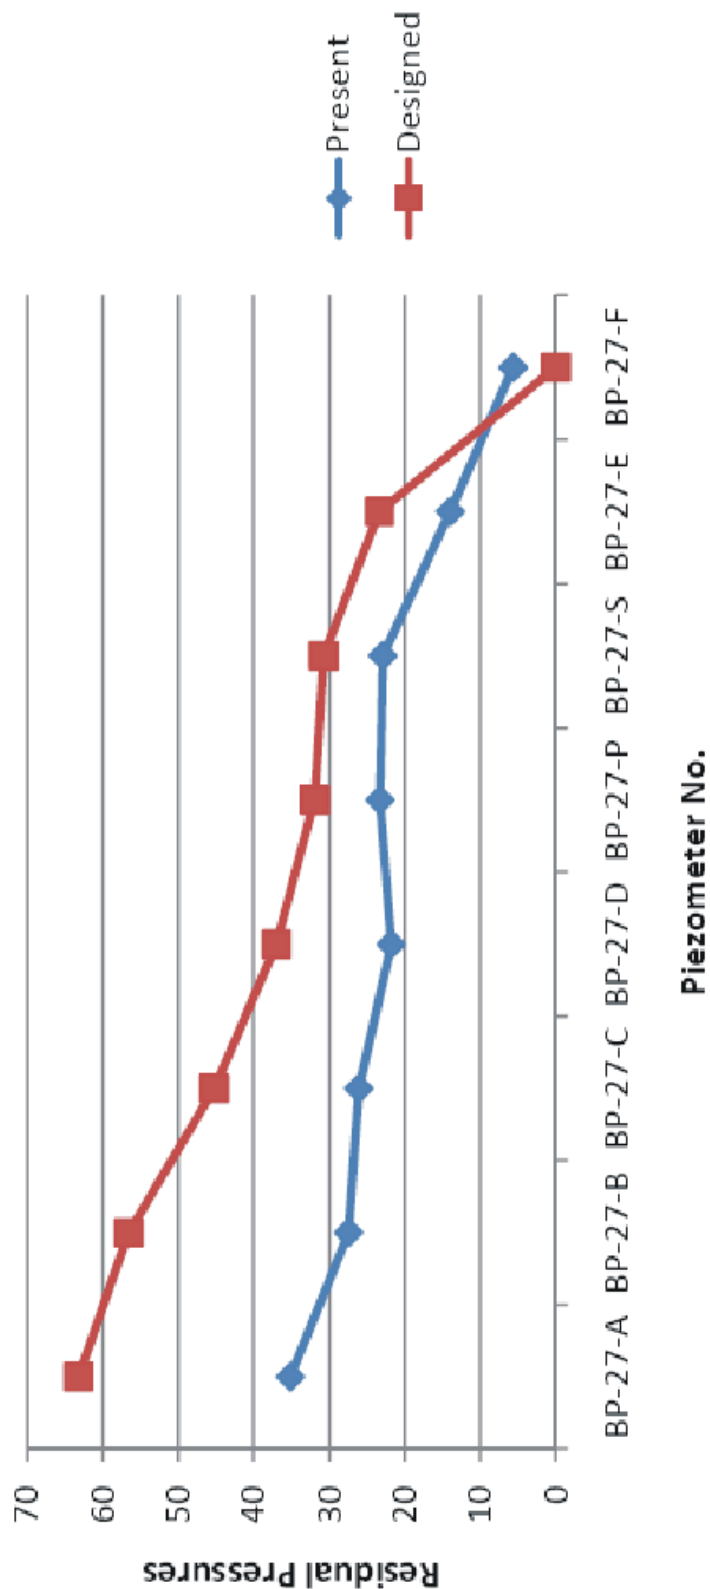
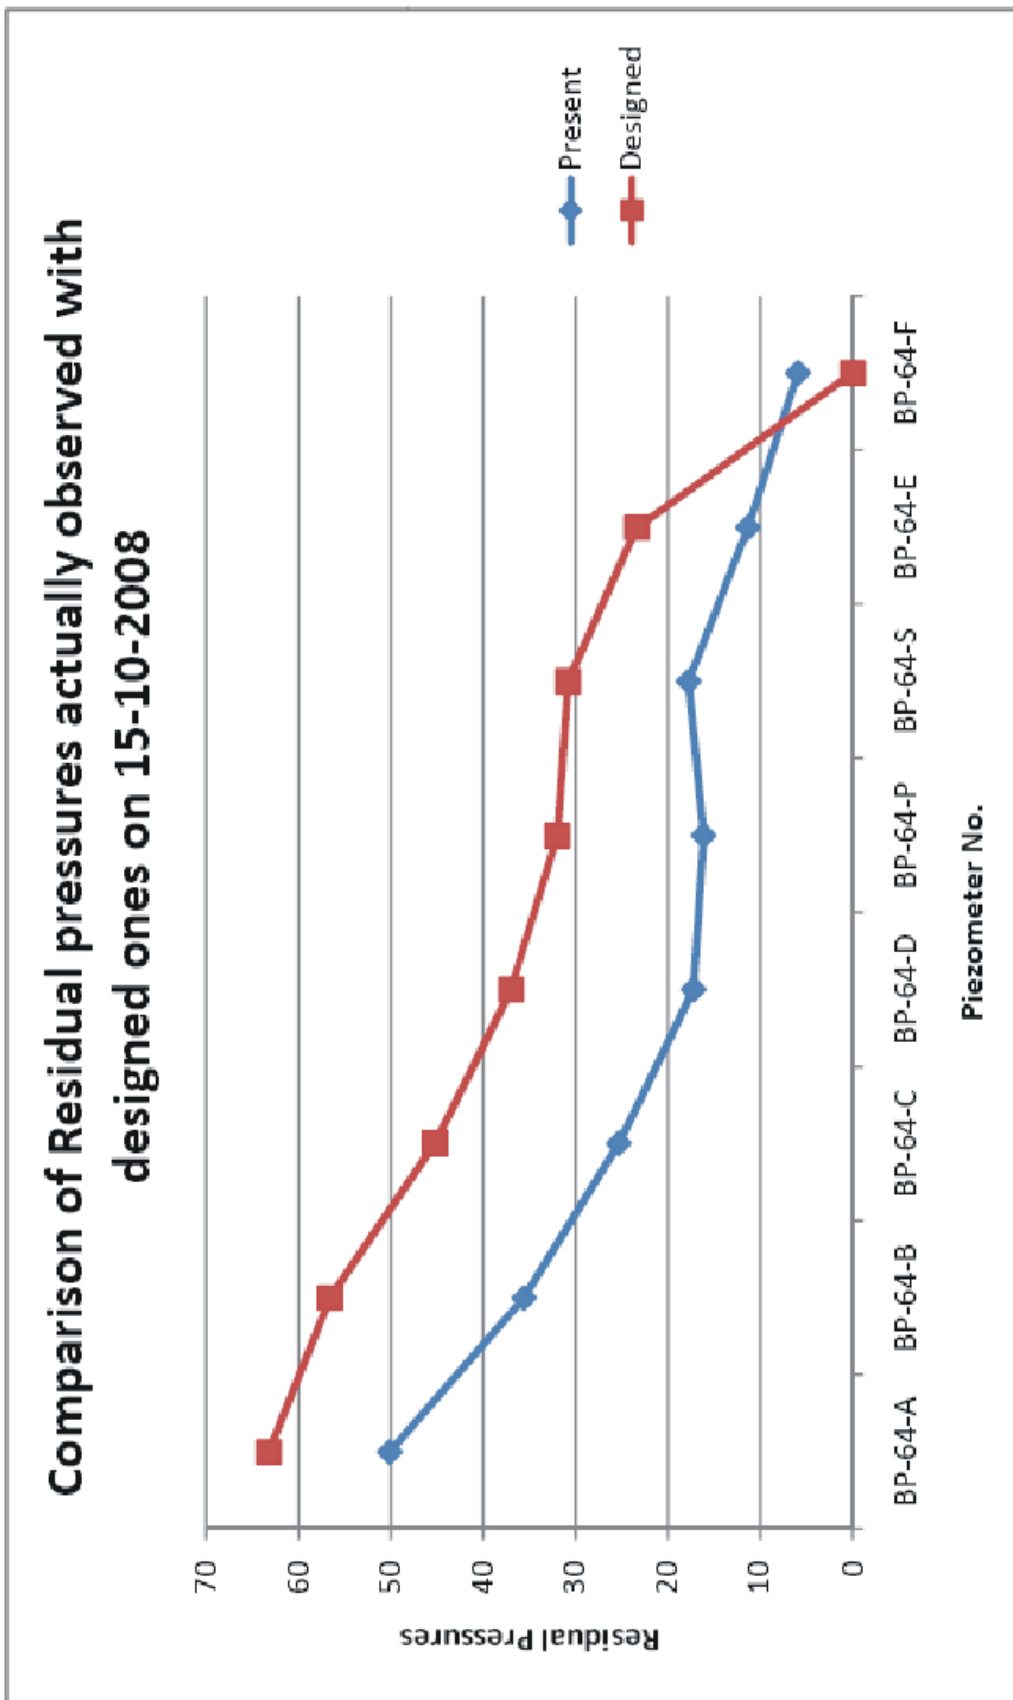
Comparison of Residual pressures actually observed with designed ones on 15-10-2008

For improving the uplift pressure variation monitoring, new peizometers were installed in ten rows in bays # 3, 14, 19, 23, 27, 40, 46, 51, 59 and 64. The location of these new peizometers is depicted in figure-6. The observations for residual pressure in the new peizometers are being taken regularly. According to available data the piezometers are working quite satisfactorily. As a sample, data for 3 bays for 15/10/2008 has been recorded in table 6. This data has also been graphically presented in figure-7 (a, b & c)

The above presentation established that the peizometers are working quite satisfactorily and projecting a correct picture of the variation of residual pressure under the barrage structure.
