**GEOTECHNICAL EVALUATION OF A MORNING
GLORY SPILLWAY FAILURE FOUNDED ON
EXPANSIVE
AND DISPERSIVE CLAY**

Farhat Javed, Brig. Asghar Nasim

ABSTRACT

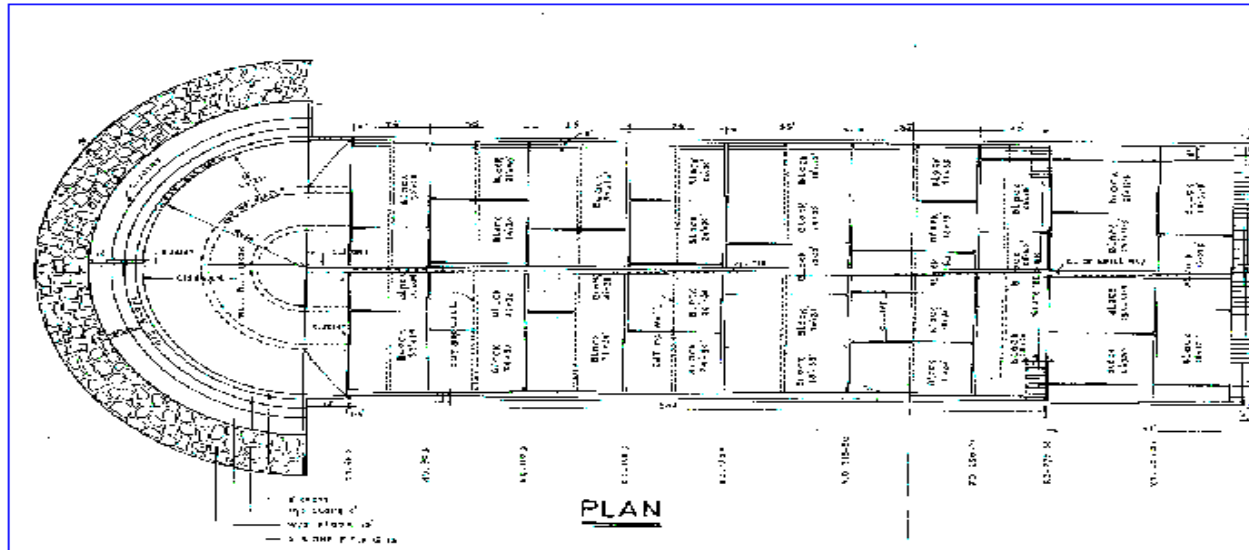
Figure 1(b) Plan view of the spillway (pl. blow up for details)

A concrete spillway structure has been provided to cater for floodwater. The spillway structure has been constructed on the right abutment about 200 m U/S of the main body of the dam by cutting through a ridge. The spillway structure consists of a morning glory type lip with semicircular crest and gently sloping glacis (Figure 1b&c).

During first event of spill the spillway structure experienced severe distress. Most of the concrete slabs resting on clay were washed down and expensive repairs were required to salvage the project. This paper reports findings of the investigations undertaken to determine causes of spillway failure.

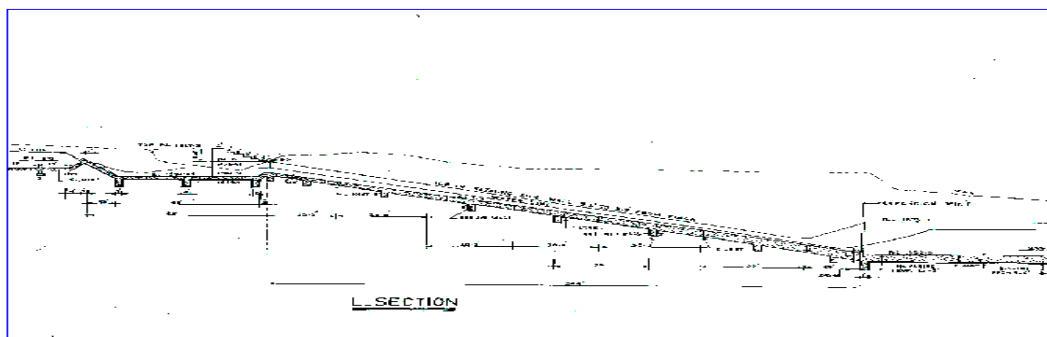
Figure 1(c). Cross section of the spillway (pl. blow up for details)

A stilling basin has been provided at the down stream end of the spillway to induce hydraulic jump for proper dissipation of energy. Two bore holes were put down in the spillway area and it was concluded that the rock units in the spillway area are the same as those at the dam site i.e., alternating beds of sandstone and clay are present in the spillway area as well. The alignment of the spillway structure is across the strike direction. The concrete spillway structure rests mostly on clay beds except for the last two rows of concrete panels and stilling basin that rest on sandstone bed.

cemented conglomerate beds. At the top the thickness of the concrete slab is only 0.5 m that increases gradually down the slope of glacis. The downward pressure exerted by the self weight of slab, therefore comes out to be around 0.1 kg/cm². As stated above the foundation is safe against bearing capacity failure. Oedometer tests (Fig 4 & 5)conducted on specimen prepared from undisturbed block specimens yielded most important results that seem to provide insight into failure mechanism. Results of all specimens collected from U/S, center and D/S portions of the spillway yielded similar results i.e., the soil expanded when it was exposed to water. The free swell of specimens was in the order of 10 %. Another set of Odometer tests indicated that the swelling pressure for the foundation material of Surla dam spillway is 1.0 kg/cm². This swell pressure is roughly ten times the downward pressure being exerted by the slab itself. This explains the lifting of slabs upon first filling of the reservoir for it is well known that swelling can initiate failure (Hudson, J.A and Harrison, J.D, 1997; Katzir & David 1968 ; Franklin, J.A and Dusseault, M.B 1989). Swelling of foundation shale upon exposure to moisture definitely took place. The heavy cracking of the slabs and possible opening up of joints can easily be visualized if the process of first ponding is taken into consideration. As water was stored in the reservoir for the first time, a waterfront within the foundation soil started to move towards the spillway structure. One can conceive that the waterfront started to move from U/S of the spillway towards its D/S end. Since the permeability of the foundation clay is reasonably low, in the order of 10⁻⁵ cm/s , it is speculated that the movement of this front was slow. As soon as the foundation material under the concreted U/S portion of the spillway received water it expanded or swelled. The swelling clay exerted uplift pressure on the slab whereas the slab tried to contain this expansion. The D/S portion of foundation soil, however, was not exposed to water due to slow movement of the waterfront and thus remained unaffected. This resulted in a pressure distribution on the slab whereby the upper portion of the concrete structure was subjected to uplift forces and the down stream portion experienced only down ward pressure due to self-weight. At some point along the structure the overturning forces were sufficiently high to cause cracking of the concrete slab reinforced with temperature steel only. This process continued as waterfront moved downstream and all slabs resting on shale experienced substantial heaving and subsequent cracking. These conclusions are further augmented by the fact that at site the concrete slabs resting on the sand stone and conglomerate beds have not experienced any distress. The foundation of these slabs is stable and therefore these slabs did not experience any damage. The situation was further aggravated by the dispersive nature of foundation soil. As already stated the soil is highly erodable. During first flood as soon as the high velocity water passed over the morning glory crest and sloping glacis, it entered the crevices and started eroding the foundation. Dispersive clay did not offer any resistance to scouring. Subsequently large caverns were formed right under the concrete slabs. Since the slabs have been provided with only temperature steel on the top, they were damaged heavily after removal of the support from the ground. Some of these were washed down the glacis into the stilling basin. The presence of natural deep cavities and under ground caverns in close vicinity of the spillway structure confirms the dispersive nature of Surla shale and testifies the findings of this study. Expensive repairs to spillway structure were subsequently required to prevent complete destruction of spillway and failure of project.

Erosion of foundation material: Surla dam clay is highly dispersive in nature. Cracking of structure initially occurred due to swelling pressure. When floodwater passed over the slabs it entered underneath them through cracks and started eroding the foundation clay. Due to highly dispersive nature of clay, the foundation did not offer any resistance to erosion and large caverns were formed under the concrete structure. The slabs subsequently sagged-in under their own weight and were washed down into the river.

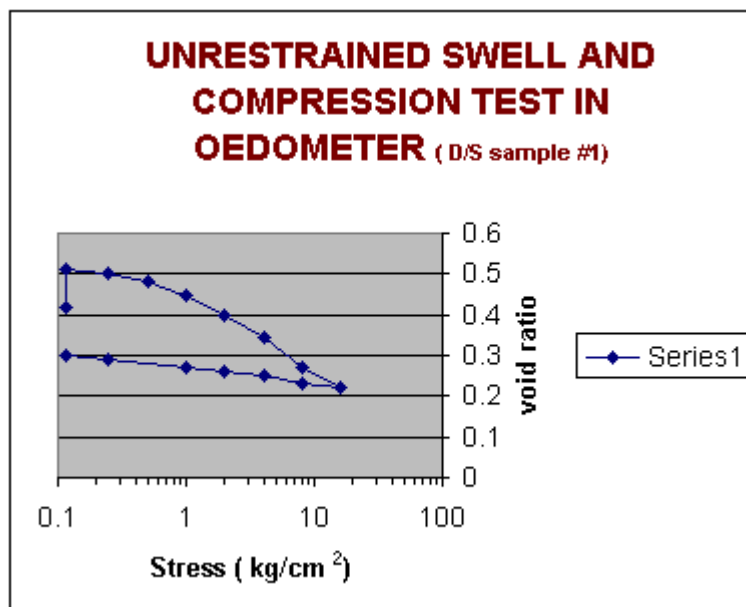
**Figure 5. Results of unrestrained swell and compression test in
Oedometer**

The region is frequented by collapsible soils and it was speculated that failure of spillway occurred due to soil collapse upon saturation. The consolidation test was performed on undisturbed samples collected from the U/S, middle and D/S portions of the spillway. These tests were expected to show collapse of soil structure upon saturation. On the contrary the soil expanded when it was saturated thus establishing that the foundation material is expansive clay. A number of methods and soil tests were used to confirm swelling characteristics of Surla dam clays. These included swelling tests and other simple laboratory tests and correlations with the classification and index properties of the soil. Swelling clays characteristically possess high liquid limit and plasticity Index. For the range of plasticity index of 15 to 28 and shrinkage limit of 10 to 16 the probable expansion of the soil is in the medium range. Thus the clay at Surla dam has medium swelling potential. Similarly when the liquid limit and in situ dry density of surla clay (40 and 1950 kg/m³ respectively) were plotted on the curve proposed by Mitchell and Gardener (1975) , the Surla clay plots as medium expansive(Figure 6). Seed, etal. (1962) developed the relationships (Fig.7) for artificial mixtures of sands and clays compacted to maximum unit weight by standard Proctor compaction and allowed to swell against a 6.9 kPa (1 psi) surcharge. These relationships between activity and percent clay sizes have also been shown to be applicable to natural soils. The purpose of Figure 7 is to identify a potentially swelling soil, which may require further study and tests such as an expansion or swell test. As per this graph Surla dam clay has medium swell potential. Based on *modified free* swell index for clays, as suggested by Sivapullaiah, Sitharam, and Rao (1987), the modified free swell index for Surla clay is 3.54 thus indicating that the soil has moderate swelling potential.
