WARSAK DAM PROJECT PROBLEMS & REMEDIES

Dr. Izhar ul haq
Director DMO WAPDA.

WARSAK DAM PROJECT PROBLEMS AND REMEDIES

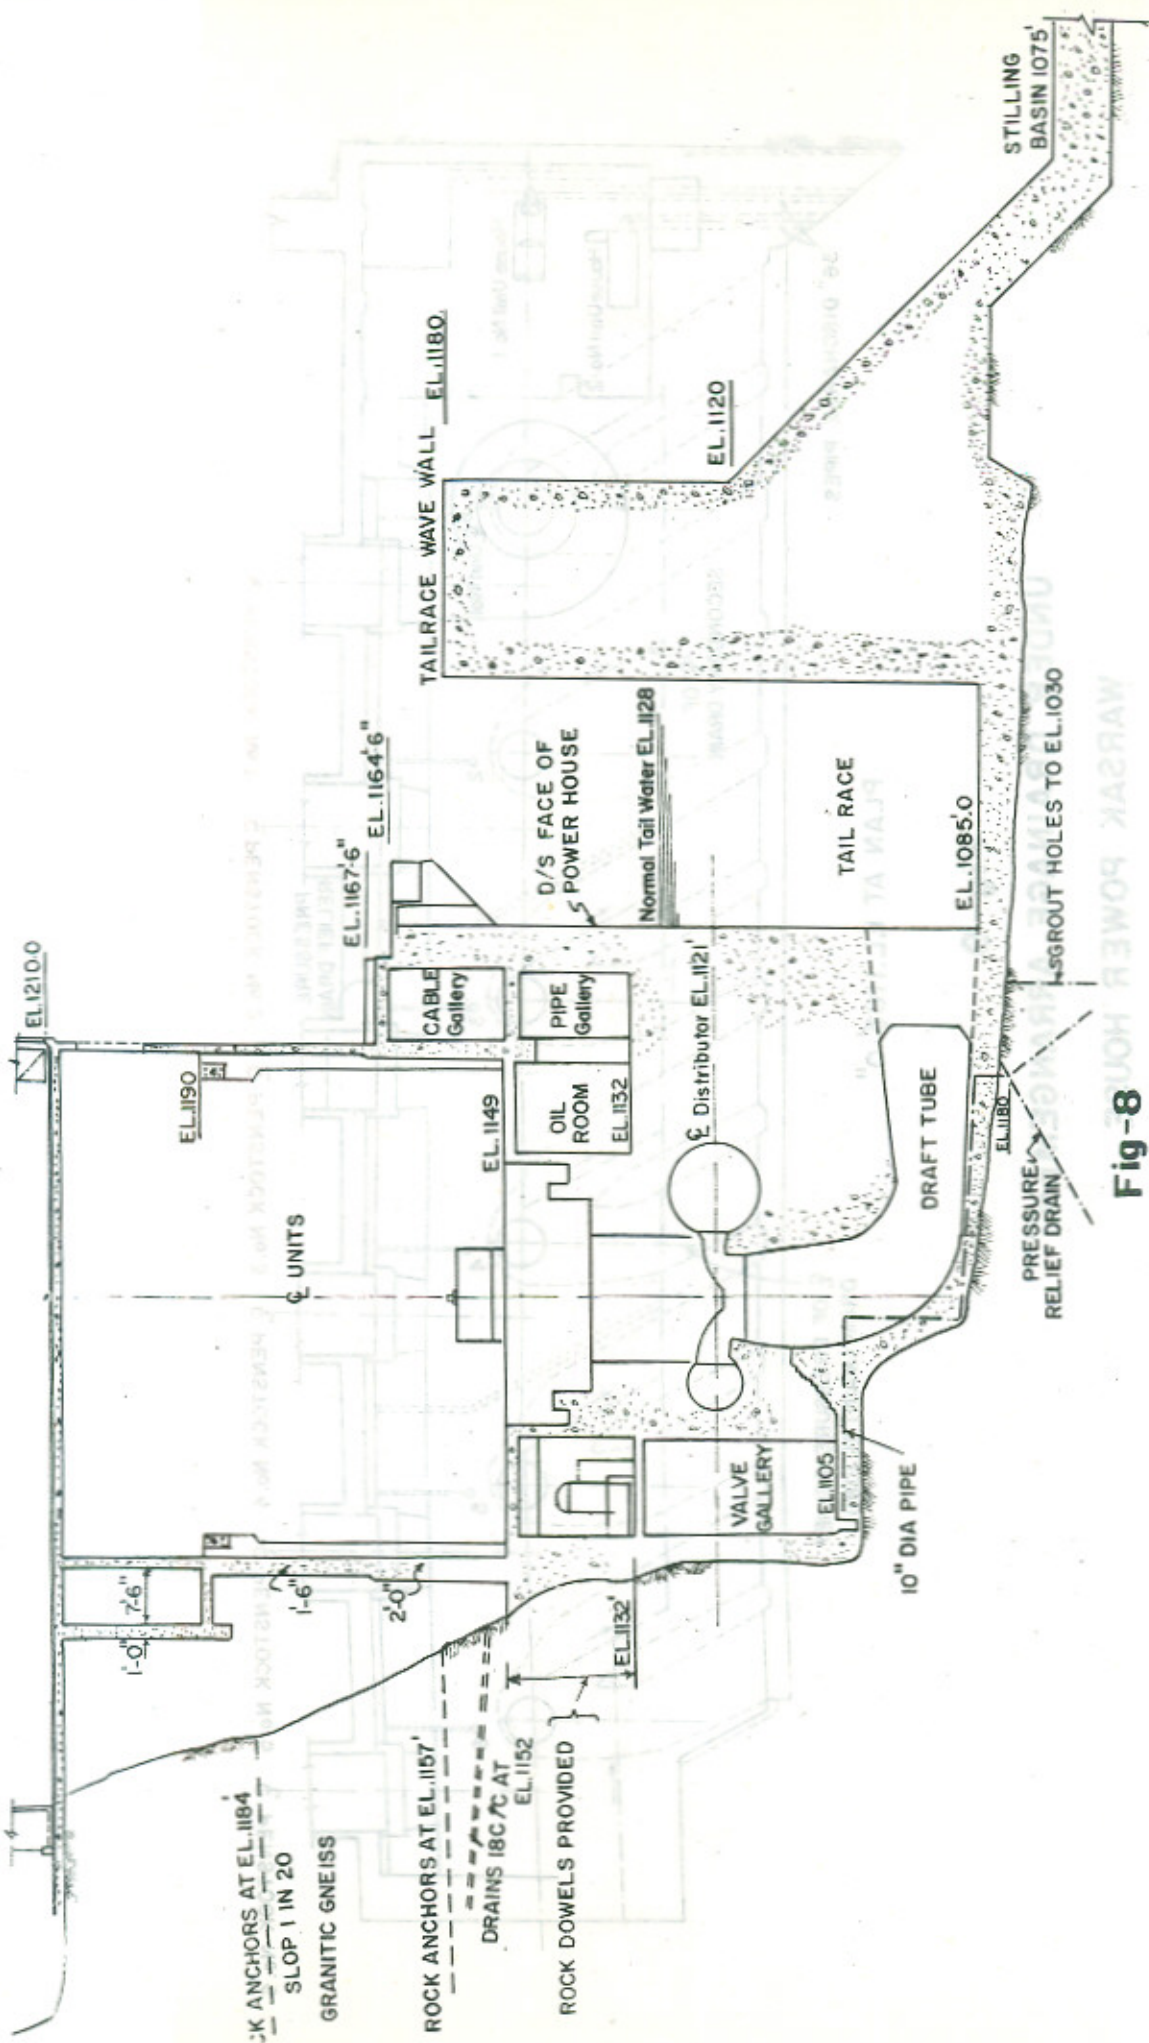
Fig-8

The condition of the various structures and different floors is briefly described in the following paragraphs. For favour of location, the Fig.8 shows a typical cross section of the power house.

**TYPICAL CROSS SECTION THROUGH ϕ UNIT No. 4
WARSAK POWER HOUSE**

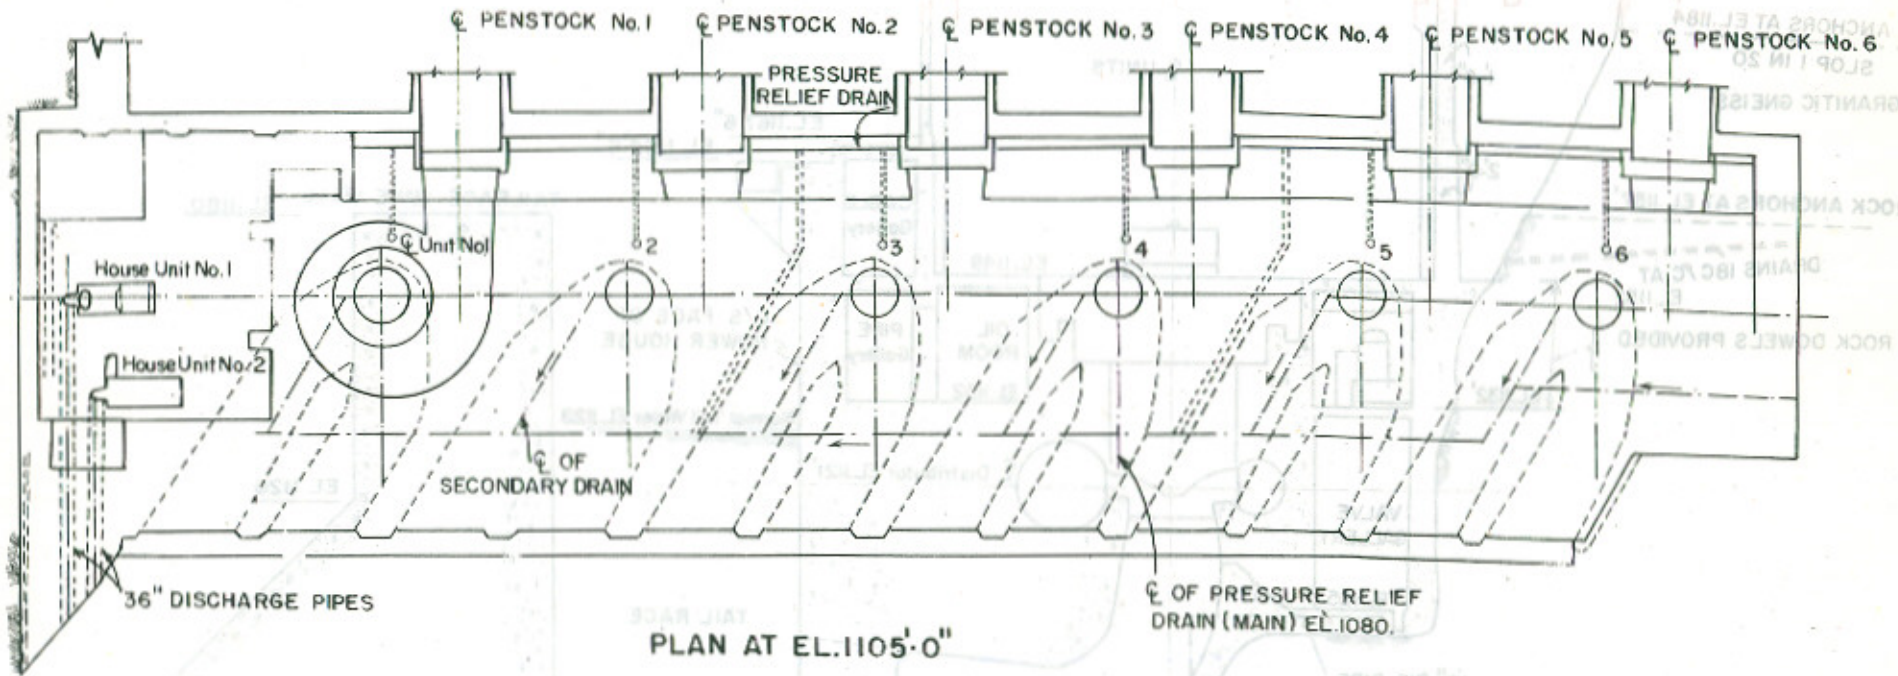
Fig-9
UNDER DRAINAGE ARRANGEMENT
WARSAK POWER HOUSE

The Warsak Power House is equipped with complex system of drains located beneath the building and emptying into an open conduit located on the upstream wall of the valve gallery where flows are channelled to the sump for removal (Fig. 9). Additional drains were also provided from valve gallery floor into rock. The pressures recorded by the piezometers installed by M/s. Golder Associates show that these are not high enough to contribute to the movements of the Power House.

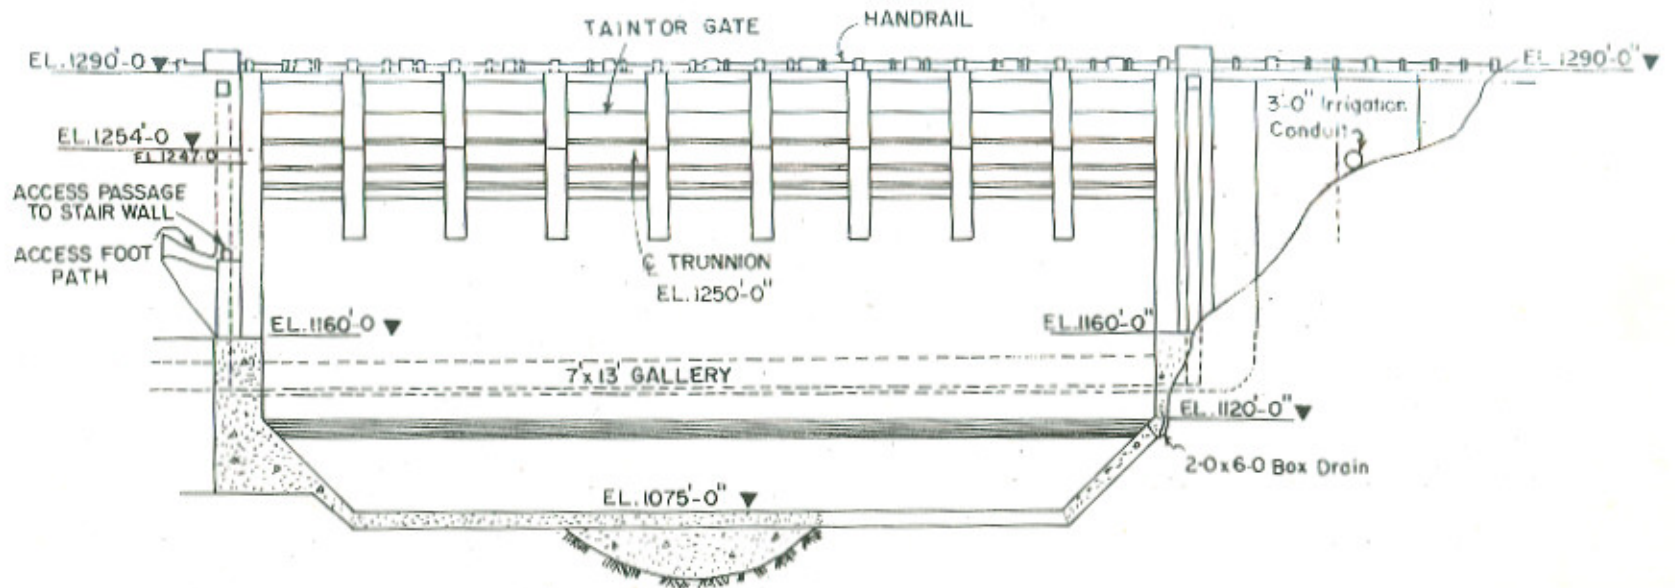
**LONG SECTION
MAIN DAM & ABUTMENTS**

Fig. 10 shows Longitudinal section of Main dam and cross section of the spillway. The design criteria for the Warsak Project included provision for the ultimate complete sedimentation of the reservoir to spillway crest level (El. 1230 ft.). Protection of the power intake structure (semi-circular in plan) was provided in the form of a curved concrete silt baffle wall, with its crest at El. 1240 ft. situated some 80 ft. upstream of the intake structure (Fig. 1). It was apparently presumed that during high flow periods, the bed load sediments would be evacuated through the spillway and that water containing only suspended sediments would pass over the baffle wall and enter the intake structure. However, the configuration of the reservoir is such that, under high flows, the main flow channel is concentrated along the right bank (on the outside of the curve) near the dam so that the direction of the flow of heavy bed load sediments is towards the intake structure before reaching the spillway. The sediments have long since overtopped the baffle wall and have burried the two lower sections of the trash racks. Model studies carried out by WAPDA indicate that as much as 80% of the total bed load sediments pass through the power intake structure at the present time.
