**SEEPAGE CONTROL AT TARBELA DAM  
THROUGH  
UPSTREAM BLANKET**

**AMJAD M. AGHA,**  
M. ASCE, MIE (Pak)

Chief, Soils and Foundation Division  
National Engineering Services (Pak.) Ltd. Lahore

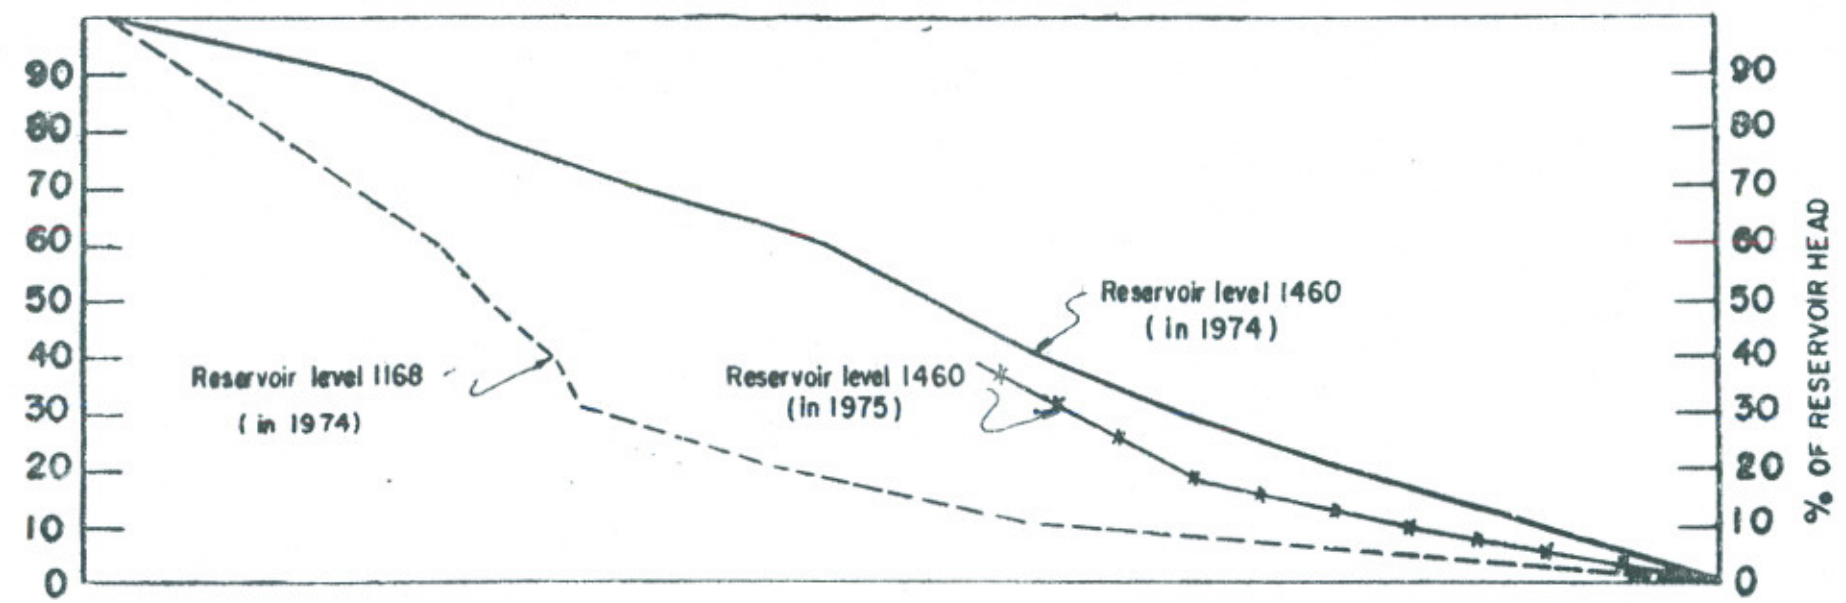
Fig. 4

plot BB, (Fig. 4) in the middle of the valley, shows very little potential drop in the extended portion of the blanket, and downstream of coffer dam 'C', there is an abruptly steep drop in the potential. The difference in the potential for higher reservoir elevation is not so significantly marked in the mid valley area. The plot CC (Fig. 5) on the left bank shows very little potential drop under the extended blanket and again downstream of cofferdam 'C' there is a steep drop. The potential lines also show a considerable shift from 1168 reservoir elevation to 1460 reservoir elevation, particularly in the area immediately downstream of the cofferdam 'C'.
