### **F-1.0 Post Damage Experiments at Irrigation Research Institute and CSU of Tunnel 3 and 2, 1974-1975.**

#### **E-6.5 Model Studies on Tunnel 2 to Investigate the cause of Damage.**

# Hydraulic Model Studies for Tarbela Dam

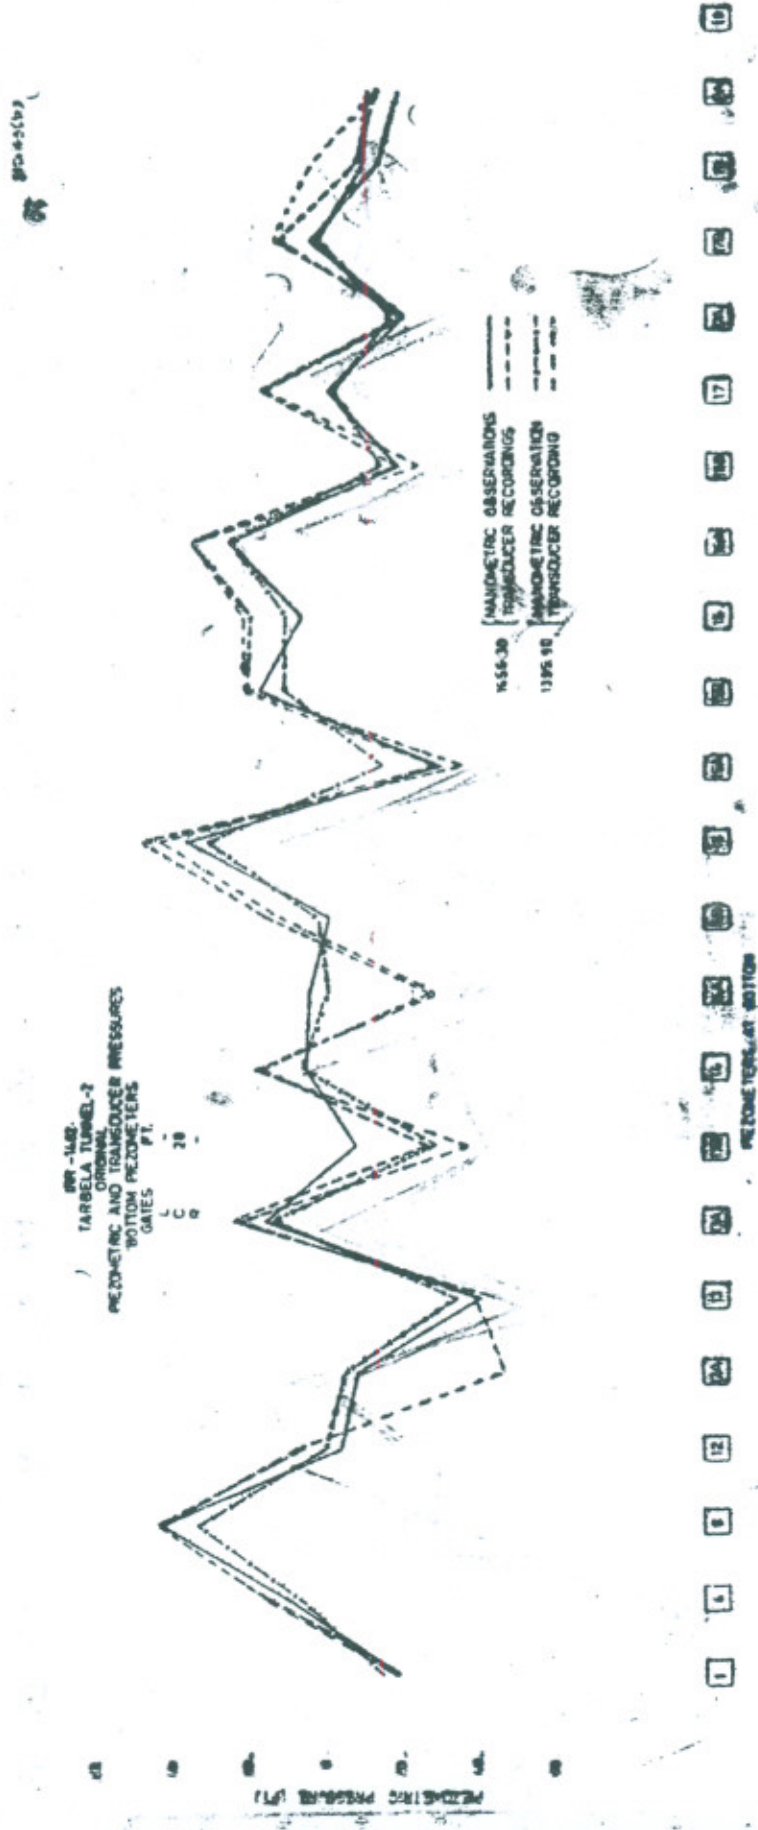
Fig. 43-b

transition. The two spiralling flows interact and form a single white jetting flow that follows the bottom section of tunnels. (See Fig. 42). The piezometric and transducer pressures along invert and  $45^\circ$  angle in the damaged portion of tunnel are plotted in Fig. 43 a-e which indicate negative pressures up to 40 feet during operational condition of 1974. The negative pressure could result in a damage by cavitation. Abrasion due to high velocity of the order of 160 ft. per/sec. can also occur. It is to be noted that material round this tunnel being Sugary lime is highly pervious. Inside negative pressure combined with outside positive pressure built up due to seepage may have caused the tunnel failure. Once the tunnel wall got damaged and punctured in the initial stages the hill consisting of sugary lime stone could be intermittently sucked into the tunnel, explaining the turning of the river water emerging from tunnel 2 intermittently brownish red for a few minutes. The damage progressively increased once the tunnel gave away at one place.
