PAPER No. 215.

RECONDITIONING OF MARALA WEIR.

By E. O. COX, M. B. E., I. S. E., SUPERINTENDING ENGINEER,

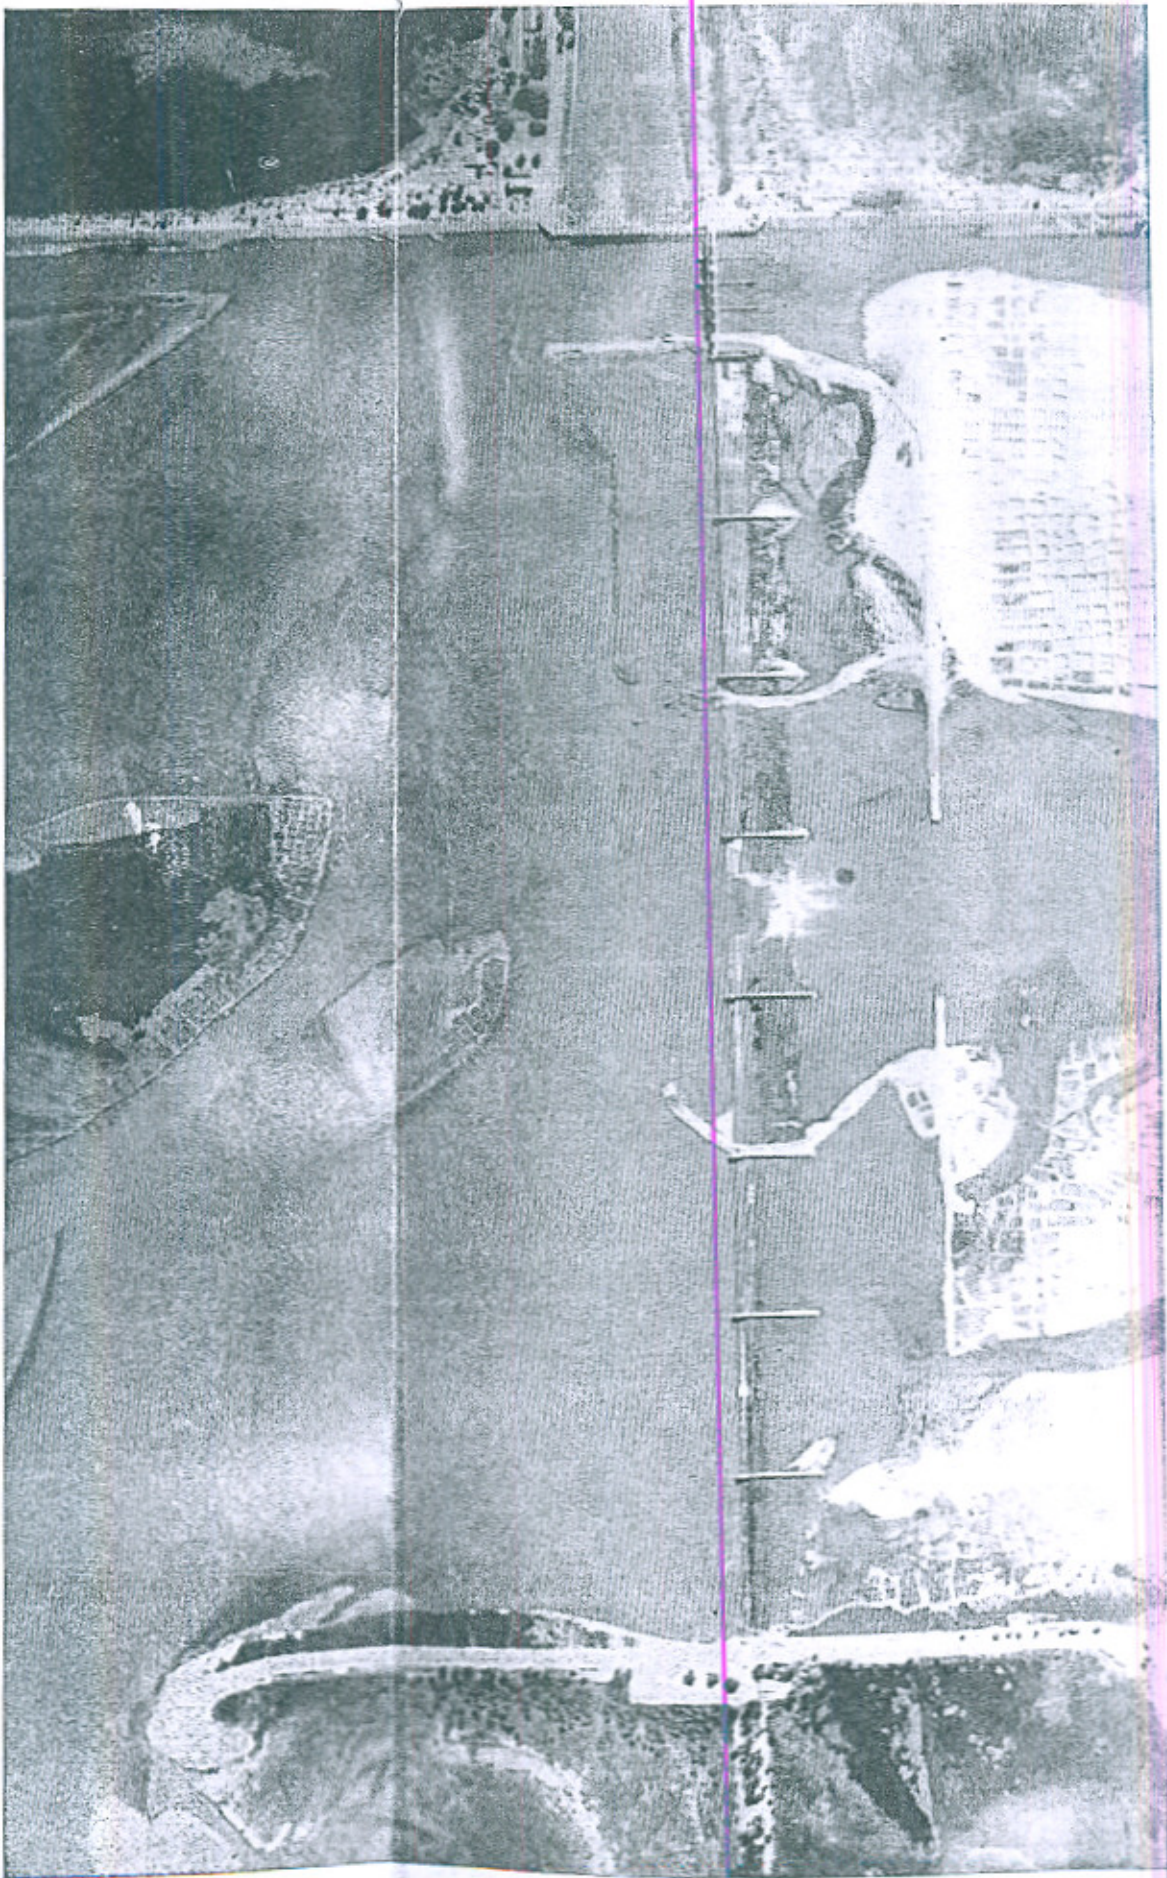
Another factor which led to this decision being arrived at was the existence of high shoals in the river both upstream and downstream of bays 1 and 2 at the end of September, 1936. Photo No. 3 which shows an aerial view of the Headworks taken about the middle of October, 1936 gives a good idea of the shoals downstream of the weir. These shoals unless utilized in the beginning of the season were liable to be carried away if there was an early freshet, and in particular the upstream shoal was going to be eroded in any case by the stream running parallel to the weir and feeding the canal. Thus the conditions which existed

Aerial view of Marala Head Works, October, 1936.

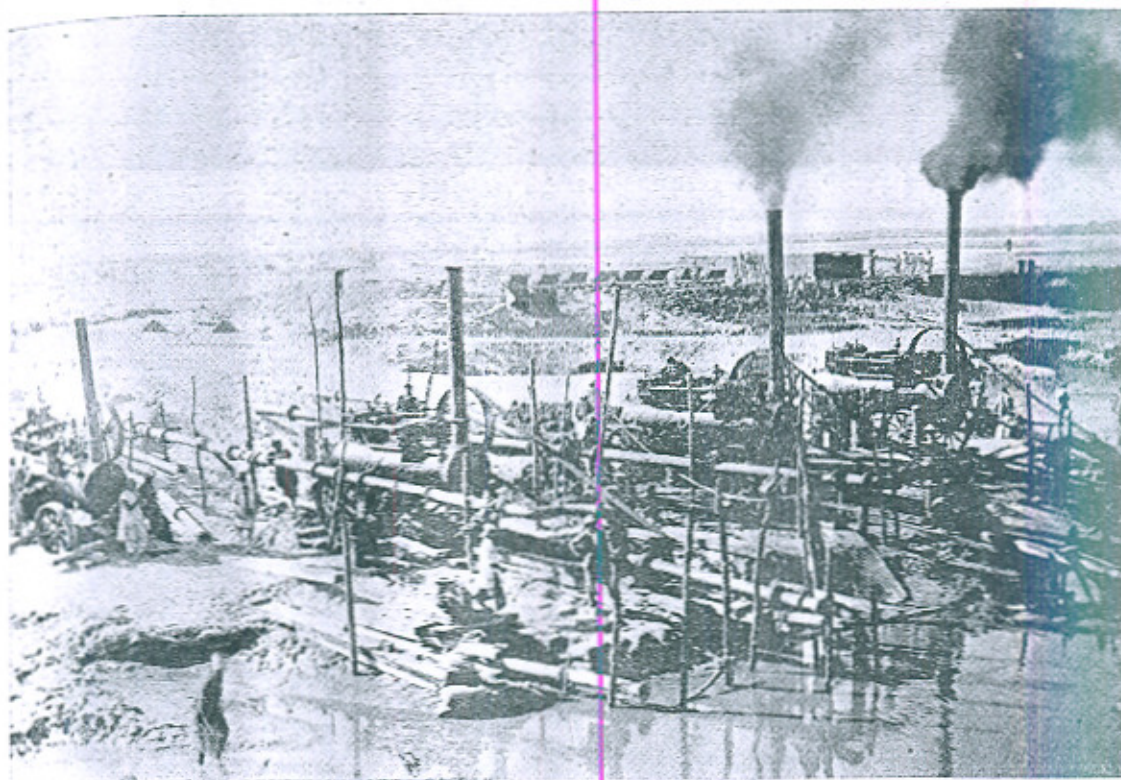
Photo No. 4.

Bays 1 and 2.—In bays 1 and 2 there were large shoals both upstream and downstream of the weir. There was a deep scour hole with bottom R. L. 783 below groyne No. 1. This was utilized as a sump and a battery of pumps was installed on it (Photo No. 4). It was found however, that with four big pumps going downstream and one upstream and discharging about 25 cusecs on the aggregate, the water level could not be lowered below R. L. 787 against a level of 785.8 of bottom of concrete between the B and C lines of wells and of 784.8 in the curtain wall over the pile line. (In the remaining weir bays this deep curtain wall was eliminated by raising the top of the piles by one foot as model observations made in the Research Laboratory, Lahore showed that this could be done safely). Local pumping had therefore to be resorted to and in the left quarter of bay 1 where as already stated above conditions were particularly difficult owing to the proximity of the undersluices, as many as 6 pumps—three electric, one 8" and two 4" and three 6" Petters—had to be installed before it was possible to unwater down to the correct level. A reference is here invited to Photo No. 5.

Battery of pumps downstream of Groyne No 1. Nov. 1936.

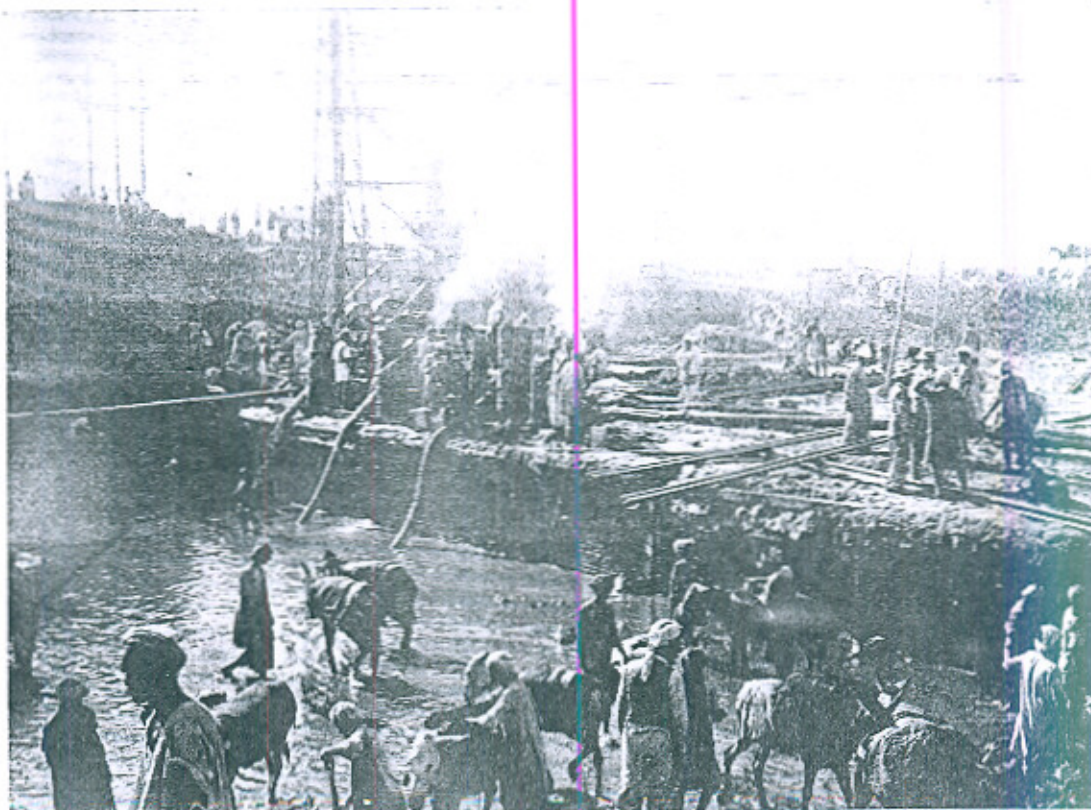
Photo No. 5.

Starting concrete in Bay No. 1 left flank. Mark concentration of local pumping. Date 17-11-36.

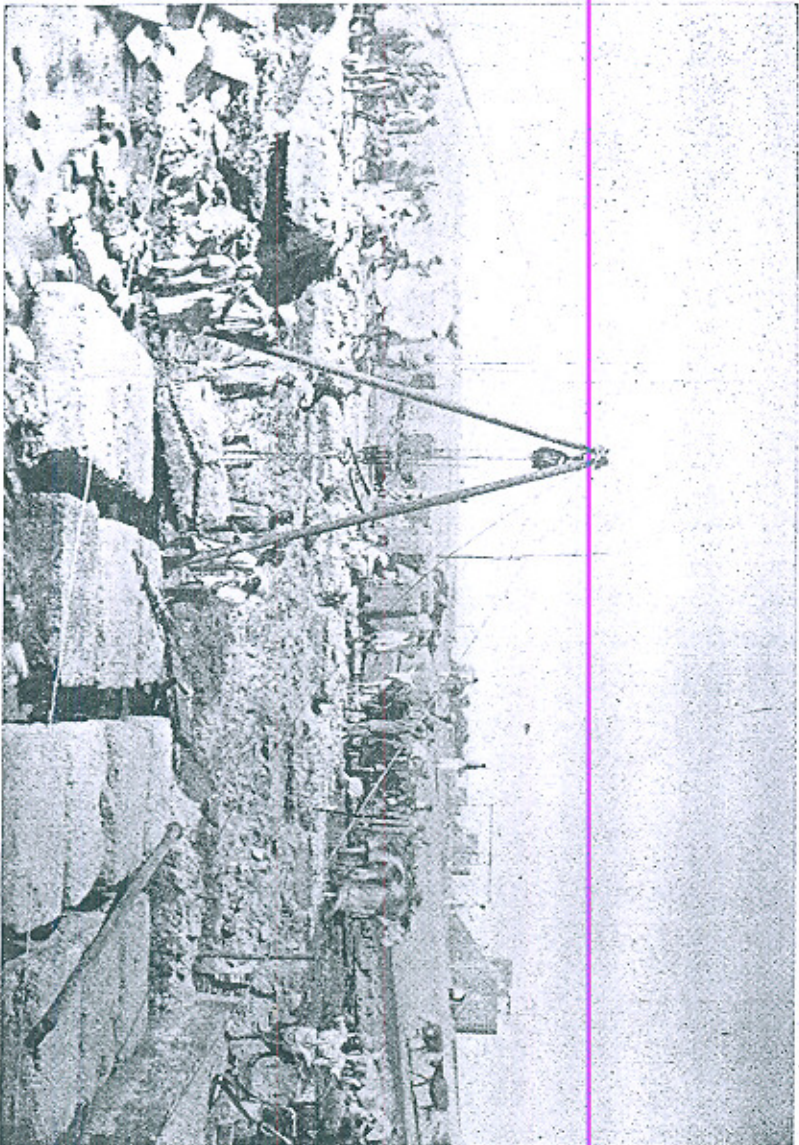
Photo No. 10

Lifting 3-ton block by shear legs. November, 1936.

In bays 4 and 5 it was found that the majority of the blocks had been washed away and replaced by mass cement concrete while many of the lime concrete blocks were damaged and useless owing to the poor quality of the surkhi sand lime mortar. The missing and damaged blocks were replaced by blocks built in stone masonry after an immense amount of labour had been spent in dismantling this raft of cement concrete, every bit of which had to be blasted with gelignite or black powder by night, broken up by crow bars, chisels and hammers during the day and removed by donkeys. As the work progressed further it was found that conditions in bays 6, 7 and 8 were even worse, the number of blocks fit to be used again being about one-seventh the total number required. This involved not only very difficult and expensive dismantling of cement concrete but also the building of new blocks over a large area. In the interest of speed and economy it was decided to build these
