## RECONDITIONING OF MARALA WEIR.

PLATE IIa  
PAPER NO. 215

PUNJAB ENGINEERING CONGRESS  
1938

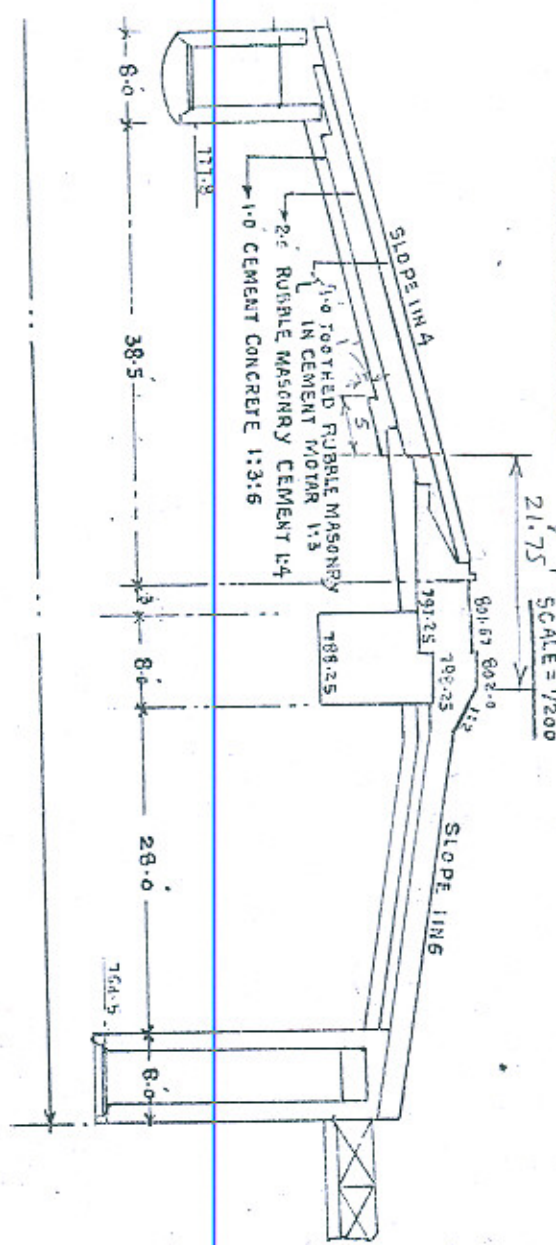
## CROSS SECTION OF WEIR AFTER RECONDITIONING

As shown in Plate II, the old downstream glacis with a flat slope of 1 in 15 was replaced by a glacis having a slope of 1 in 4 above the B line and a horizontal floor between the latter and the C line, depressed 4 feet below the original level. On Plate VIII is given a cross section which shows details of the junction of new work with old and of reinforcement of the new horizontal floor between B and C lines of wells. At the upstream end the new work was bonded into the old glacis by giving a stepped joint in which reinforcement bars were embedded, the latter being grouted into holes jumped in the old work. Unlike the old section the new glacis has a bottom layer of concrete to give it proper bedding on sand which is impossible with stone masonry. Over this bottom concrete there is 2 feet of rubble masonry in 1 : 4 cement mortar

covered by 1'0 foot of toothed *kharwanja* in 1 : 3 cement mortar. As shown in Photo No. 9 the necessary bond between the different layers was provided by the use of binder stones, also the stones in the lower layer were cleared of all mortar before the upper layer was put on. At the B line the requisite bond has been provided by having a layer of concrete at the top of the wells and in the gaps in between and carrying it above and below the well line in one continuous operation. Short reinforcement bars were provided on either side projecting from the concrete inside the wells into that under the sloping floor upstream and the horizontal floor downstream. The latter consists of a mass concrete section 4 feet thick, the bottom 3 feet being a 1 : 4 : 7½ mix and the top one foot a 1 : 2 : 3½ mix. Concrete was laid in layers as at Khanki, the bond between the different layers being provided by stone plumb obtained from dismantling the old floor and by mild steel vertical stirrups. The top layer is reinforced for temperature stresses by ½ inch bars spaced 9" centres both longitudinally and transversally to the weir, the latter being tied to the sheet piles by means of triangular stirrups attached to each pile.

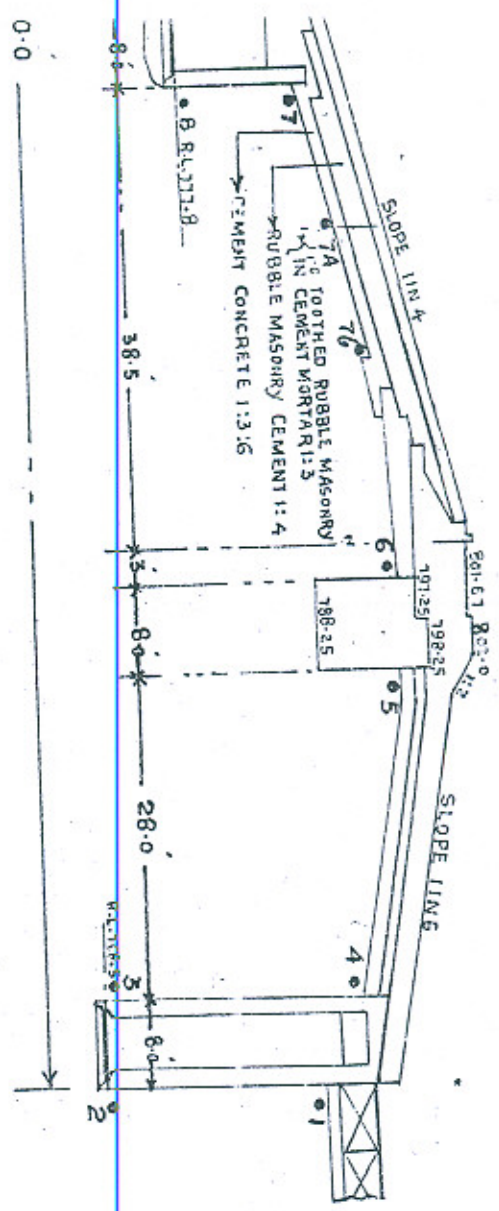
SECTION OF WEIR SHOWING POSITION OF PRESSURE PIPES

Advantage was taken of the work of reconditioning the weir to put in a number of observation pipes under the floor of the weir with the object of determining the pressures under the floor at different sites. The location of these pipes which is shown in Plate XV was decided on in consultation with Dr. McKenzie Taylor, Director, Irrigation Research and Rai Bahadur A. N. Khosla. The water levels in these pipes are being read and recorded regularly. The results obtained so far, however, have been vitiated by the fact that a good deal of the silt deposit on the upstream side of the weir caused by the gapping of the upstream ringbunds after the completion of the work is still there, as during the last monsoon

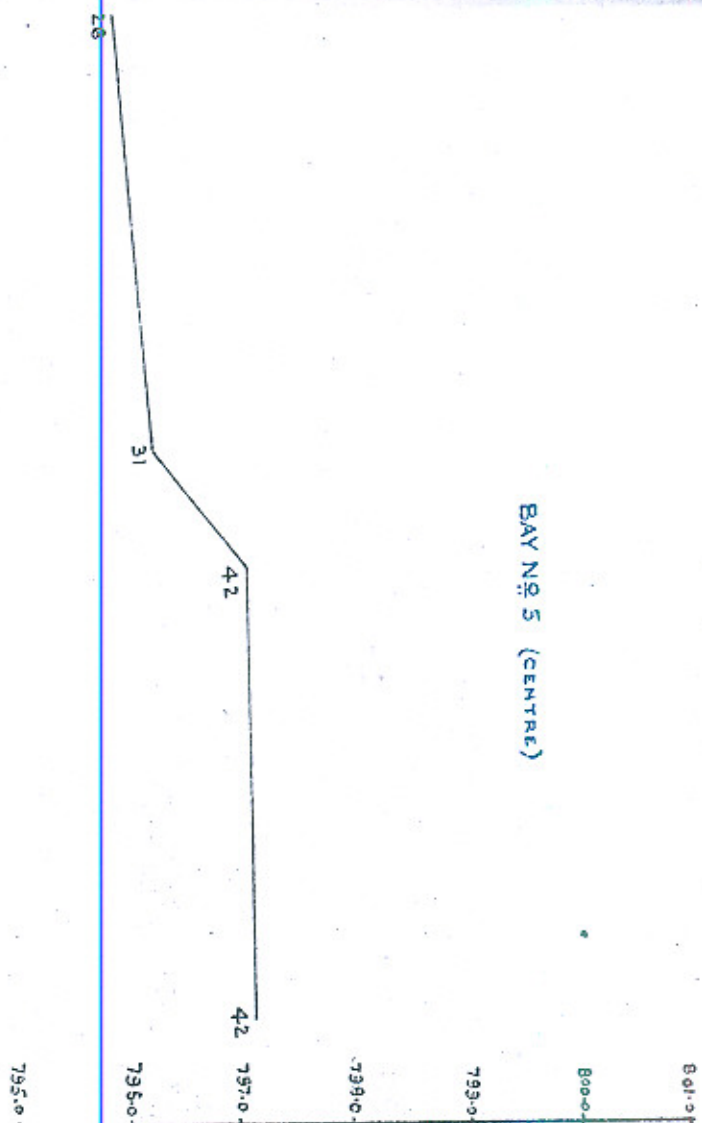
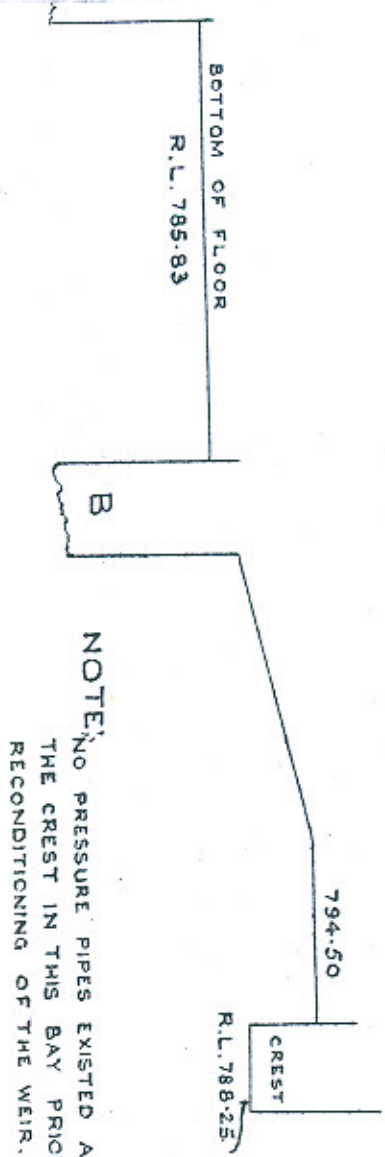
BAY NO. 5 (CENTRE)

DATE 10-2-36  
 U/S WATER LEVEL... 80.0  
 D/S WATER LEVEL... 794.3  
 HEAD ..... 6.7

NOTE: NO PRESSURE PIPES EXISTED ABOVE THE CREST IN THIS BAY PRIOR TO RECONDITIONING OF THE WEIR.

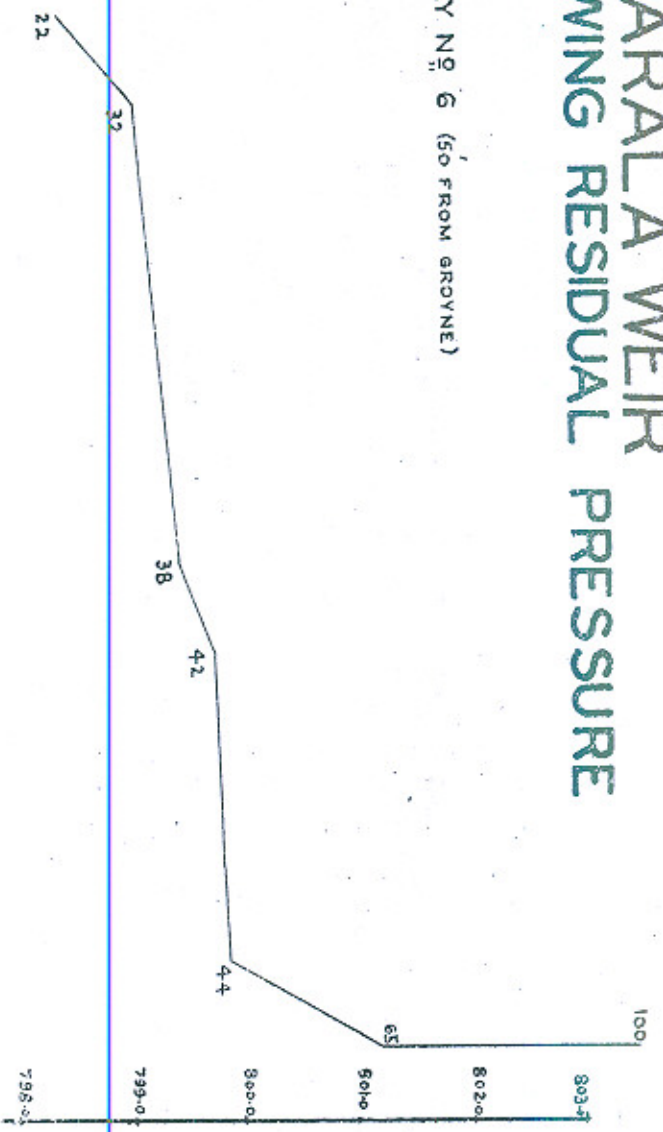
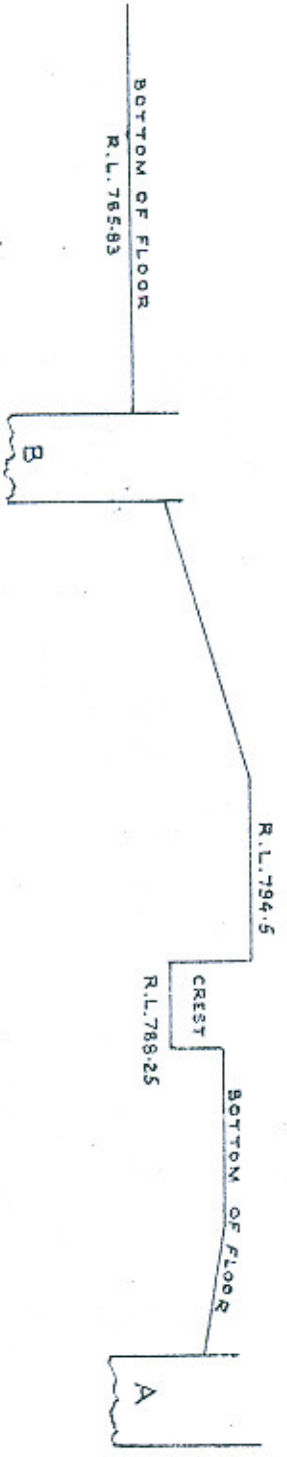
BAY NO. 6 (50' FROM GROUYNE)

DATE 22-3-36  
 U/S WATER LEVEL ..... 803.45  
 D/S WATER LEVEL ..... 797.00  
 HEAD ..... 6.45
