RECONSTRUCTION  
OF  
MARALA WEIR  
PLAN OF WEIR (BAY NO. 3)  
SCALE 1/500

EXECUTIVE ENGINEER  
MARALA DIVISION U.C.C.  
PUNJAB ENGINEERING CONGRESS  
1938

RE-CONDITIONING OF MARALA WEIR  
PUMPING DIAGRAM

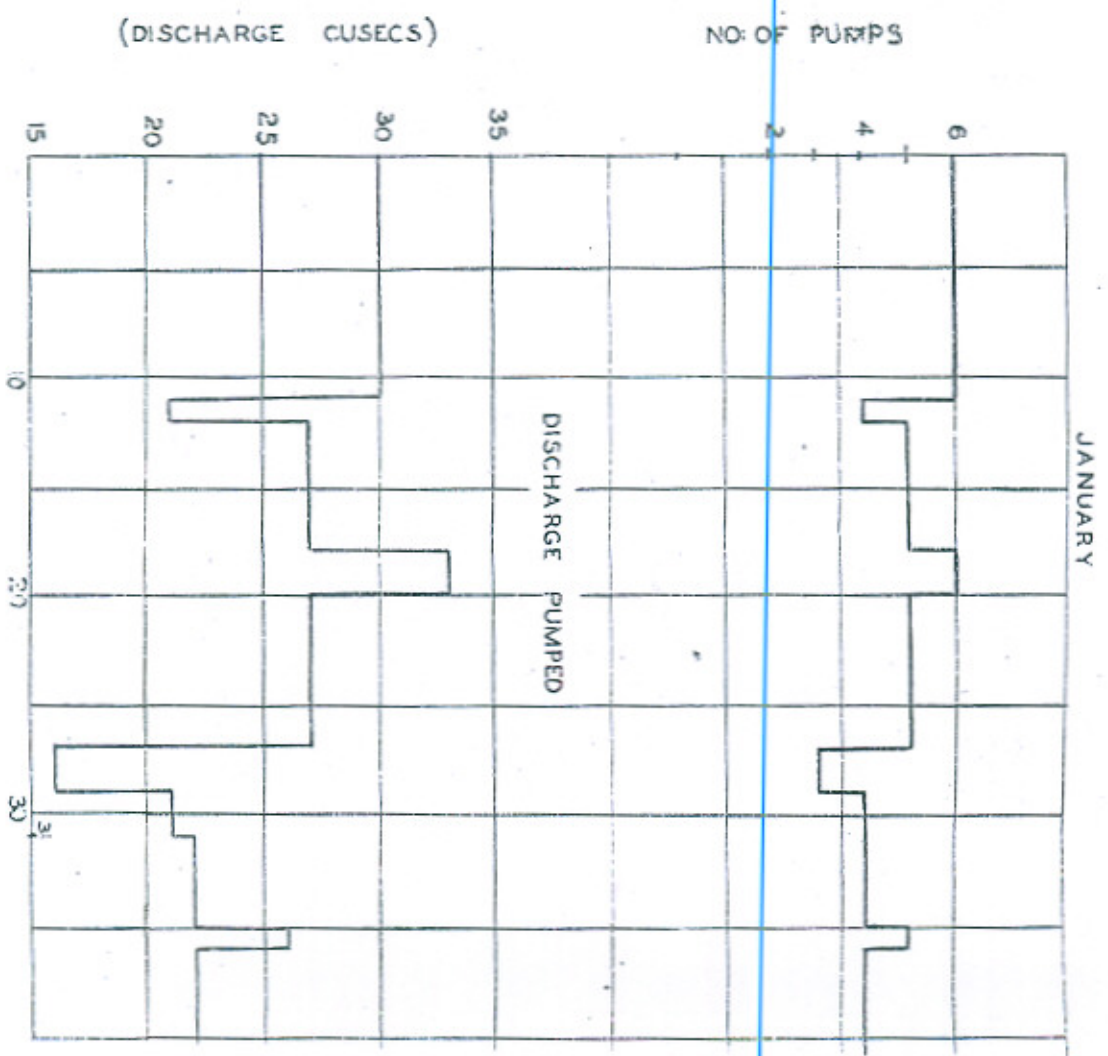
In regard to the pumping arrangements, described on pages 176 to 178, care was taken to see that no sand found its way into the sumps, whether natural or artificial, over which the big pumps were installed. This was secured by proper maintenance of the unwatering drains which led into the sumps. This not only did away with the necessity for carrying out any dredging in the sumps but also eliminated the possibility of the impellers of the pumps being damaged by gritty water.

It had to be stated that the pumping operations done with the old steam engines were most satisfactory. In particular the pumps in the right group were so installed that the water level was depressed 3 or 4 feet below the foundation level and concreting was done almost under dry conditions. The Author had mentioned the programme of work drawn out at the beginning of the construction (Plate V). This programme was jointly drawn out by S. B. Raghbir Singh and the Speaker and supported by the Executive Engineer and accepted by the Superintending Engineer. It was remarkable that the final dates of completion worked very nearly to programme, except for a lag of about a fortnight, as far more concreting had to be done in bays 6, 7 and 8 due to the block protection having been found in a far worse condition than presumed.

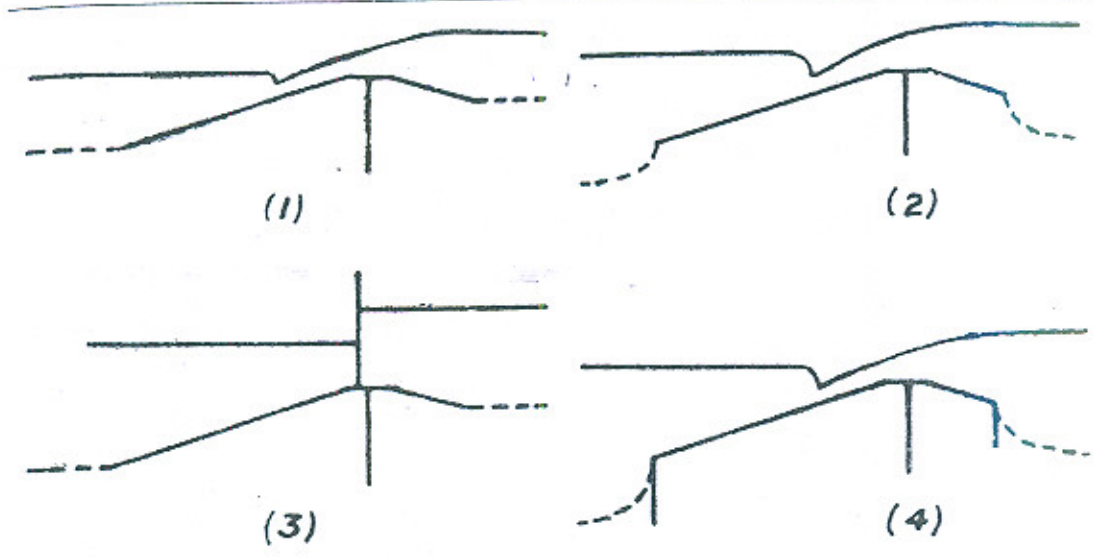
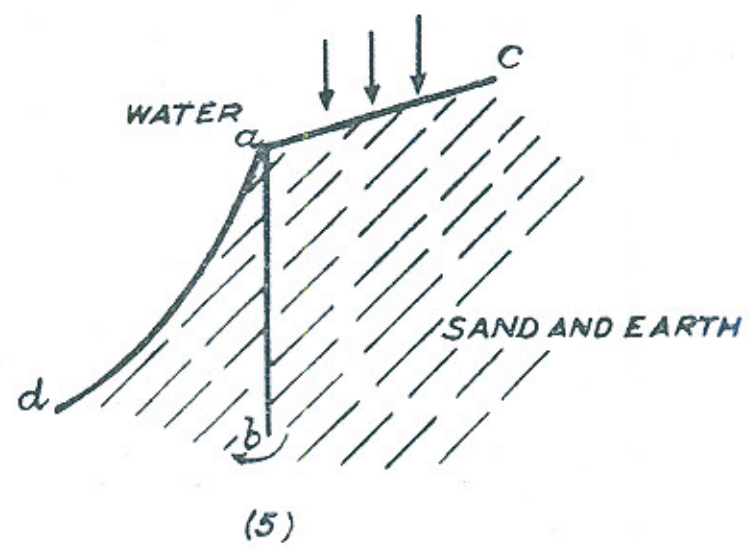
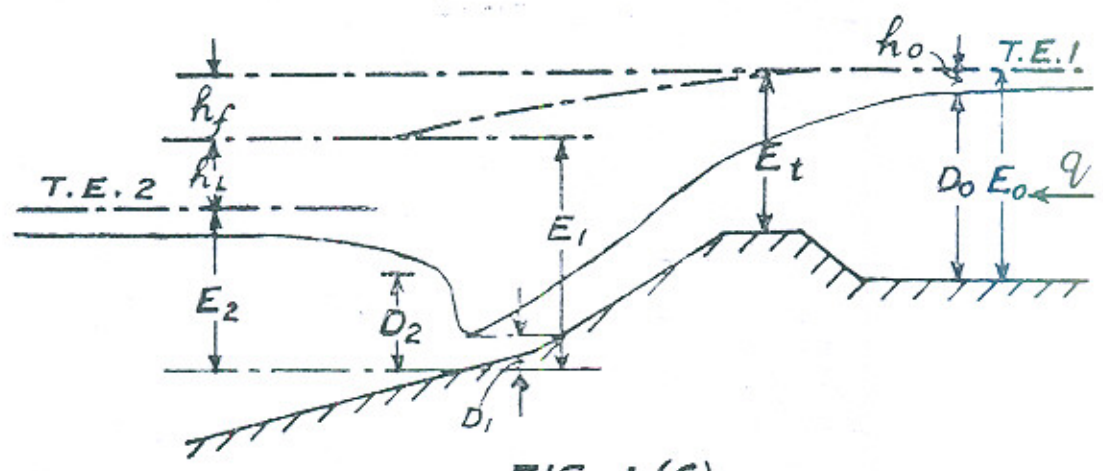
FIG. 1 (6)

The need for understanding not only physical conditions but also physical *principles* was illustrated by the standing wave model for Marala which gave the wave much too small and too far up the glacis. (Another model, for Islam, was said to have reversed the error). The Central Board of Irrigation Publication on the Standing Wave should show the errors likely to arise in model work, and how to correct for them, although some supplementary knowledge was also requisite. In fact there seemed no need for a wave model when it was easy to calculate accurately all that was required.

Thus, suppose Fig. 1 (6) represented conditions over a model, using the conventional symbolism of the Central Board of Irrigation Publication, the upstream total energy (T.E.) line would drop rapidly beyond the crest, due to friction ( $hf$  was the friction loss, which could be assessed almost entirely from the loss on the glacis while  $h_1$  was the loss of head in the wave, the critical depth corresponding to the discharge  $q$  per foot breadth as given by  $D_c^3 = q^2/g$ .

$$h_1 = E_1 - E_2 = \frac{1}{2} D_c^3 (1/D_1^2 - 1/D_2^2) - (D_2 - D_1) \quad (2)$$

Let us suppose, the Speaker said, that the prototype was  $n$  times as big. Could we arrange for exact geometric similarity of flow? To test, put  $nD_1$  and  $nD_2$  for  $D_1$  and  $D_2$  in (1) and it would be satisfied if  $nD_c$  replaced  $D_c$ . This meant that the discharge per foot of the prototype would have to be  $n^{1.5}$  times as great for the model. Neglecting friction between the upstream gauge and the downstream edge of crest, and remembering that the discharge over a long-crested weir varied as  $E_t^{1.5}$  (not as  $H_t^{1.5}$ ), we saw that the upstream still-pond level must be  $n$  times higher from the crest than in the prototype. The waterlevel at the gauge site would not be  $n$  times higher, but somewhat more, as velocity head varied as the square of velocity, which, in turn, meant direct variation almost exactly as  $H_t$ . To be specific, if model  $H_t$  be 1.05 and prototype  $H_t$  be 10.5 and the upstream floor level with crest velocity head.

would be 0.17 foot and 1.56 feet respectively. So generally we could not expect much deviation from truth by dealing with upstream gauge levels (relative to crest) instead of still-pond levels, although theoretically there was some deviation.
