**SECOND REMODELLING PROPOSED FOR
BALLOKI HEADWORKS**

Muhammad Aslam Chohan

1. THE HEADWORKS

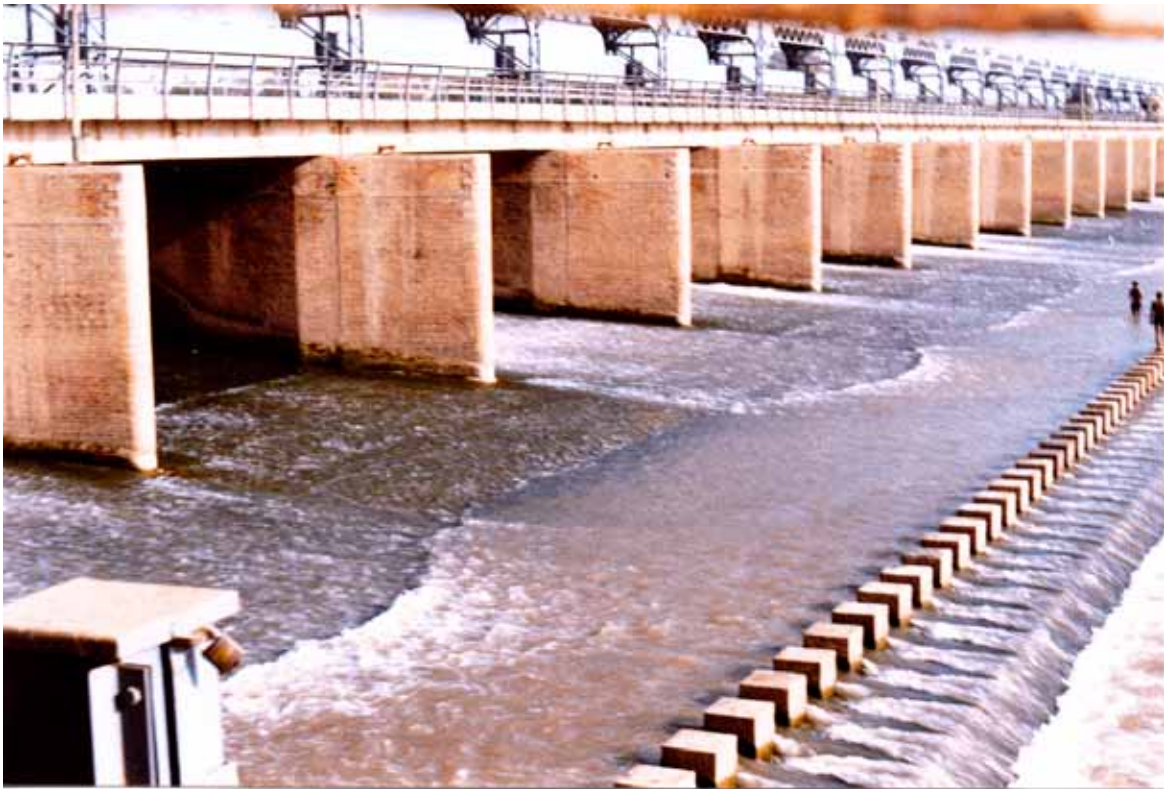
Figure – 4

BALLOKI BARRAGE

Downstream view of Balloki Barrage showing conical extended piers, non-existence of glacis, very flat slope of floor and position of baffle wall with row of friction blocks over it & triangular blocks chute at its downwards slope end (introduced on remodelling in 1964-65).
