PAPER No. 226.

TRAINING WORKS, RIVER CONTROL AND METHODS  
OF REGULATION AT RUPAR, KHANKI, MERALA  
AND RASUL.

By B. K. KAPUR, I.S.E.

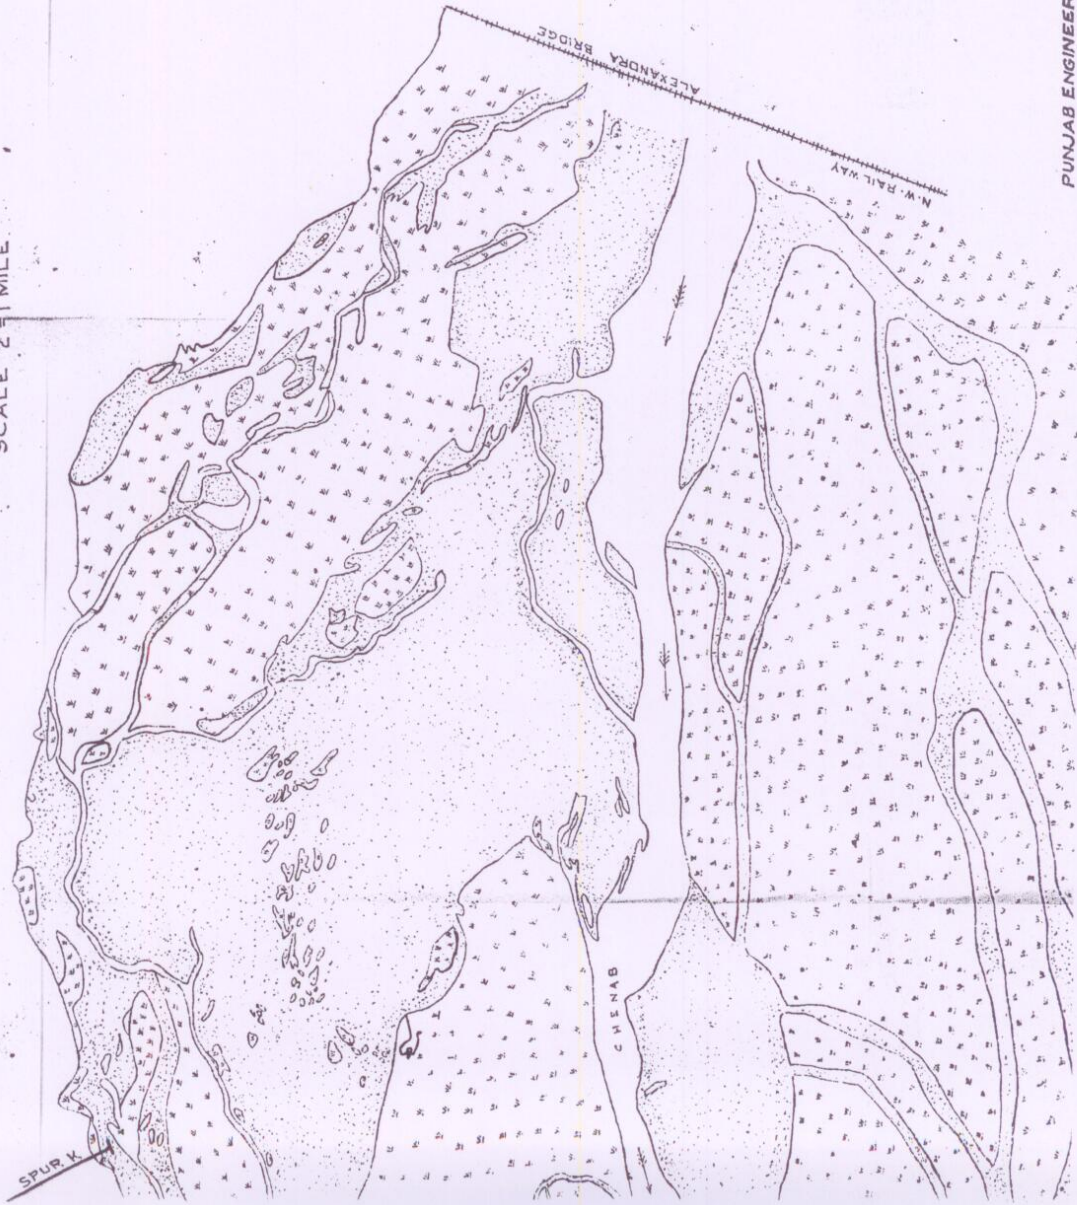
RIVER CHENAB AT KHANKI  
SURVEY PLAN FOR THE YEAR 1903-04  
SCALE 2 = 1 MILE
