TARBELA DAM PROJECT
HYDRAULIC MODEL STUDIES
DEFINITION SKETCH

D-1.0 Hydraulic model studies on Service and Auxiliary Spillway of Tarbela Dam

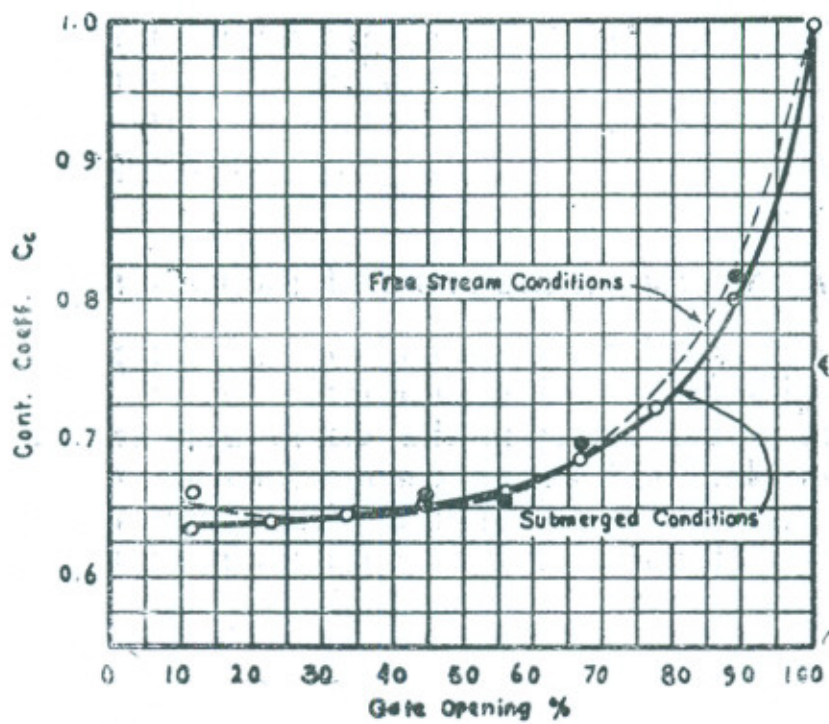
Fig. 25
TARBELA DAM PROJECT
HYDRAULIC MODEL STUDIES
CONTRACTION COEFFICIENTS FOR SERVICE GATE

$\frac{V_c^2}{2g}$ an important flow parameter was used as non-dimensioning parameter. The critical velocity V_c was at the vane contracta of the jet flowing beneath the gate. The contraction co-efficients for submerged and free jets were determined on the model 1/69.6 scale (described earlier with the modification that it had a new gate structure which included total length of the shaft to ground level). The contraction coefficient for both free and submerged conditions is plotted in Fig. 25.

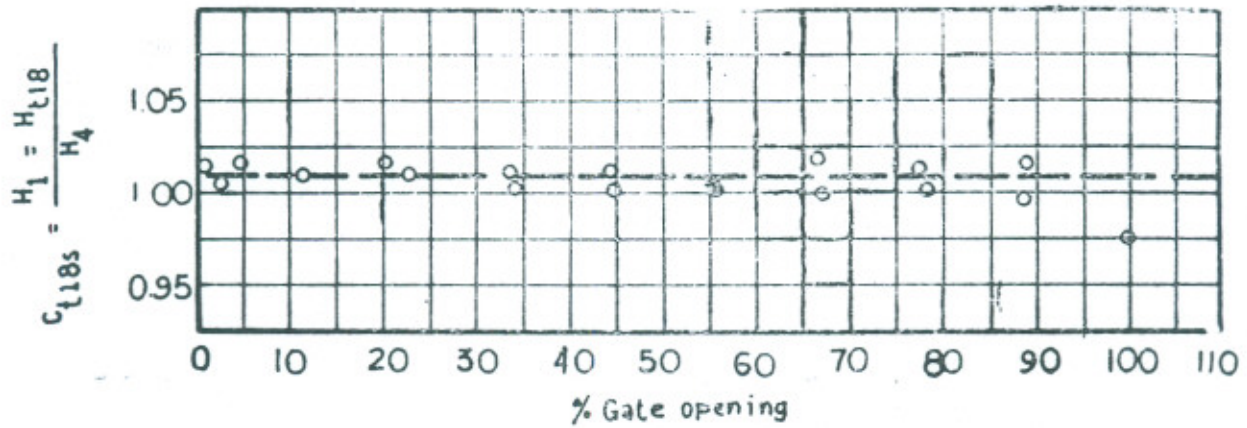
TARBELA DAM PROJECT
HYDRAULIC MODEL STUDIES

Pressure Head Coefficients for the top side of Beam 18
