## Regirdering Ravi Bridge at Abdul Hakim

### The Scheme.

This Bridge was opened to traffic in its original form on the 14th of April, 1900, with the opening of the Toba Tek Singh-Khanewal Section of the Wazirabad-Multan line. It consisted of  $1 \times 100'$  and  $4 \times 90'$  Warren type Pony trusses fabricated in Wrought iron. In 1914 they were strengthened by the addition of a secondary system of triangulation fabricated in steel and by extra sections in the top and bottom chords and end rakers. Extra cross girders were provided at the panel points of the secondary system of triangulation-thus also strengthening the floor system. Fig. 1 shows the spans as strengthened. This strengthening brought the bridge upto SB plus 25% standard of loading, which is equivalent to the present day M.L. loading.

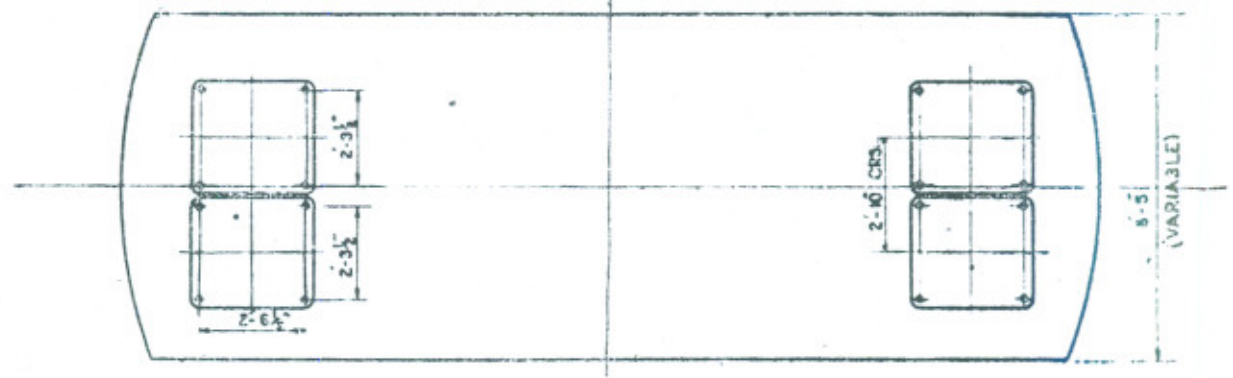
**FIG: 4**

**REGIRDERING RAVI BRIDGE AT ABDOUL HAKIM**

**ELEVATION**

**PLAN**
